**US-70 Over Lake Texoma
(Franklin D. Roosevelt Memorial Bridge)
Section 4(f) Alternatives Analysis &
Report - Revision 2**

**Oklahoma Department of Transportation
JP 33873(07)
Bryan and Marshall Counties**

January 2022

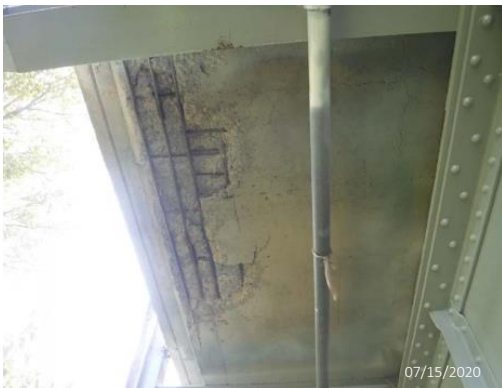
- *Description:* The concrete deck provides a 24’ roadway with 1’-6” wide curbs. The deck thickness varies from 7 3/8” to 8 3/8”.
- *Existing Physical Condition:* The deck generally has cracking, spalling with exposed rebar, failed asphalt patching, abrasion, wear, and lifting off floor beams throughout. The deficiencies cause serviceability concerns for rideability and safety concerns due to loose concrete at the bridge soffit above a navigable waterway.

Figure 18: Inspection Photo: Deck Soffit Spall

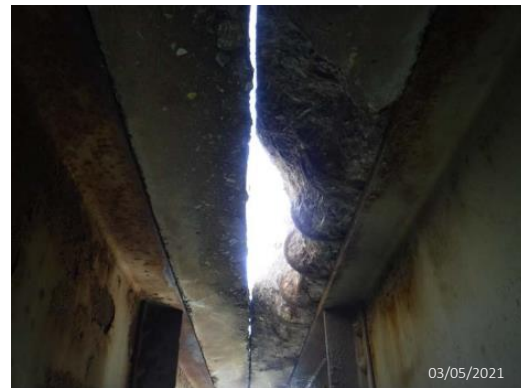
Figure 19: Inspection Photo: Deck Spall

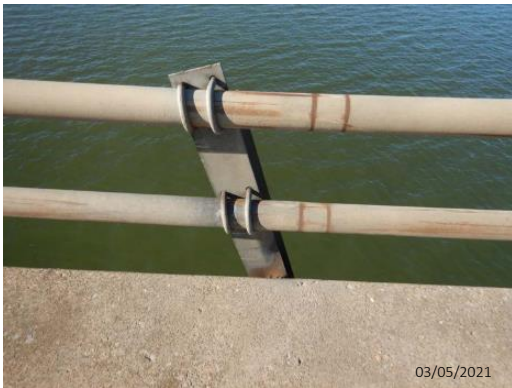
- *Description:* The metal bridge rail is composed of steel W-shape posts anchored to the concrete curb and each floor beam. The horizontal rails are 3 ½" STD. steel pipes attached to the posts with U-bolts.
- *Existing Physical Condition:* The metal bridge railing has been impacted multiple times by vehicles and exhibits misalignment throughout. Past experience has shown that this rail does not adequately re-direct vehicles. Approximately 33% of connection locations are compromised due to sheared, missing, and/or failed connections resulting in complete loss of support capacity. The deficiencies present a safety hazard for the traveling public due to the inadequacy of the rail to protect drivers.

Figure 20: Inspection Photo: Failed Rail Post

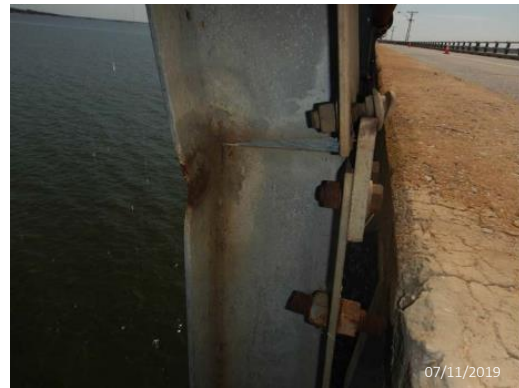
Figure 21: Inspection Photo: Sheared Rail Bolt

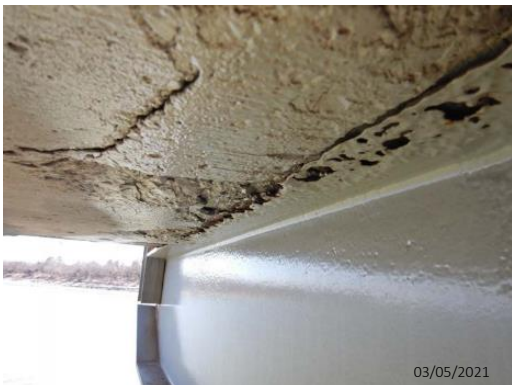
- *Description:* The floor beams are W16x45 steel beams supporting the deck transversely. They are spaced at 8'-7" max center-to-center and cantilever past the primary steel girders 6'-3 ¾".
- *Existing Physical Condition:* The intermediate floor beams exhibit section loss of varying degrees. In general, the section loss is about 1/8" in the flanges. The end floor beams have more substantial section loss with up to 3/8" in the web and 9/16" in the flanges. Recent and ongoing blasting/painting operations have resulted in more section loss than prior inspections revealed. Many of the floor beam exhibit knife edging in the top flanges and in some locations, complete section loss.

Figure 22: Inspection Photo: Floor Beam Section Loss & Knife Edging in Top Flange

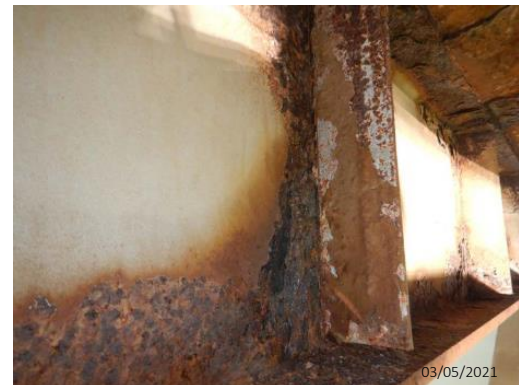
Figure 23: Inspection Photo: Floor Beam Section Loss & Corrosion in Web

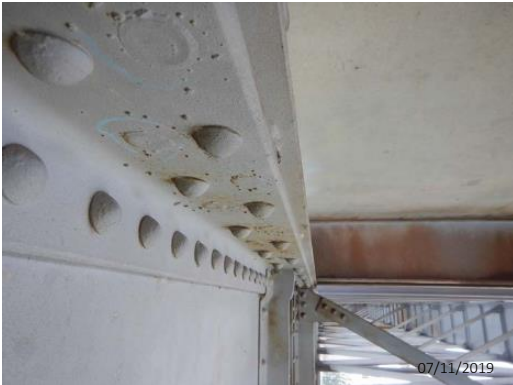
Figure 24: Inspection Photo: Primary Girder Plug Welds

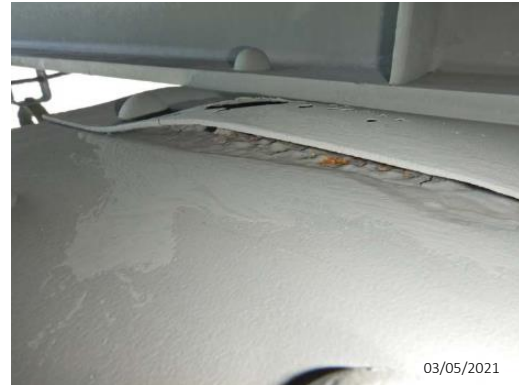
- The web at the beam ends has isolated 1/4" max (1/8" average) deep pitting and surface corrosion at the ends adjacent to bearings; however, the loss is typically beyond the bearing and does not significantly impact the beam shear capacity.

Figure 25: Inspection Photo: Primary Girder Pitting

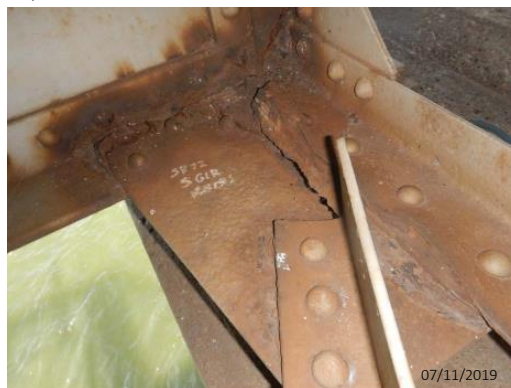
- *Description:* The cross bracing is made up of various single angle cross braces and double angle struts.
- *Existing Physical Condition:* There is pack rust with section loss (including through holes) with adjacent knife edging at many end panels adjacent to piers.

Figure 26: Inspection Photo: Bracing Corrosion

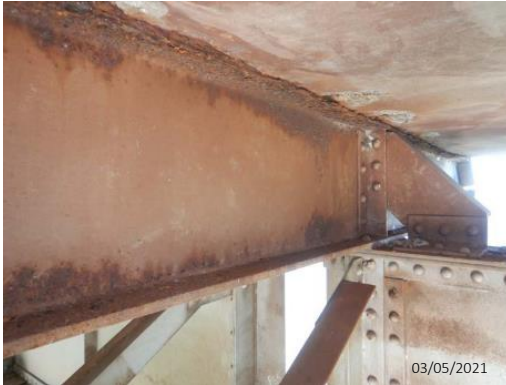
- *Description:* Utility towers carrying overhead electric run the full length of the bridge. These towers are framed to the superstructure at the midspan of 34' spans. A combination of channels and angles form the frame that cantilevers off of the primary girders to support the tower. The tower, made up of a network of single angle members is connected to the superstructure frame with plates.
- *Existing Physical Condition:* The frames exhibit cracks in the connected bracket welds. The floor beam members of the frame have similar corrosion and deterioration as the W shape floor beams

Figure 27: Inspection Photo: Floor Beam Section Loss & Corrosion

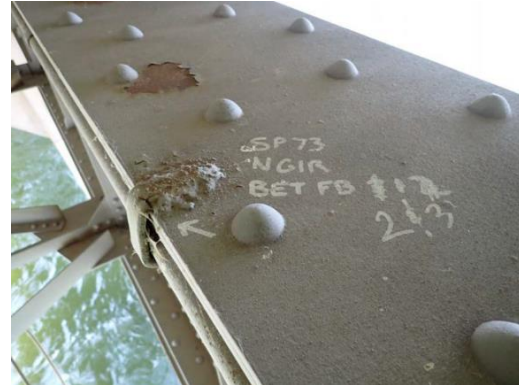
Figure 28: Inspection Photo: Cracks in Connected Bracket Welds

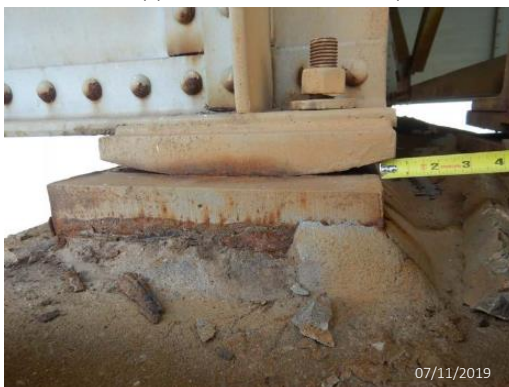
- Support No. 66/Forward Span/South girder – Shifted to east ½"

Figure 29: Inspection Photo: Shifted Rocker Bearing

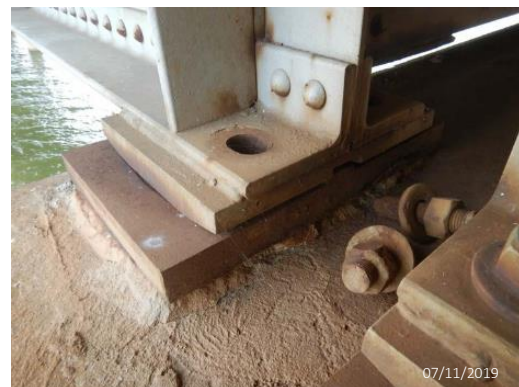
Figure 30: Inspection Photo: Sheared Bolts at Bearing

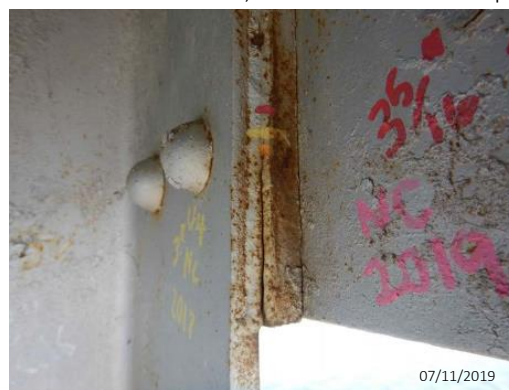
- *Description:* Lower chord truss members consist of double-channel members with riveted batten plates connecting the top and bottom flanges.
- *Existing Physical Condition:* The lower chord members exhibit minor corrosion resulting in about a 5% member capacity reduction. A 2½" crack is present in one of the lower chord batten plates. Because the batten plate is attached to the low chord with a riveted connection, this crack is unable to propagate into the main members.

Figure 33: Inspection Photo: Crack in Fill Plate Adjacent to Vertical Inside Upper Panel Point

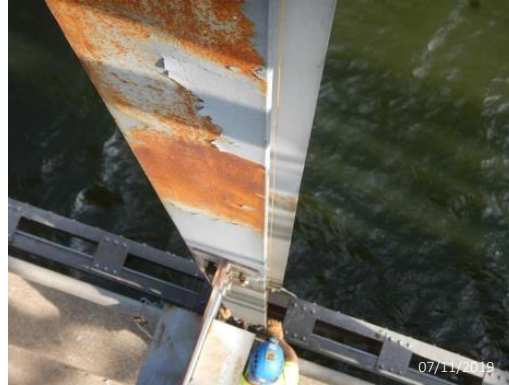
- *Description:* Vertical members consist of I-shaped rolled members; diagonal members consist of I-shaped rolled members or built-up members consisting of an I-shape riveted to double channels.
- *Existing Physical Condition:* Some verticals are misaligned due to traffic impact to a maximum magnitude of $\frac{1}{4}$ " longitudinal & $\frac{3}{4}$ " transverse. Due to these members being tension or zero-force members, the capacity is not affected. Some cracks have been observed in fillet welds between zero-force verticals and fill plates, but due to the members being zero-force, no capacity reduction is needed.

Figure 34: Inspection Photo: Truss Vertical Member Misalignment

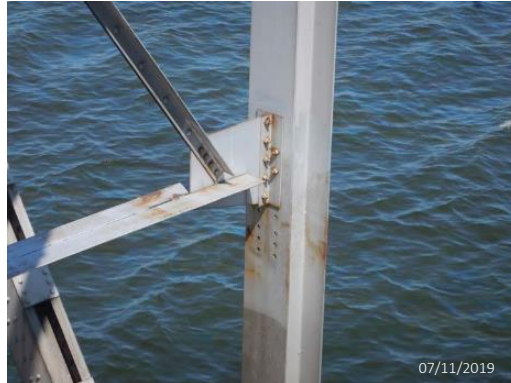
- *Description:* The lower strut of the sway bracing was previously damaged by traffic impact, and all sway bracing was replaced at a higher elevation to increase vertical clearance.
- *Existing Physical Condition:* The upper (original) portion of the sway braces exhibit minor surface corrosion, resulting in no appreciable reduction in member capacity.

Figure 35: Inspection Photo: Relocated Sway Bracing Connection

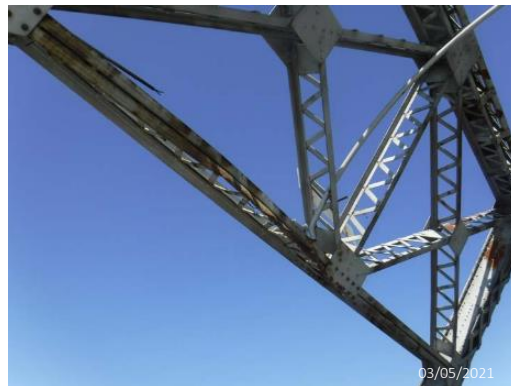
- *Description:* The end portal frames brace the ends of the truss and are composed of built-up struts and X-frame cross bracing (double angles).
- *Existing Physical Condition:* The portal bracing has been damaged by vehicular impact. The bottom inboard angle of the west portal exhibits several local kinks due to vehicle collision damage near the roadway centerline.

Figure 36: Inspection Photo: Damaged Portal Bracing

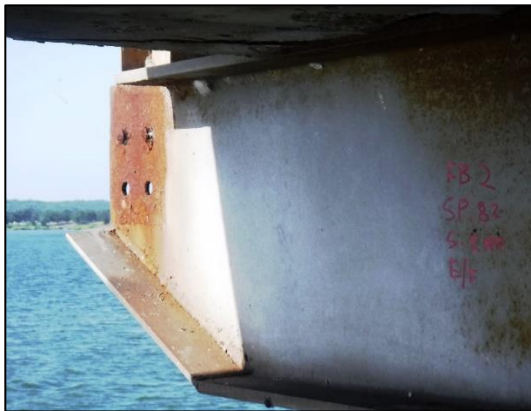
The existing bridge rail PRs are less than 1.0; however, the existing bridge rail in its current configuration does not meet geometric criteria including the minimum height requirement for a pedestrian rail (42”) and the maximum opening size between elements (4”); the rail is only 31” above the top of the existing curb and has openings between elements greater than 4” (See Figure 60). Furthermore, 33% of the rail connections to the floor beams are severely damaged with some locations missing a connection altogether (See Figure 59).

Figure 59: Missing Rail Connection
