Photo 1: Roosevelt Memorial Bridge, Overall

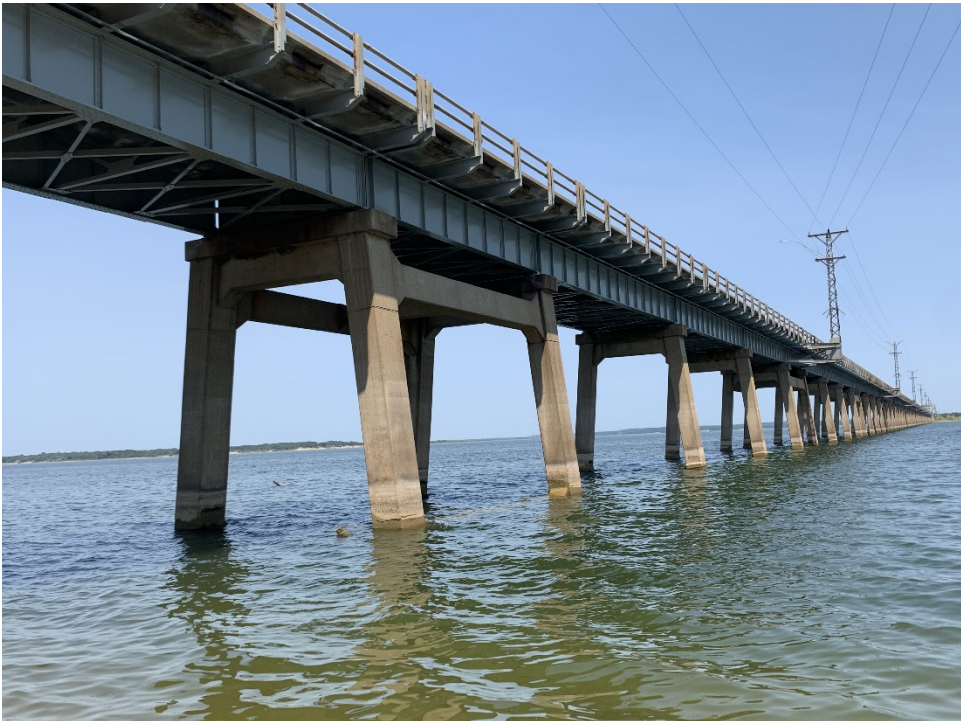
Photo 2: Roosevelt Memorial Bridge, Elevation

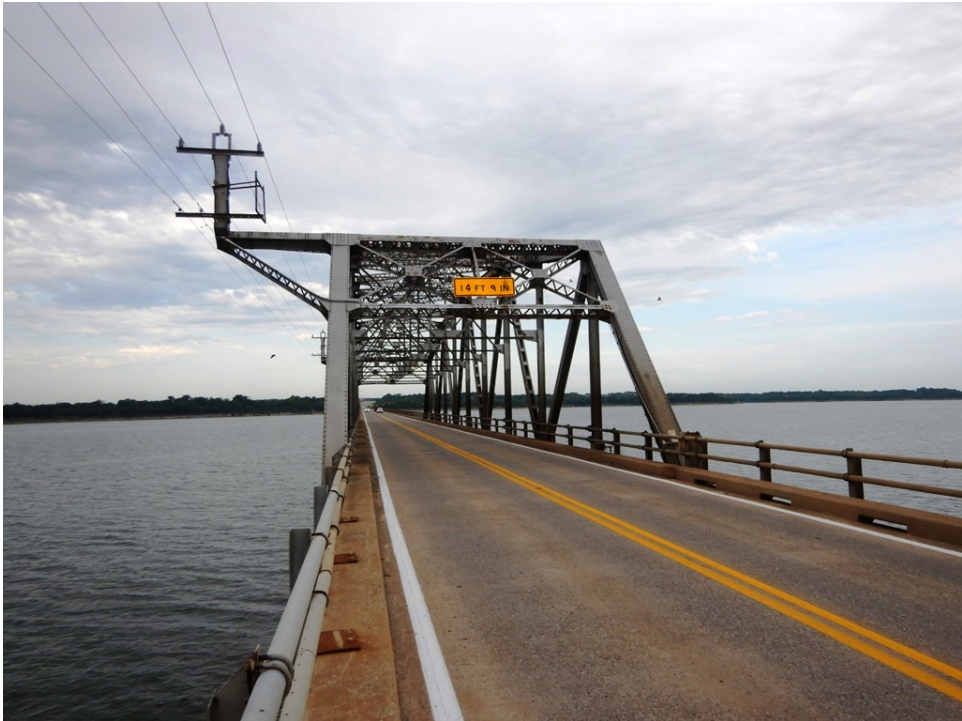
Photo 3: Truss Span, Approach

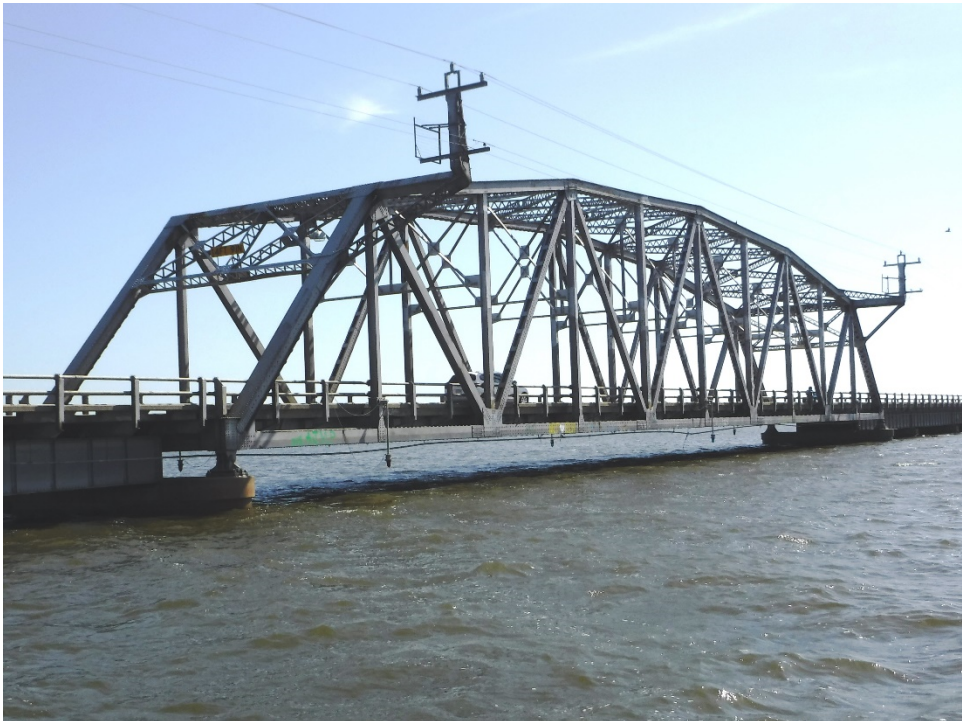
Photo 4: Truss Span, Elevation

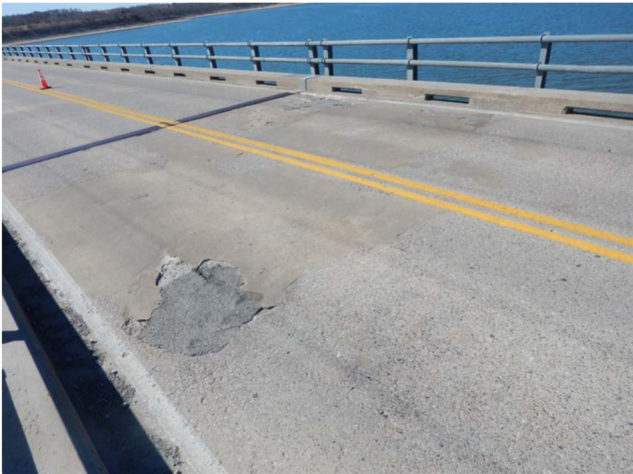
Photo 5: Typical Condition of Deck Slab

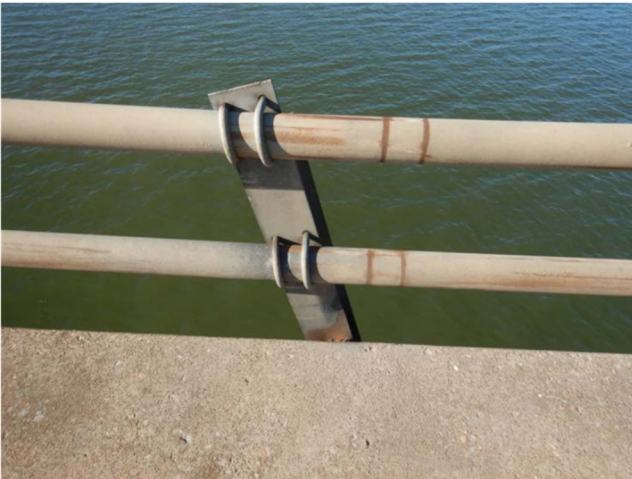
Photo 6: Traffic Rail Damage Due to Vehicular Collision

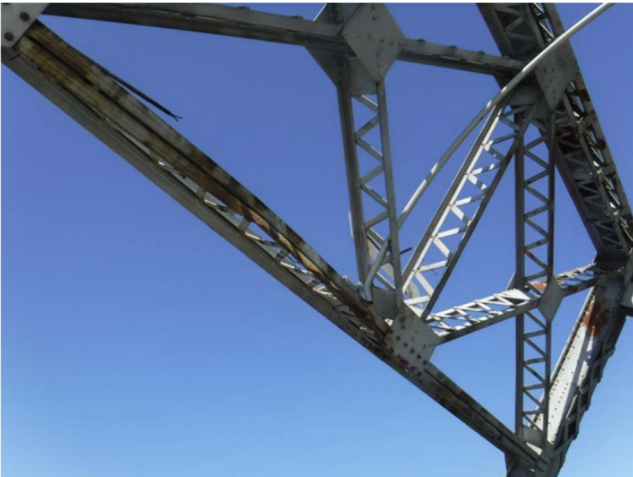
Photo 7: Portal Strut Vehicular Collision Damage

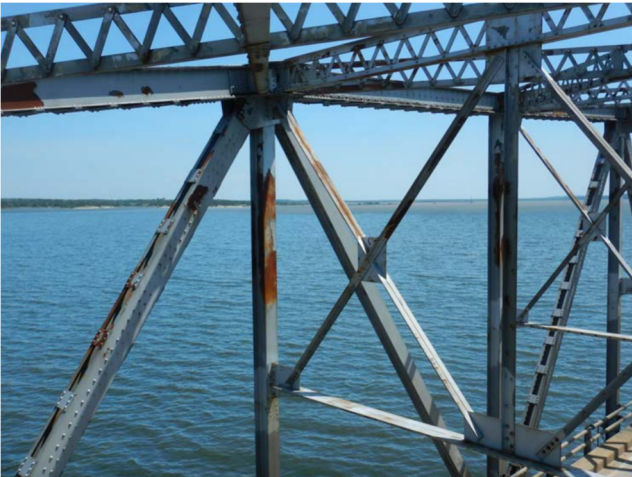
Photo 8: Typical Condition of Truss Sway Bracing (Previously Replaced)

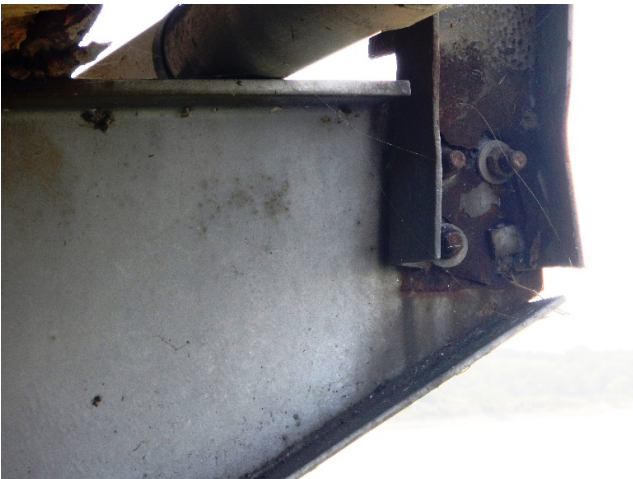
Photo 9: Failed Traffic Rail Connection to Floor Beam

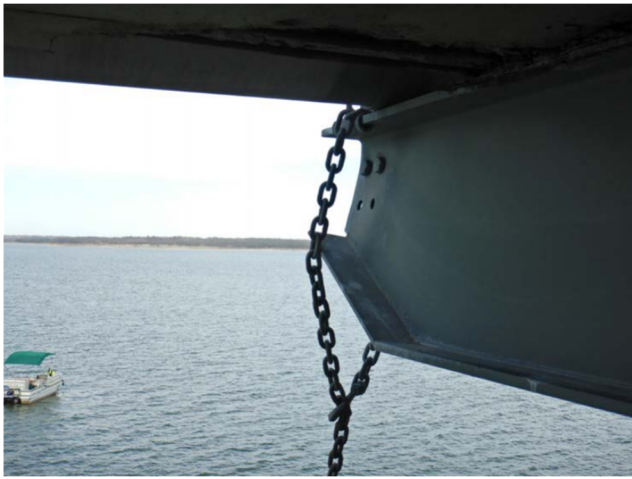
Photo 10: Deflected Floor Beam Due to Vehicular Collision to Traffic Rail

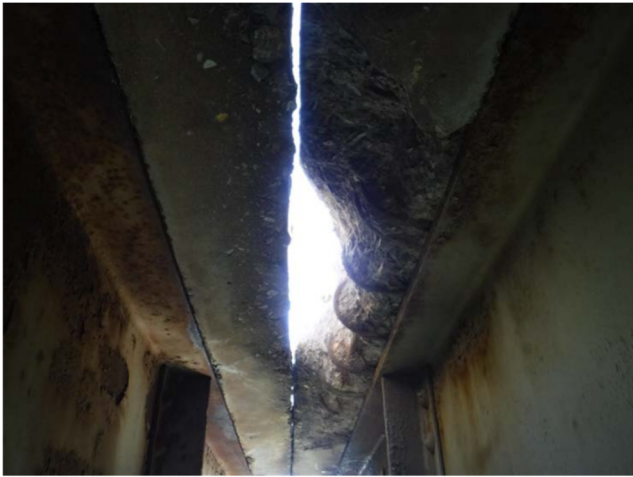
Photo 11: Soffit at Joints with Full Depth Spalling

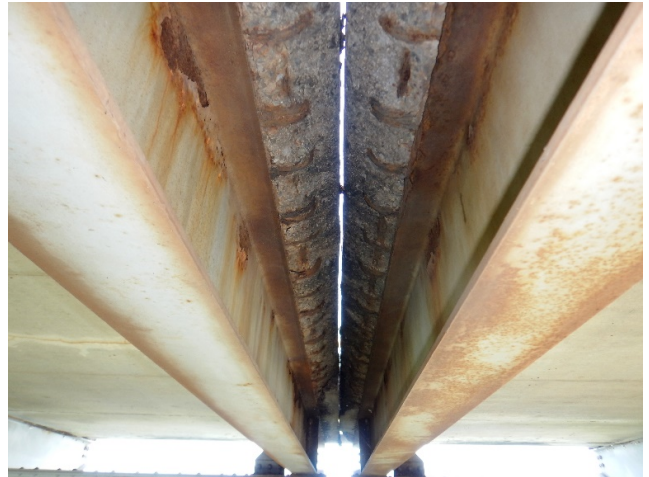
Photo 12: Soffit at Joints with Partial Depth Spalling

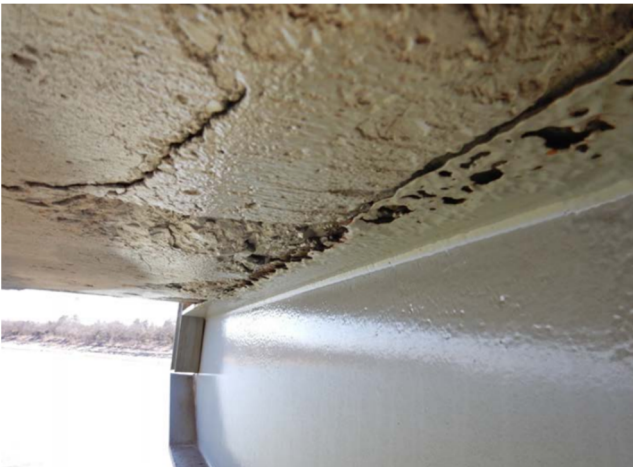
Photo 13: Floor Beam Substantial Section Loss of Top Flange

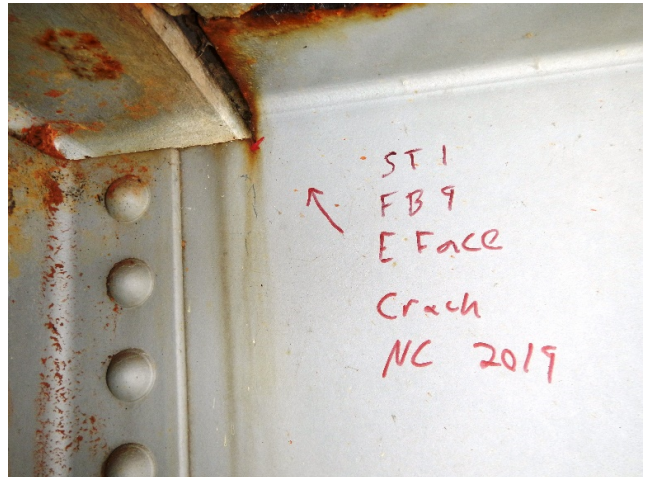
Photo 14: Cracking at Re-entrant Corners of Stringers

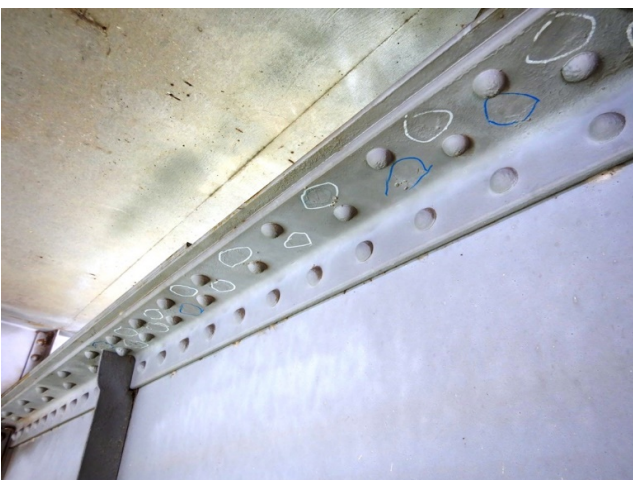
Photo 15: Built-Up Primary Girders with Plug Welds in Rivet Holes (Fatigue Concern)

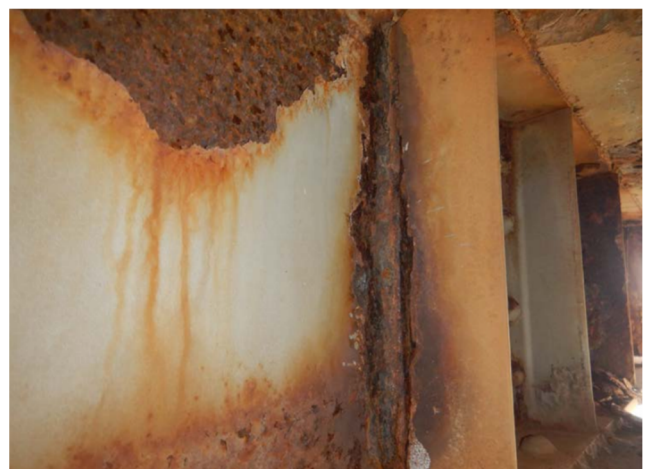
Photo 16: Built-Up Primary Girders with Section Loss of Webs Near Angle Stiffeners

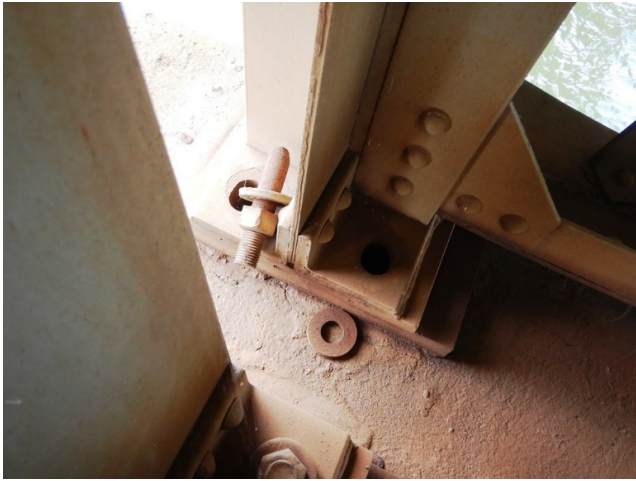
Photo 17: Broken Anchor Bolts

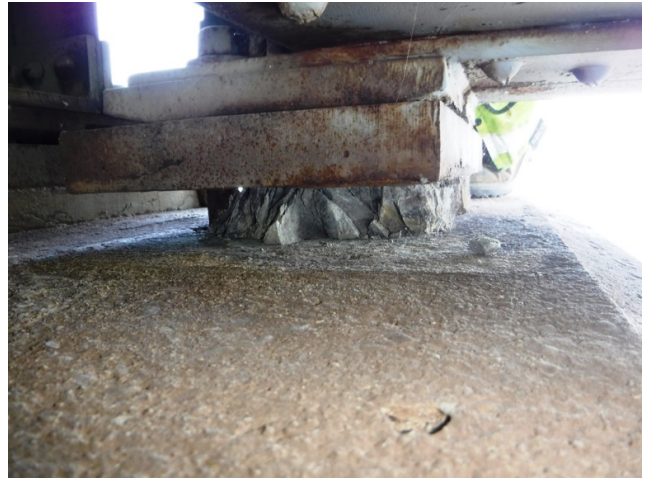
Photo 18: Loss of Grout Pad Beneath Primary Girders

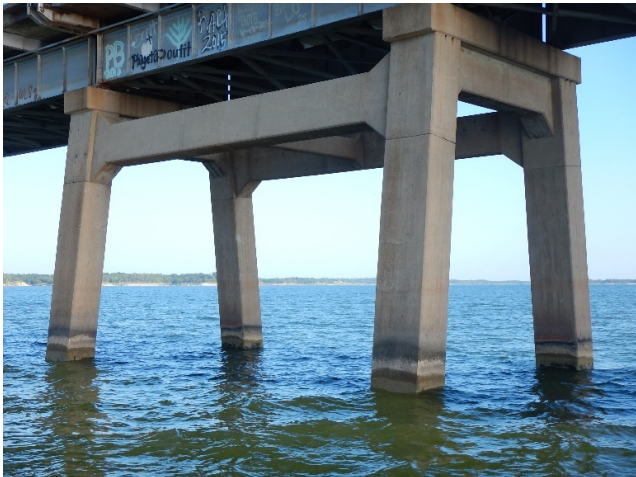
Photo 19: Typical Condition of Substructure (Tower Shown, Bent Similar)

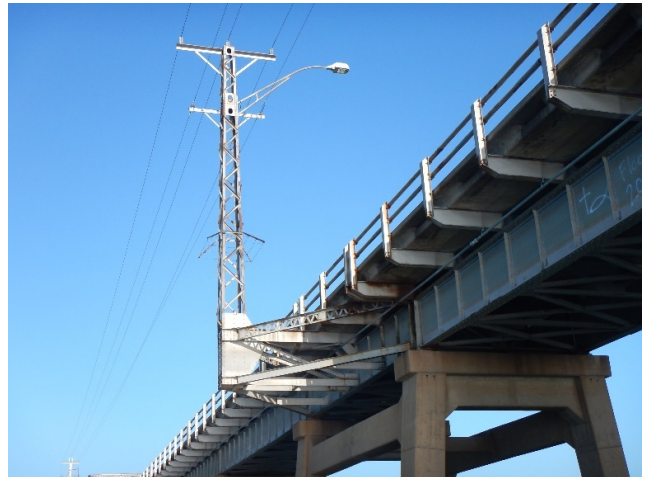
Photo 20: Typical Utility Tower
