**Oklahoma Department of Transportation**  
**ADA Self-evaluation and Transition Plan**  
**Building Cost Projection Summary**  
1/26/2016

**ODOT FACILITY REPORT**  
**Oklahoma City Central Office**

**Latitude:** 35.490848  
**Address:** 200 NE 21st Street

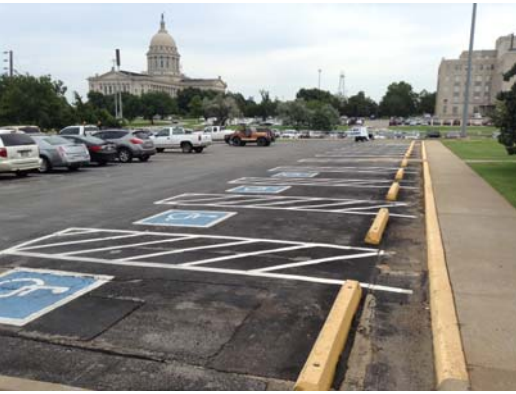
1 Parking Violation 1

Visitor parking area at main entrance - 4 parking spaces designated with accessible parking signs. No van accessible parking space is provided.

Restripe accessible parking areas to accommodate required parking space and access aisle widths.

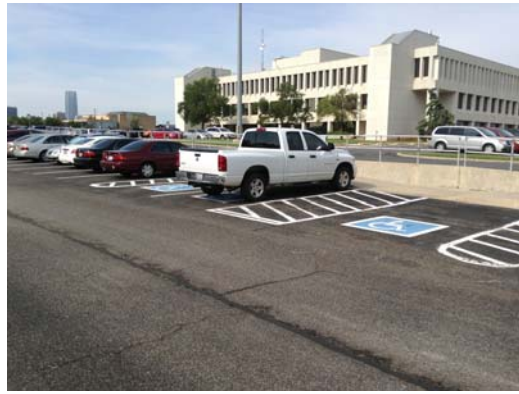
2 Parking Violation 2

Overflow visitor lot - 3 parking spaces striped as accessible but only two are designated with signs. No van accessible parking space provided.

Restripe accessible parking areas to accommodate required parking space and access aisle widths.

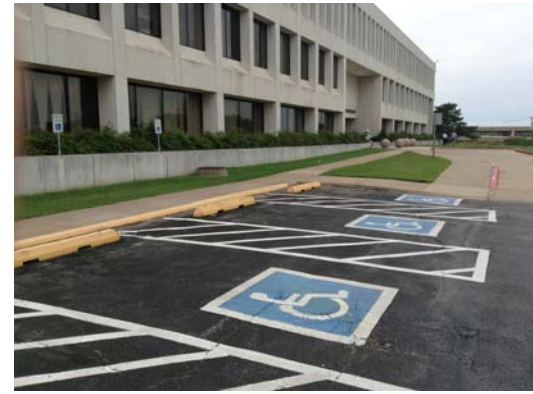
3 Parking Violation 3

Overflow visitor lot - accessible parking signs are 52" and 54" above the parking surface where 60" minimum is required.

Raise signage.

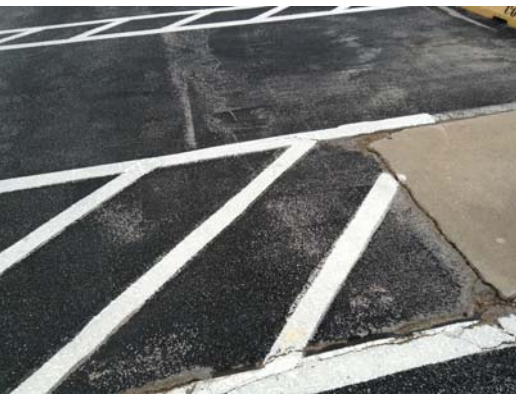
4 Parking Violation 4

South ODOT permit lot serving south entrance - 7 accessible parking spaces designated with striping. The striping as it exists does not comply with minimum requirements. Standard HC car spaces are required to be 98" wide with 60" minimum aisle. No van accessible parking provided. Van spaces must be 132" wide with 60" aisle or 96" wide with 96" aisle.

Restripe accessible parking areas to accommodate required parking space and access aisle widths.

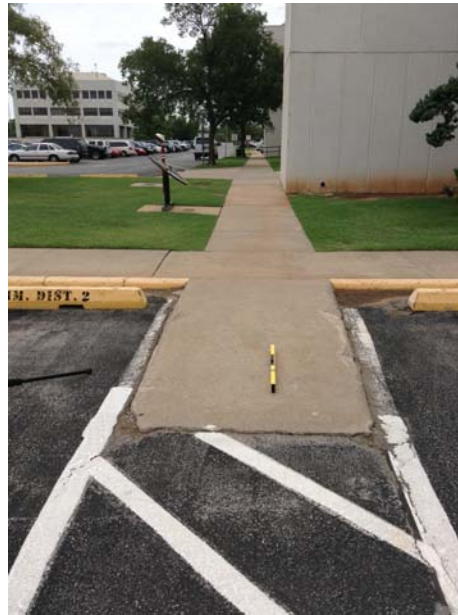
5 Parking Violation 5

South ODOT permit lot serving south entrance - the curb ramps project into the accessible parking access aisle.

Provide recessed curb ramps.

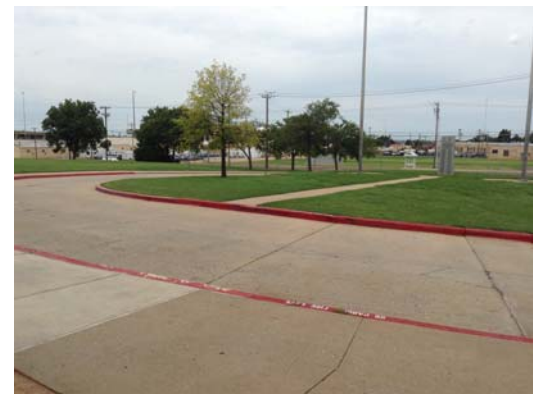
6 Accessible Route Violation 1

No accessible route from office building to flag poles or to memorial plaque at front of building.

Provide accessible route to flagpoles and plaque. Remove and replace curb ramps at visitor parking area, and along 21st Street. Repair heaved portion of sidewalk along 21st Street. Relocate accessible parking spaces in overflow lot to more convenient location.

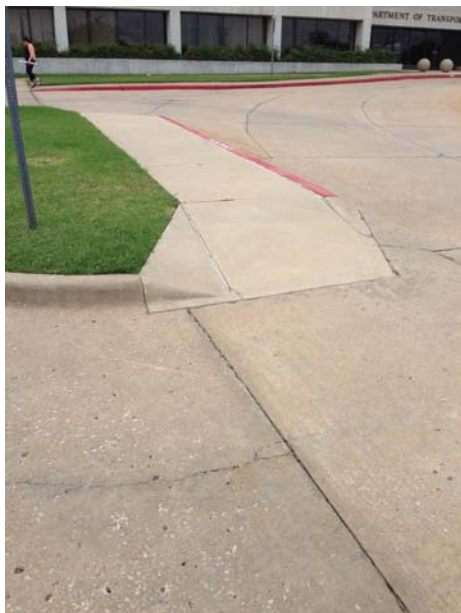
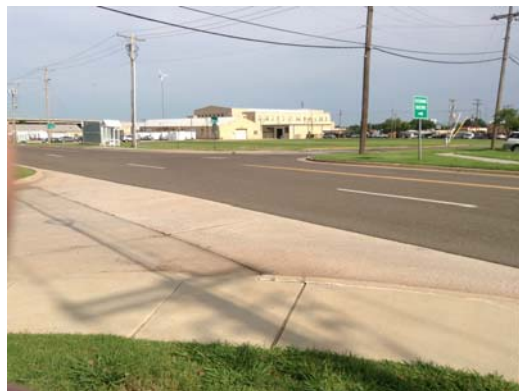
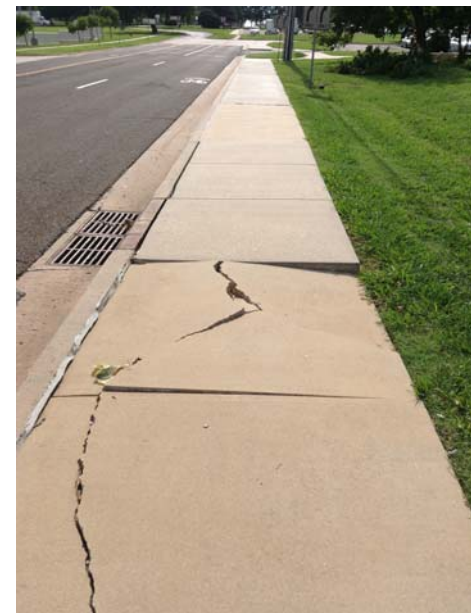
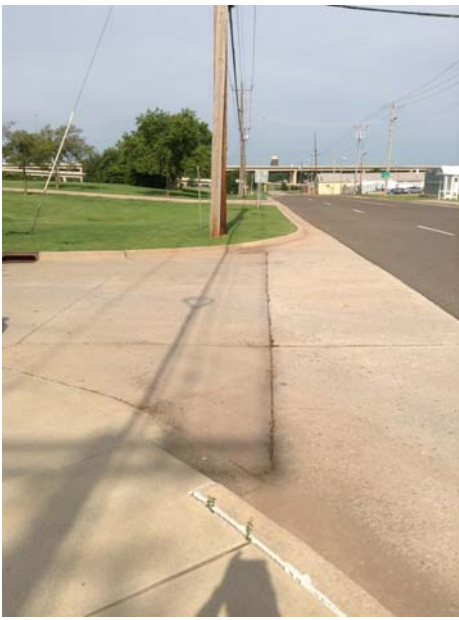
7 Accessible Route Violation 2

Curb ramps at entrance into visitor parking area have a running slope of 15% with cross slopes from 3.7% to 4.9%. Visitor parking lot - access from the far right accessible parking space includes a cross slope of 2.3% to 6.3% at sidewalk along firelane. Access from front of building to NE 21st Street includes a curb ramp at the corner of the entrance drive and 21st Street. This curb ramp does not provide any type of connection across the street. The running slope of the ramp is 5.9% which becomes a 5.9% cross slope if traveling across the ramp. Sidewalk along 21st Street has heaved and has created unsafe slopes and level changes.

Provide accessible route to flagpoles and plaque. Remove and replace curb ramps at visitor parking area, and along 21st Street. Repair heaved portion of sidewalk along 21st Street. Relocate accessible parking spaces in overflow lot to more convenient location.

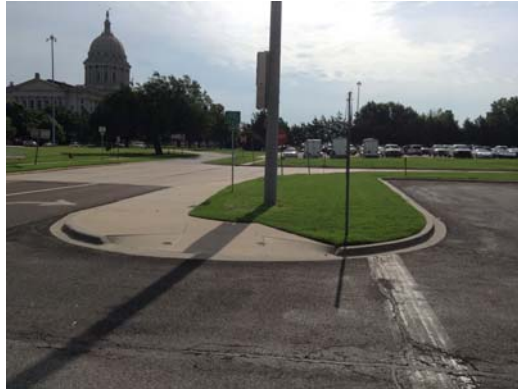
11 Accessible Route Violation 3

Curb ramp along 21st Street at entrance into parking lot has 6.3% running slope at top of curb ramp where a level landing must be provided.

Provide accessible route to flagpoles and plaque. Remove and replace curb ramps at visitor parking area, and along 21st Street. Repair heaved portion of sidewalk along 21st Street. Relocate accessible parking spaces in overflow lot to more convenient location.

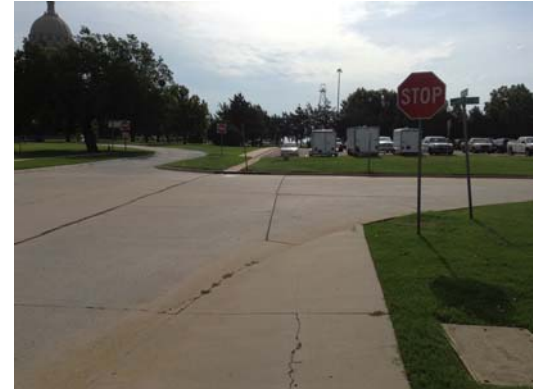
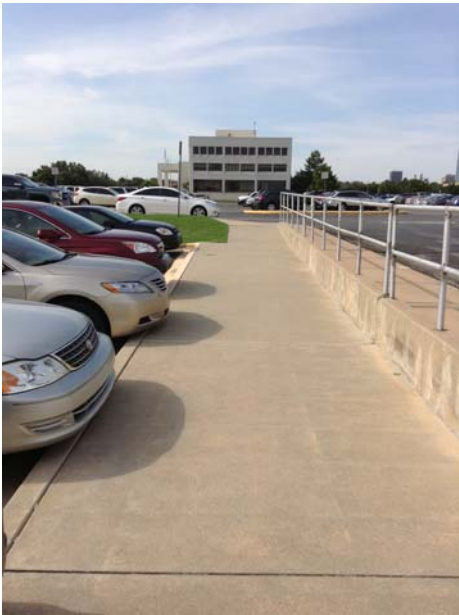
12 Accessible Route Violation 4

Curb ramp at 21st Street and Stiles has a 6.4% cross slope at ramp and 12.6% cross slope at bottom of ramp. There is no corresponding curb ramp on the other side of Stiles. Sidewalk at front of the 3 accessible parking spaces in the overflow visitor lot has a running slope of 6.6% to 7.2% and does not comply with ramp requirements.

Demo and replace sidewalk with compliant slopes.

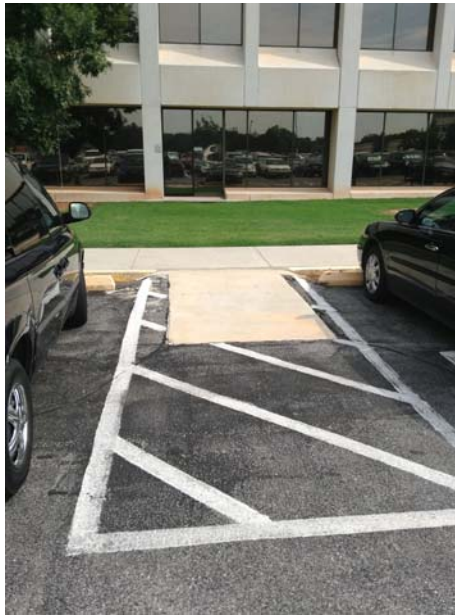
14 Accessible Route Violation 5

South ODOT permit lot serving south entrance - the curb ramps project into the accessible parking access aisle.

Provide recessed curb ramps..

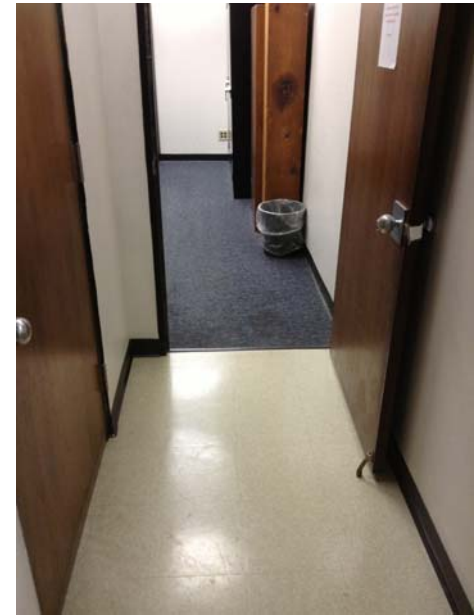
15 Hallway Violation 1

**Violation #1:** All doors throughout facility are equipped with knob hardware.

**Recommendation:** Replace with lever hardware.

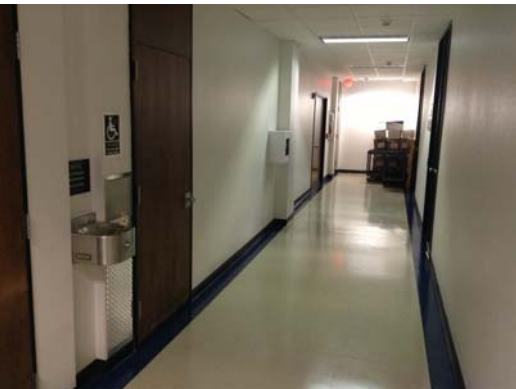
16 Hallway Violation 2

**Violation #2:** All drinking fountains in the facility are protruding objects.

**Recommendation:** Relocate or modify drinking fountains into alcoves so that they are not protruding objects.

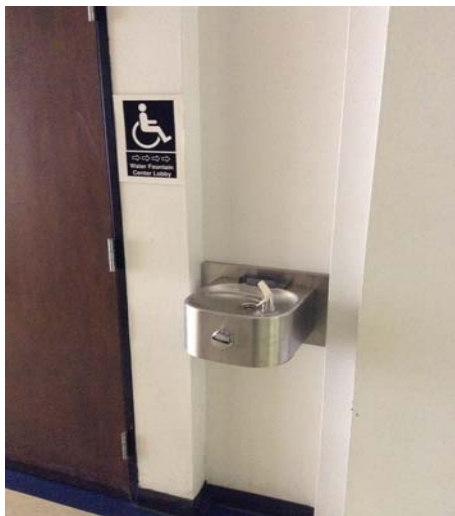
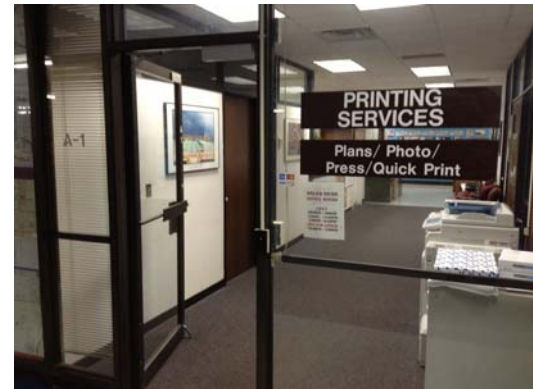
17 Hallway Violation 3

**Violation #3:** All room signs, except for restroom signs, are not compliant (no raised characters or Braille)

**Recommendation:** Install compliant rooms signs.

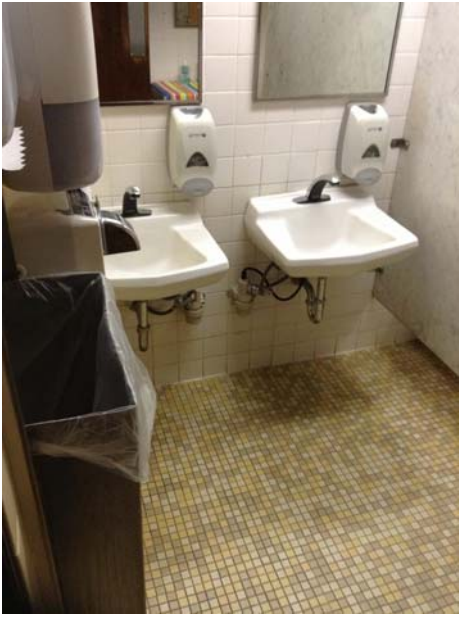
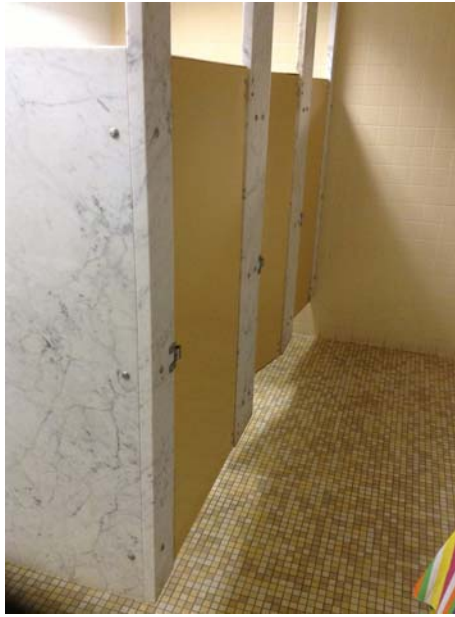
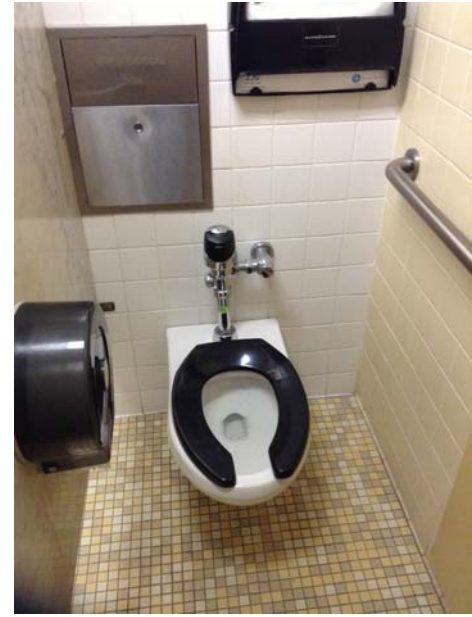
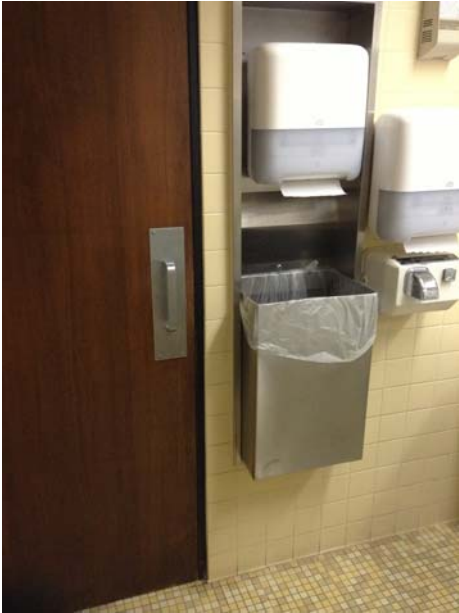
19 Restroom Violation 1

Basement Women restroom - No pipe wrap at lavatory drains, 47" to bottom edge of mirror, 3 toilet stalls, none are accessible (33" wide, 22 1/2" door), and When exiting toilet room the door has 56" clear from face of door to toilet partition where 60" minimum is required

Basement Women restroom - Wrap lavatory drains. Lower mirror or provided a full length mirror. Provide an fully accessible stall.

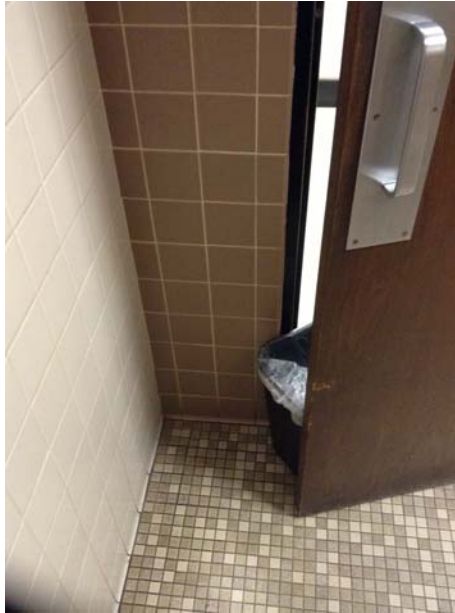
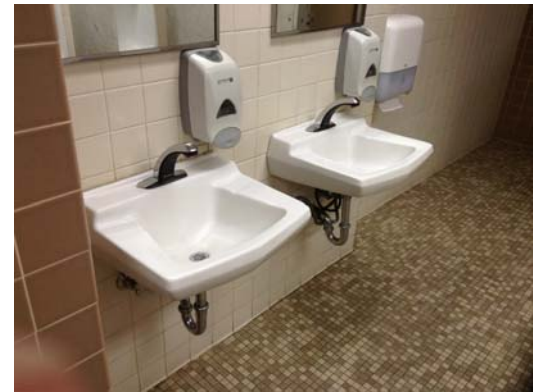
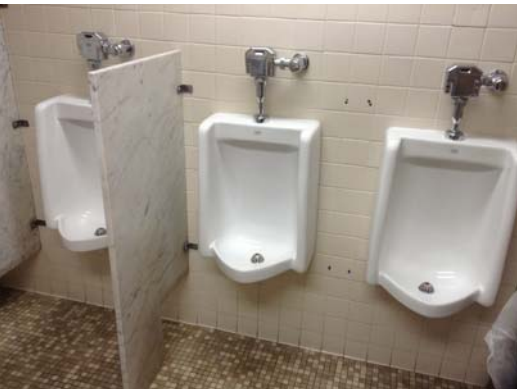
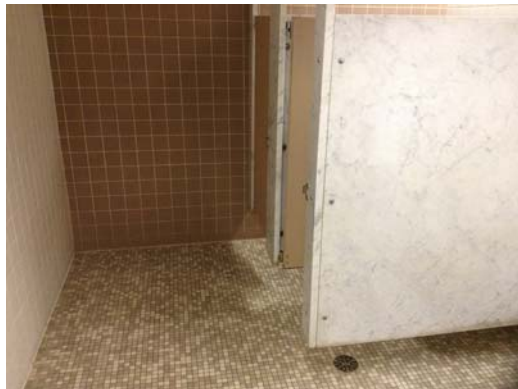
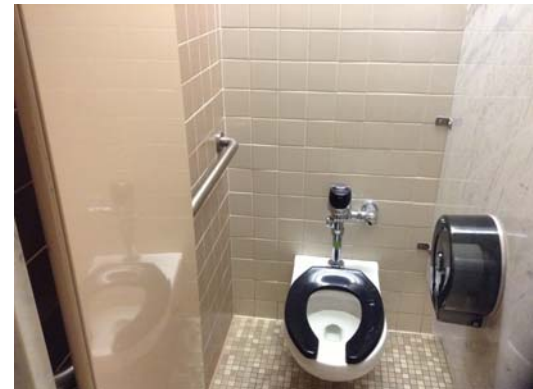
23 Restroom Violation 2

Basement Men restroom - Interior pull side clearance at entrance door is 14" where 18" min is required, No pipe wrap at lavatory drains, 47" to bottom edge of mirror, 3 urinals, all 24 1/2" to rim above floor, and 2 toilet stalls, none are accessible (33" wide, 22 1/2" door)

Basement Men restroom Provide the required maneuvering clearane or install a power opener. Wrap lavatory drains. Lower mirror or provided a full length mirror. Lower at least one urinal. Provide an accessible stall

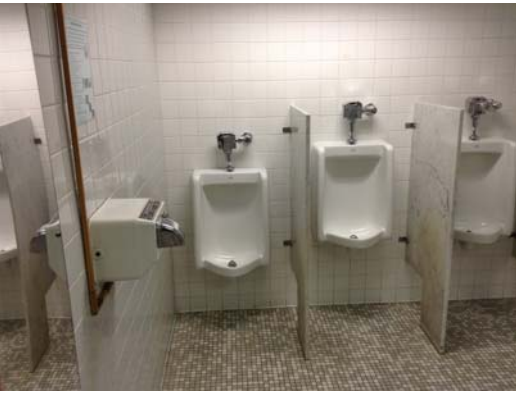
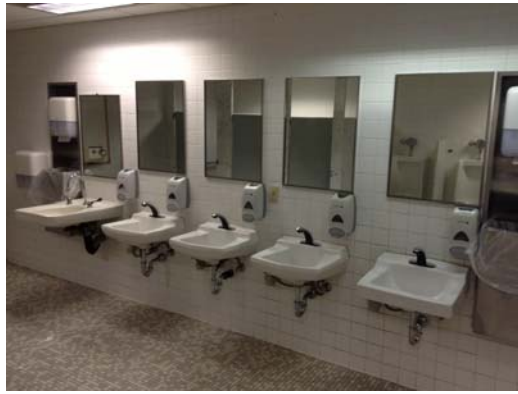
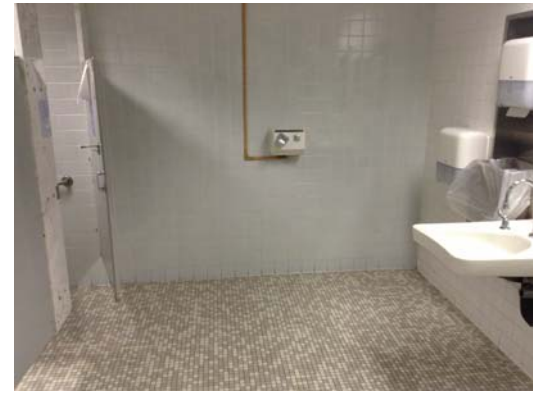
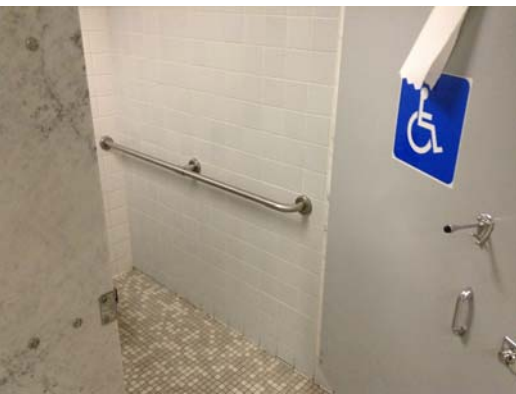
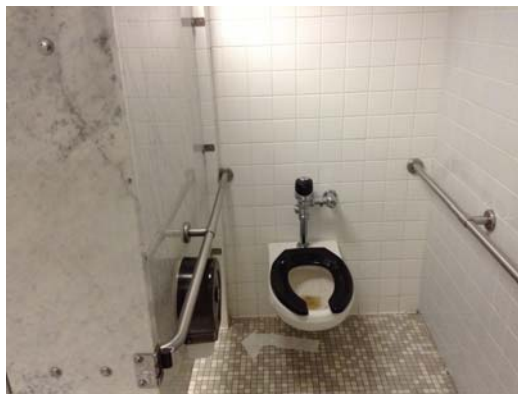
28 Restroom Violation 3

First Floor Elevator Core Men restroom ("accessible" per signs in corridor) Vestibule is 49 1/2" wide and doors have closers. Width of 54" min is required. Hand dryer extends 10 1/4" from wall and is a protruding object. Accessible urinal rim 18" from floor, 17" max required, 3 toilet stalls, one stall 43" wide with parallel grab bars, water closet is 20 1/2" from sidewall. Toilet seat cover dispenser located above water closet, 42 1/2" to bottom of accessible mirror. Total stalls and urinals, one ambulatory stall required in addition to accessible stall.

First Floor Elevator Core Men RR ("accessible" per signs in corridor) Remove closers or install power openers. Recess hand dryer or install an object below hand dryer that will be detected. Lower urinal. Provide accessible stall. Relocate toilet seat cover dispenser, ensure it is within reach ranges. Lower mirror or provided a full length mirror. Provide one ambulatory stall.

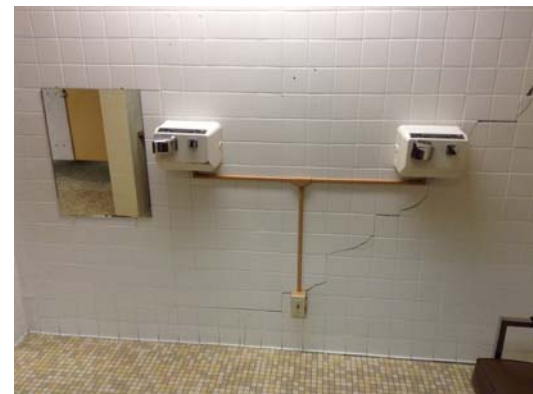
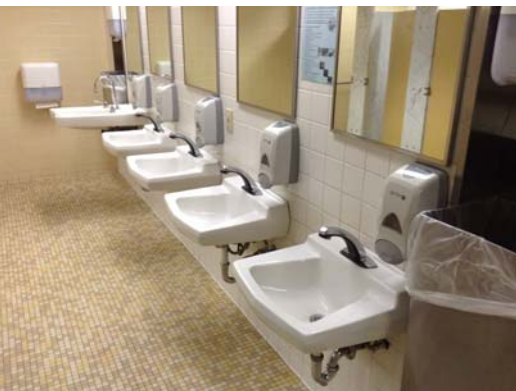
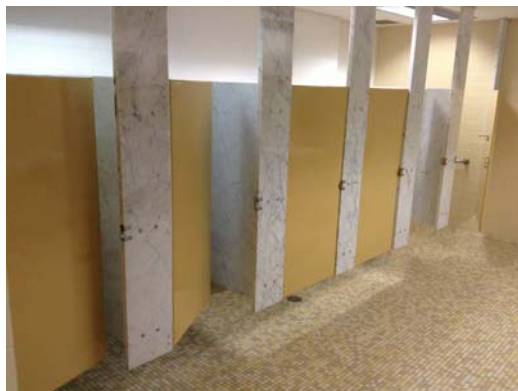
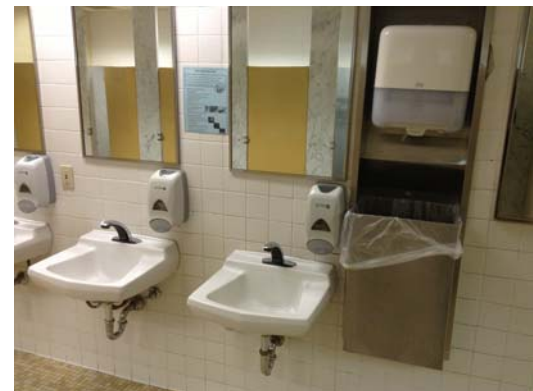
33 Restroom Violation 4

First Floor Elevator Core Women restroom ("accessible" per signs in corridor) Hand dryers extend 10 1/4" from wall and are protruding objects. 6 toilet stalls, one stall 43" wide with parallel grab bars, water closet is 20 1/2" from sidewall. 6 toilet stalls, one ambulatory stall is required in addition to accessible stall. 43" to bottom edge of accessible mirror. Toilet seat cover dispenser located above water closet

First Floor Elevator Core Women restroom ("accessible" per signs in corridor) Recess hand dryer or install an object below hand dryer that will be detected. Provide accessible stall. Provide one ambulatory stall. Lower mirror or provided a full length mirror. Relocate toilet seat, ensure it is within reach ranges.

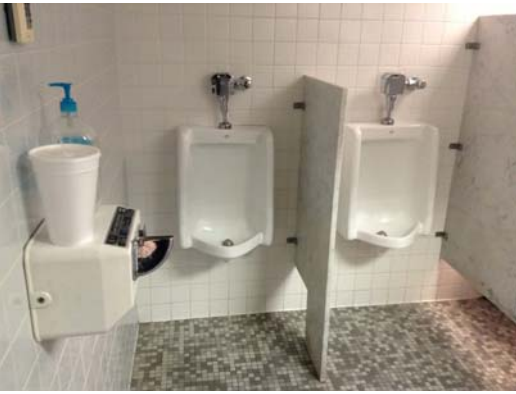
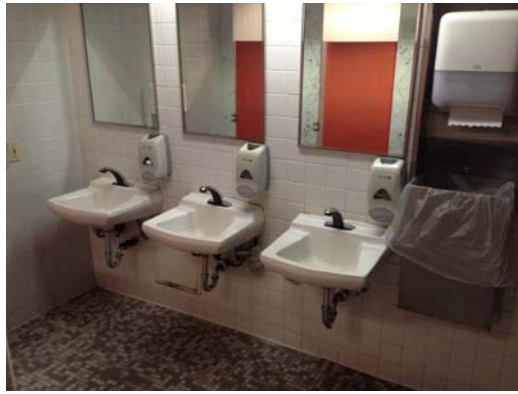
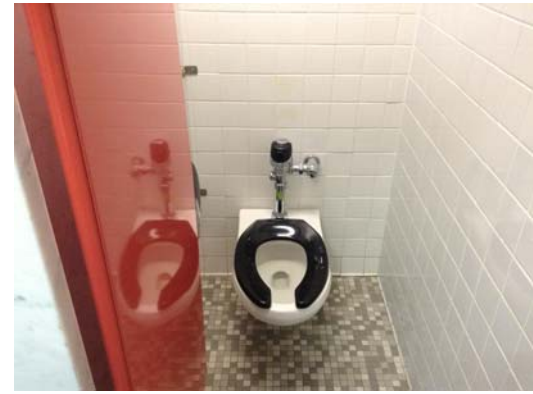
37 Restroom Violation 5

First Floor NE Hallway Men restroom Entry doors 29 1/4" clear, 7 1/2" clearance on interior pull side when exiting restroom. Hand dryer extends 10 1/4" from wall and is a protruding object. Urinals 24" rim above floor. 44" to bottom edge of mirror. 2 toilet stalls, no accessible stall.

First Floor NE Hallway Men restroom Provide 32 " clear doorway with 18" on the pull side, Recess hand dryer or install an object below hand dryer that will be detected, Lower Urnal, Lower mirror or provided a full length mirror, and Provide accessible stall

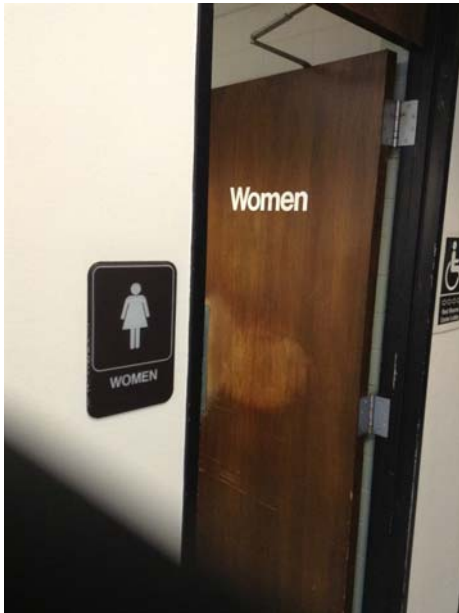
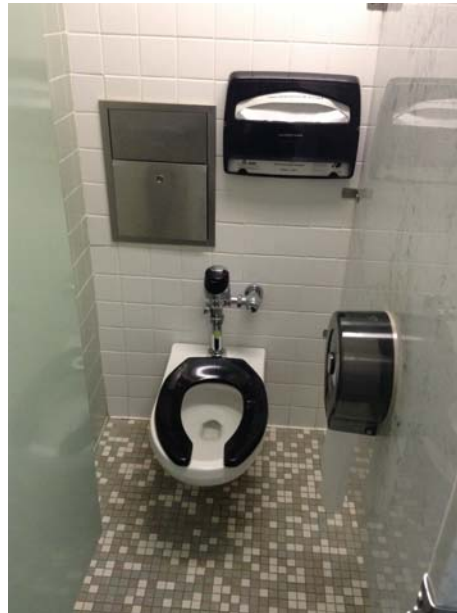
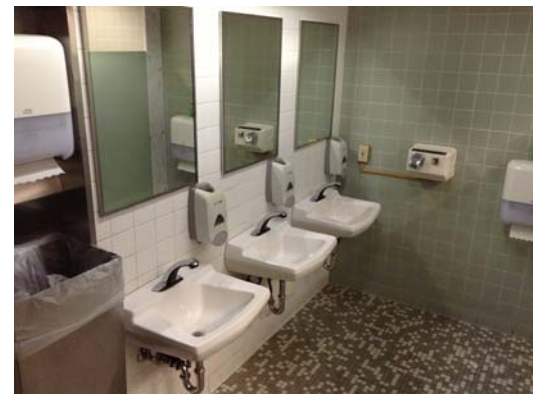
40 Restroom Violation 6

First Floor NE Hallway Women restroom Entry door 29" clear width. 48" to bottom edge of mirror. 4 toilet stalls, no accessible stall

First Floor NE Hallway Women restroom Provide 32 " clear doorway with 18" on the pull side, Lower mirror or provided a full length mirror, and Provide accessible stall

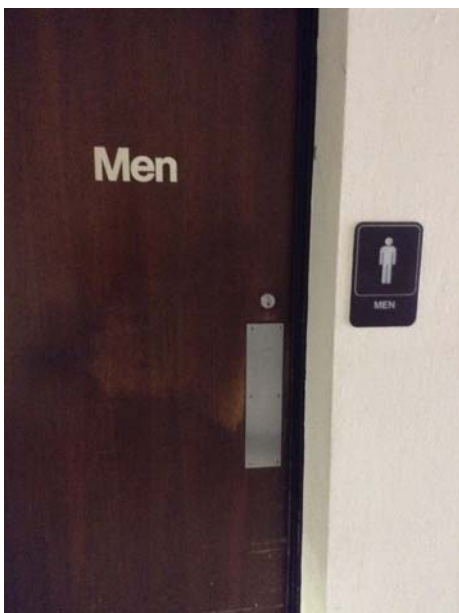
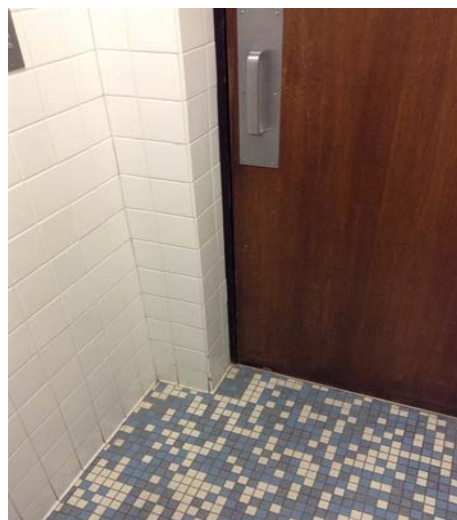
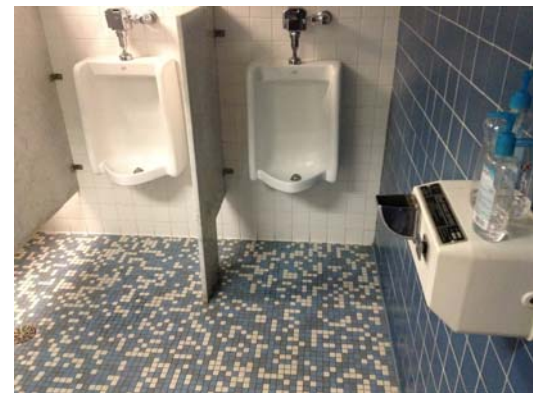
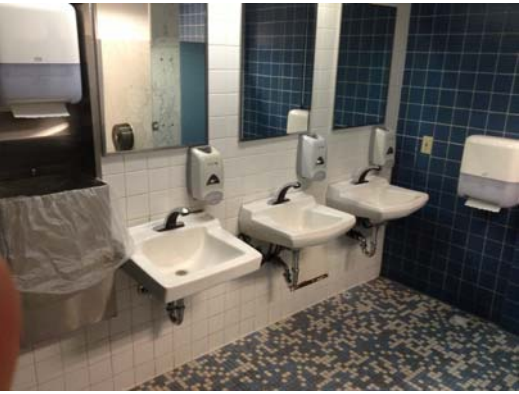
43 Restroom Violation 7

First Floor SE Hallway Men restroom Entry doors 29 1/4" clear, 7 1/2" clearance on interior pull side when exiting restroom. Hand dryer extends 10 1/4" from wall and is a protruding object. Urinals 24" rim above floor. 44" to bottom edge of mirror. 2 toilet stalls, no accessible stall.

First Floor SE Hallway Women restroom Provide 32 " clear doorway with 18" on the pull side, Lower mirror or provided a full length mirror, and Provide accessible stall

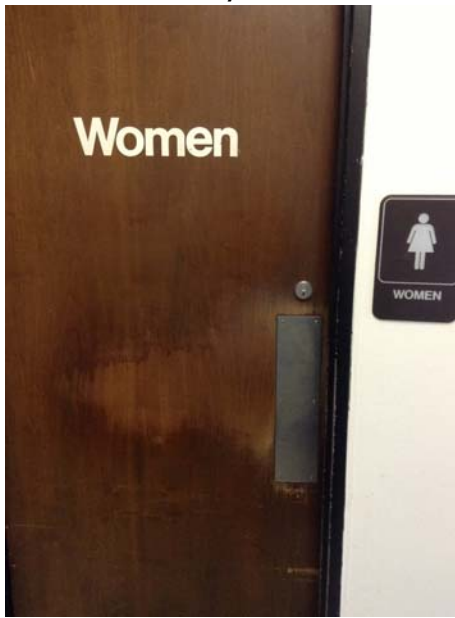
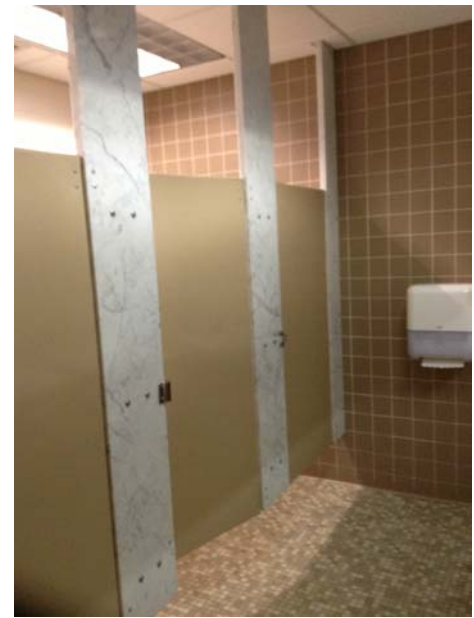
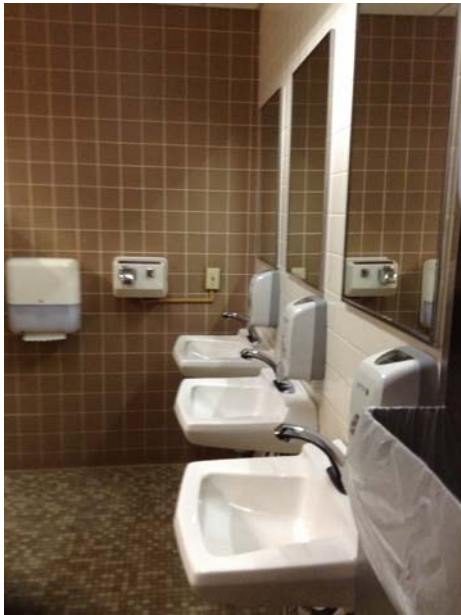
47 Restroom Violation 8

First Floor SE Hallway Women restroom Entry door 29" clear width. 48" to bottom edge of mirror. 4 toilet stalls, no accessible stall

First Floor SE Hallway Women restroom Provide 32 " clear doorway with 18" on the pull side, Lower mirror or provided a full length mirror, and Provide accessible stall

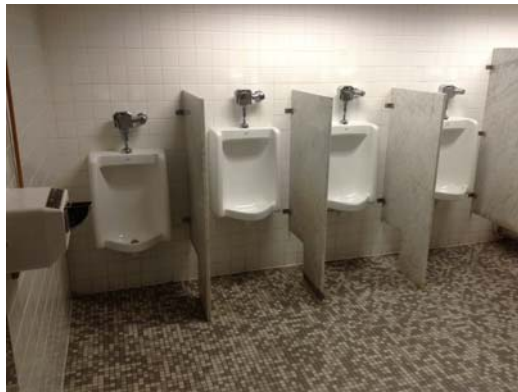
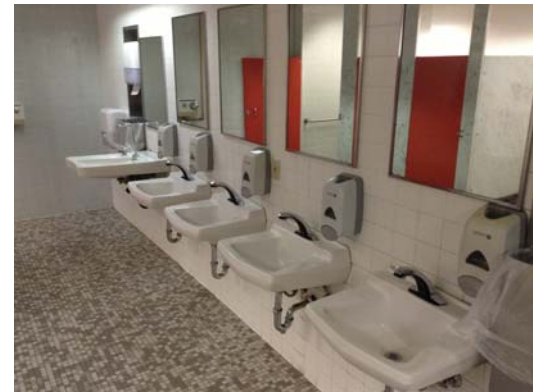
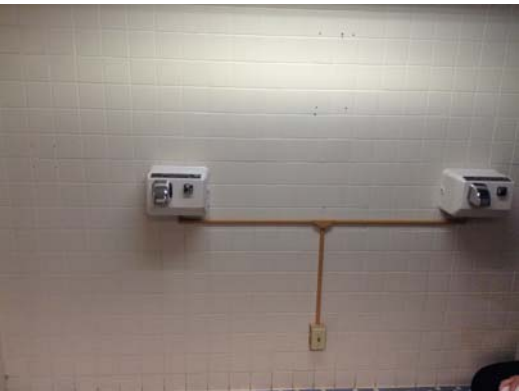
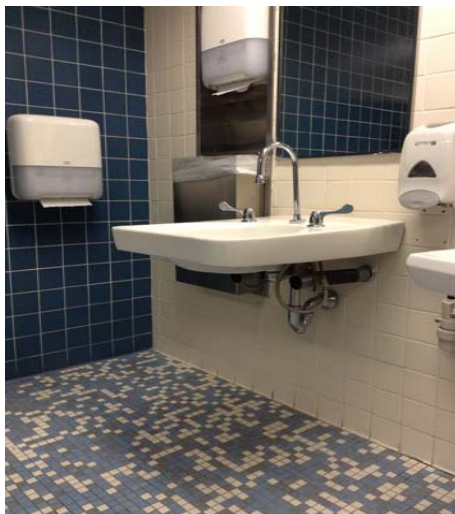
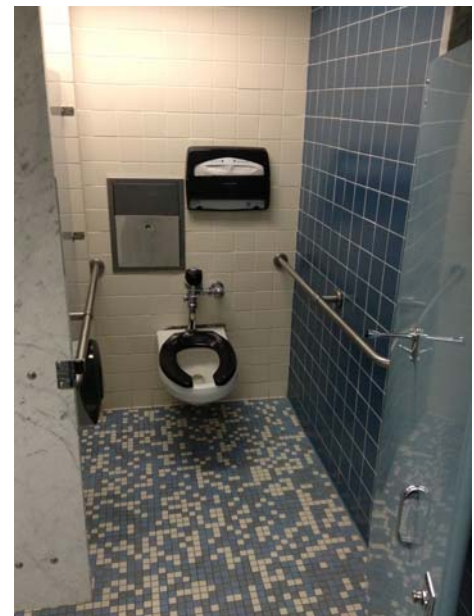
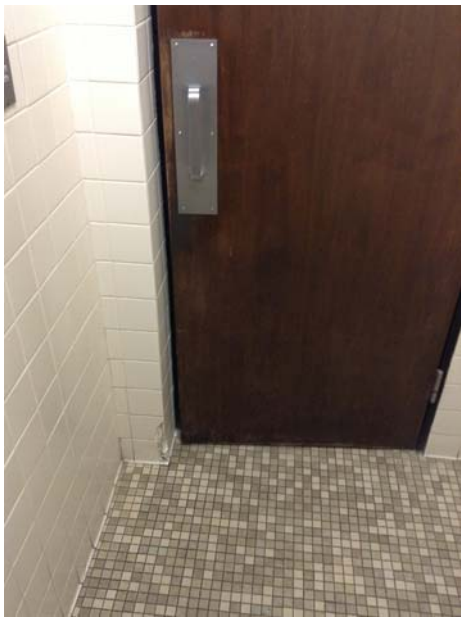
50 Restroom Violation 9

2nd & 3rd Floor Elevator Core Men & Women restroom - same as ground floor  
2nd & 3rd Floor SE hallway Men & Women restroom - same as ground floor  
2nd & 3rd Floor NE Hallway Men & Women restroom - same as ground floor

Provide fully compliant restrooms on each floor.  
2nd & 3rd Floor Elevator Core Men & Women restroom - same as ground floor  
2nd & 3rd Floor SE hallway Men & Women restroom - same as ground floor  
2nd & 3rd Floor NE Hallway Men & Women restroom - same as ground floor

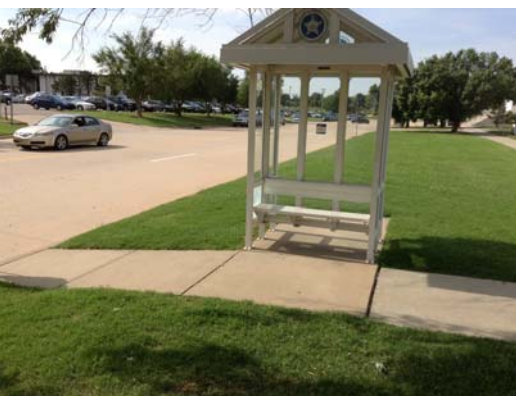
58 Miscellaneous Violation 1

Sidewalk serving the bus shelter along Stiles has a 10.9% running slope down to street. No accessible seating is provided under the shelter.

Replace sidewalk serving bus shelter with compliant slopes. Lower counter at map printing center to 36".

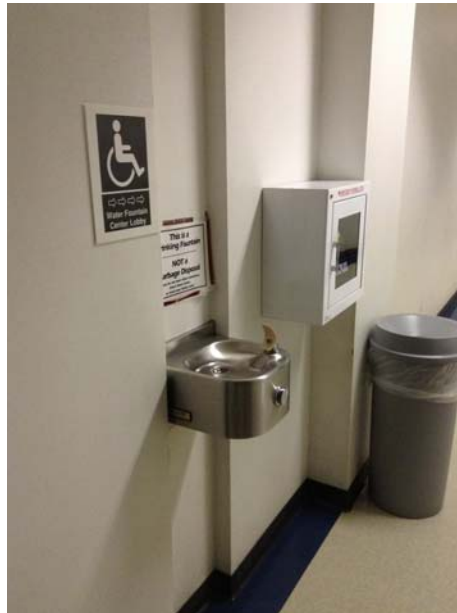
60 Miscellaneous Violation 3

Basement - 1 drinking fountain, none accessible  
 First Floor - 6 drinking fountains, none fully accessible  
 Second Floor - 6 drinking fountains, none fully accessible  
 Third Floor - 6 drinking fountains, none fully accessible

50% of the drinking fountains per floor must be fully accessible.

Replace 50% of the drinking fountains with accessible units.
