NBI # 13079
STRUCTURE NUMBER 6702-04.02X
COUNTY SEMINOLE
FACILITY CARRIED U.S. 270
FEATURE INTERSECTED CARTER CREEK
11/30/2017

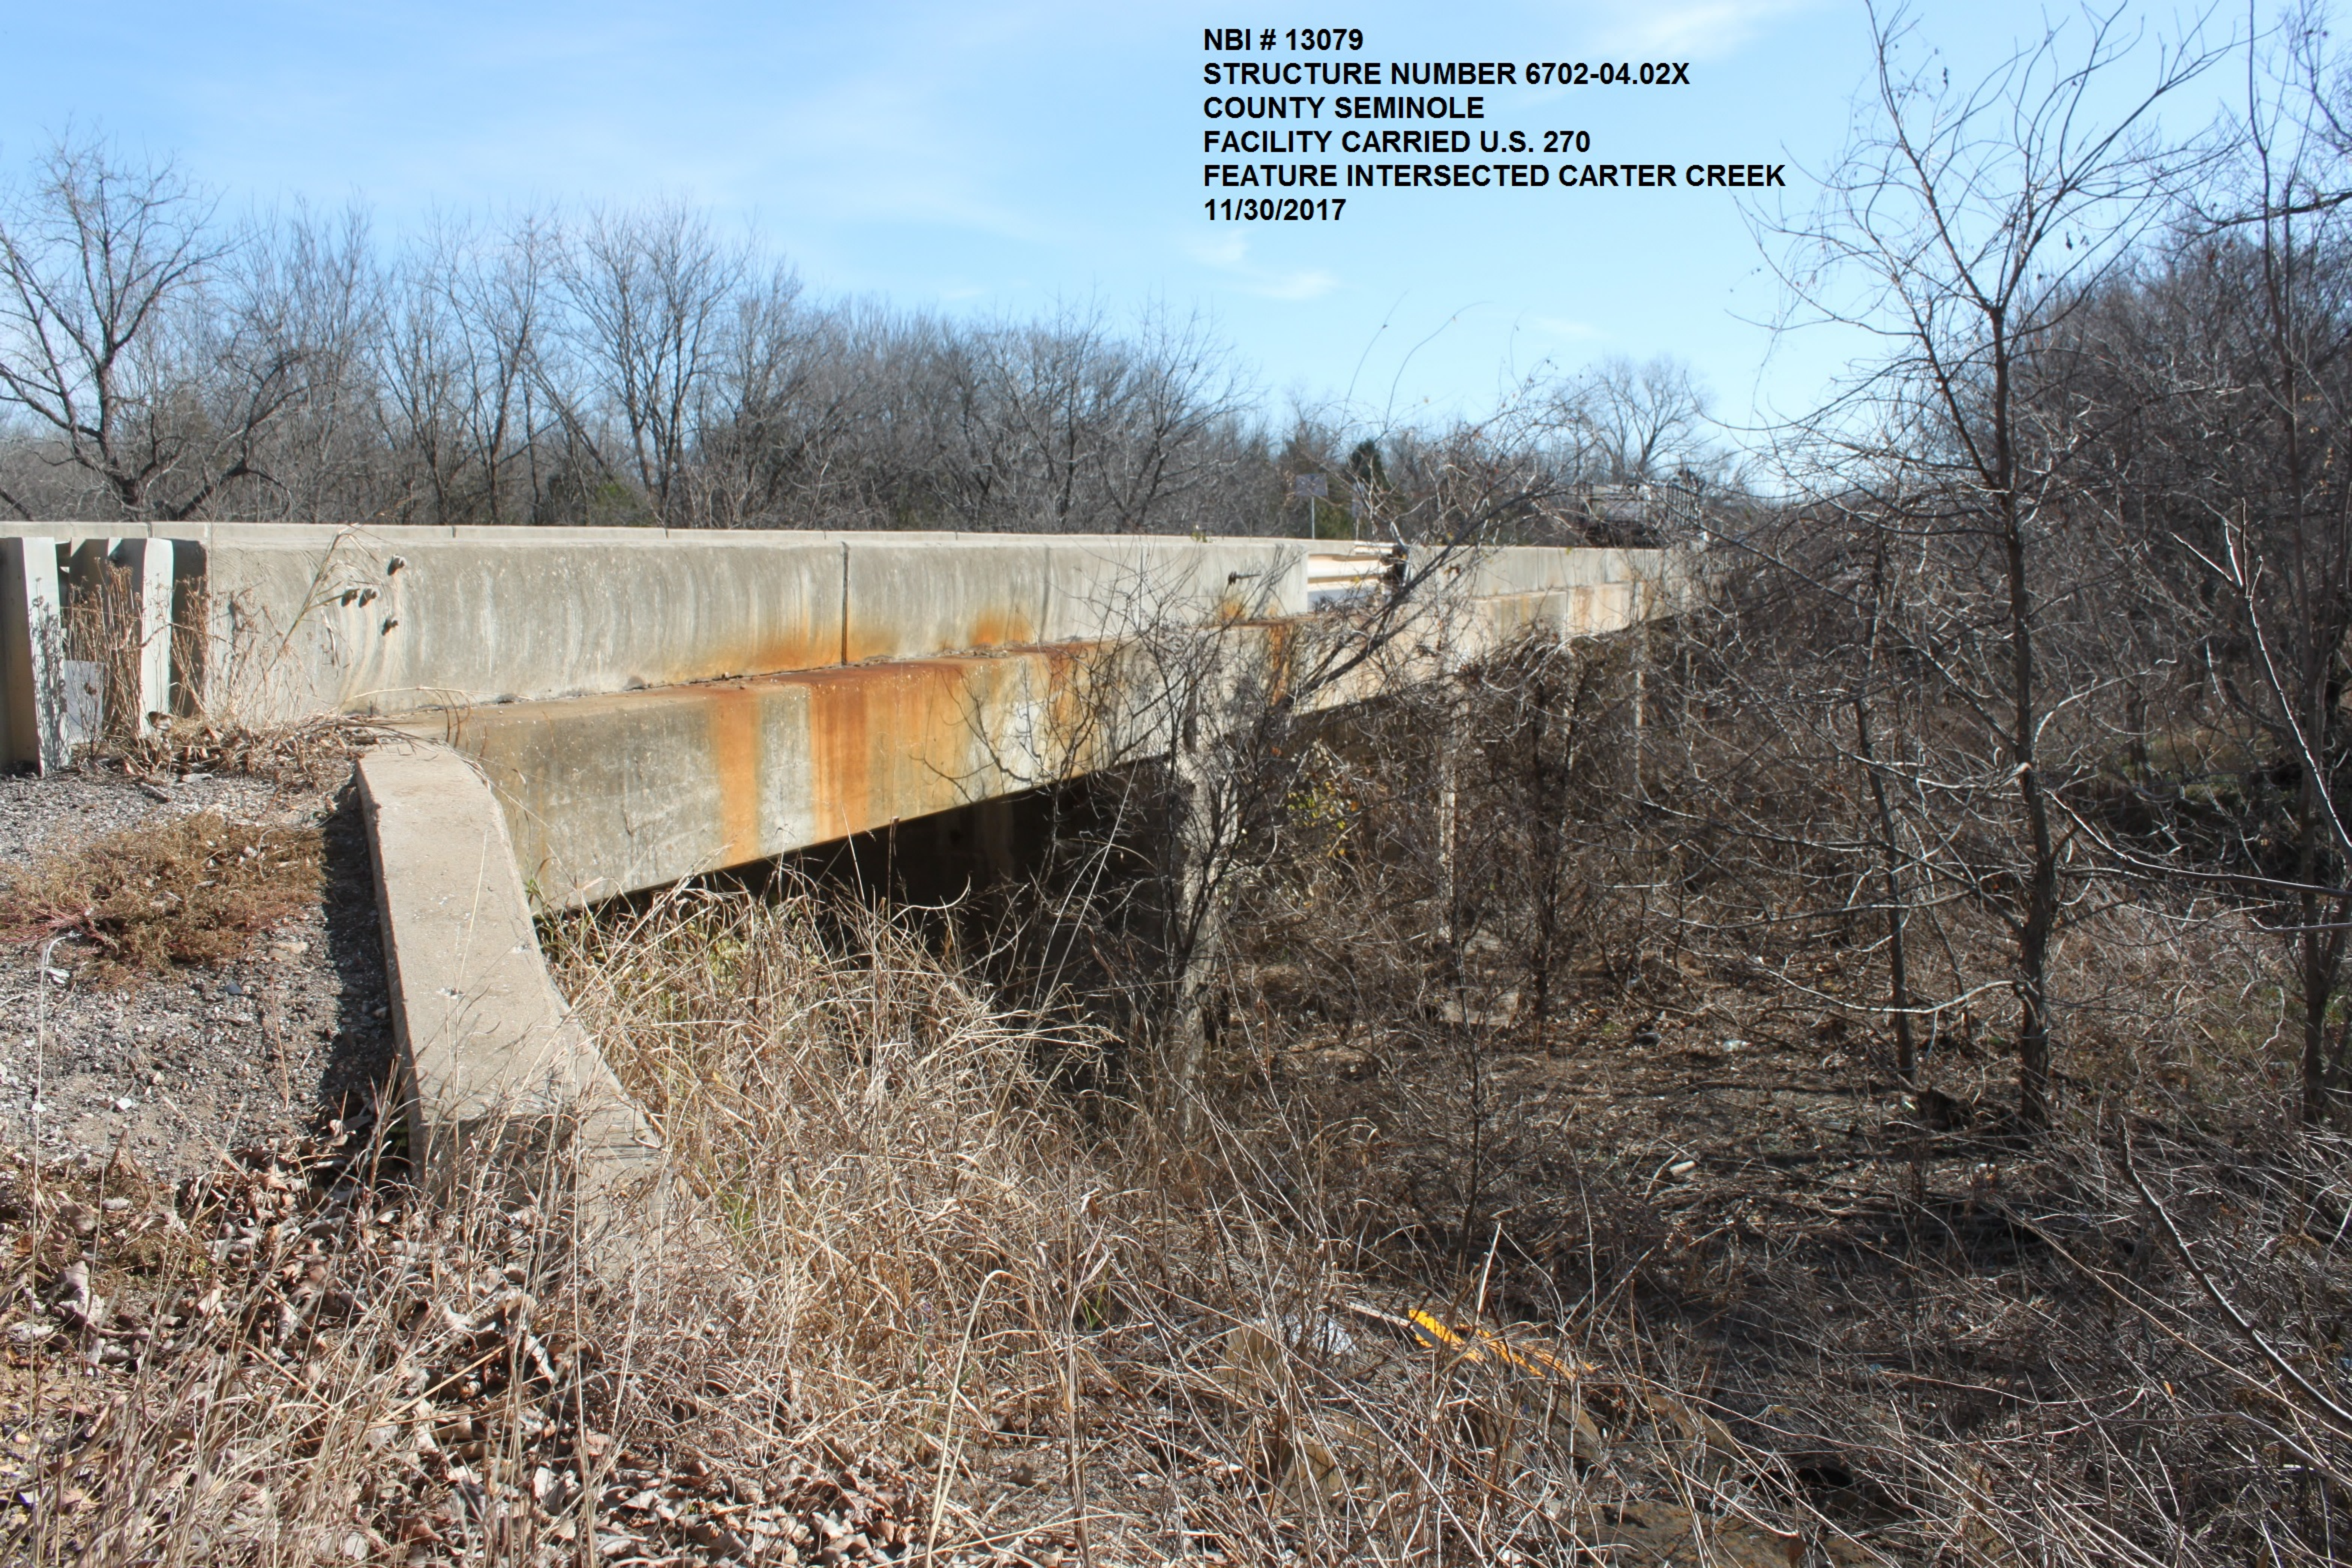
**NBI # 13079
STRUCTURE NUMBER 6702-04.02X
COUNTY SEMINOLE
FACILITY CARRIED U.S. 270
FEATURE INTERSECTED CARTER CREEK
11/30/2017
N. SIDE CURB/RAIL DETERIORATION
@ BTM.**

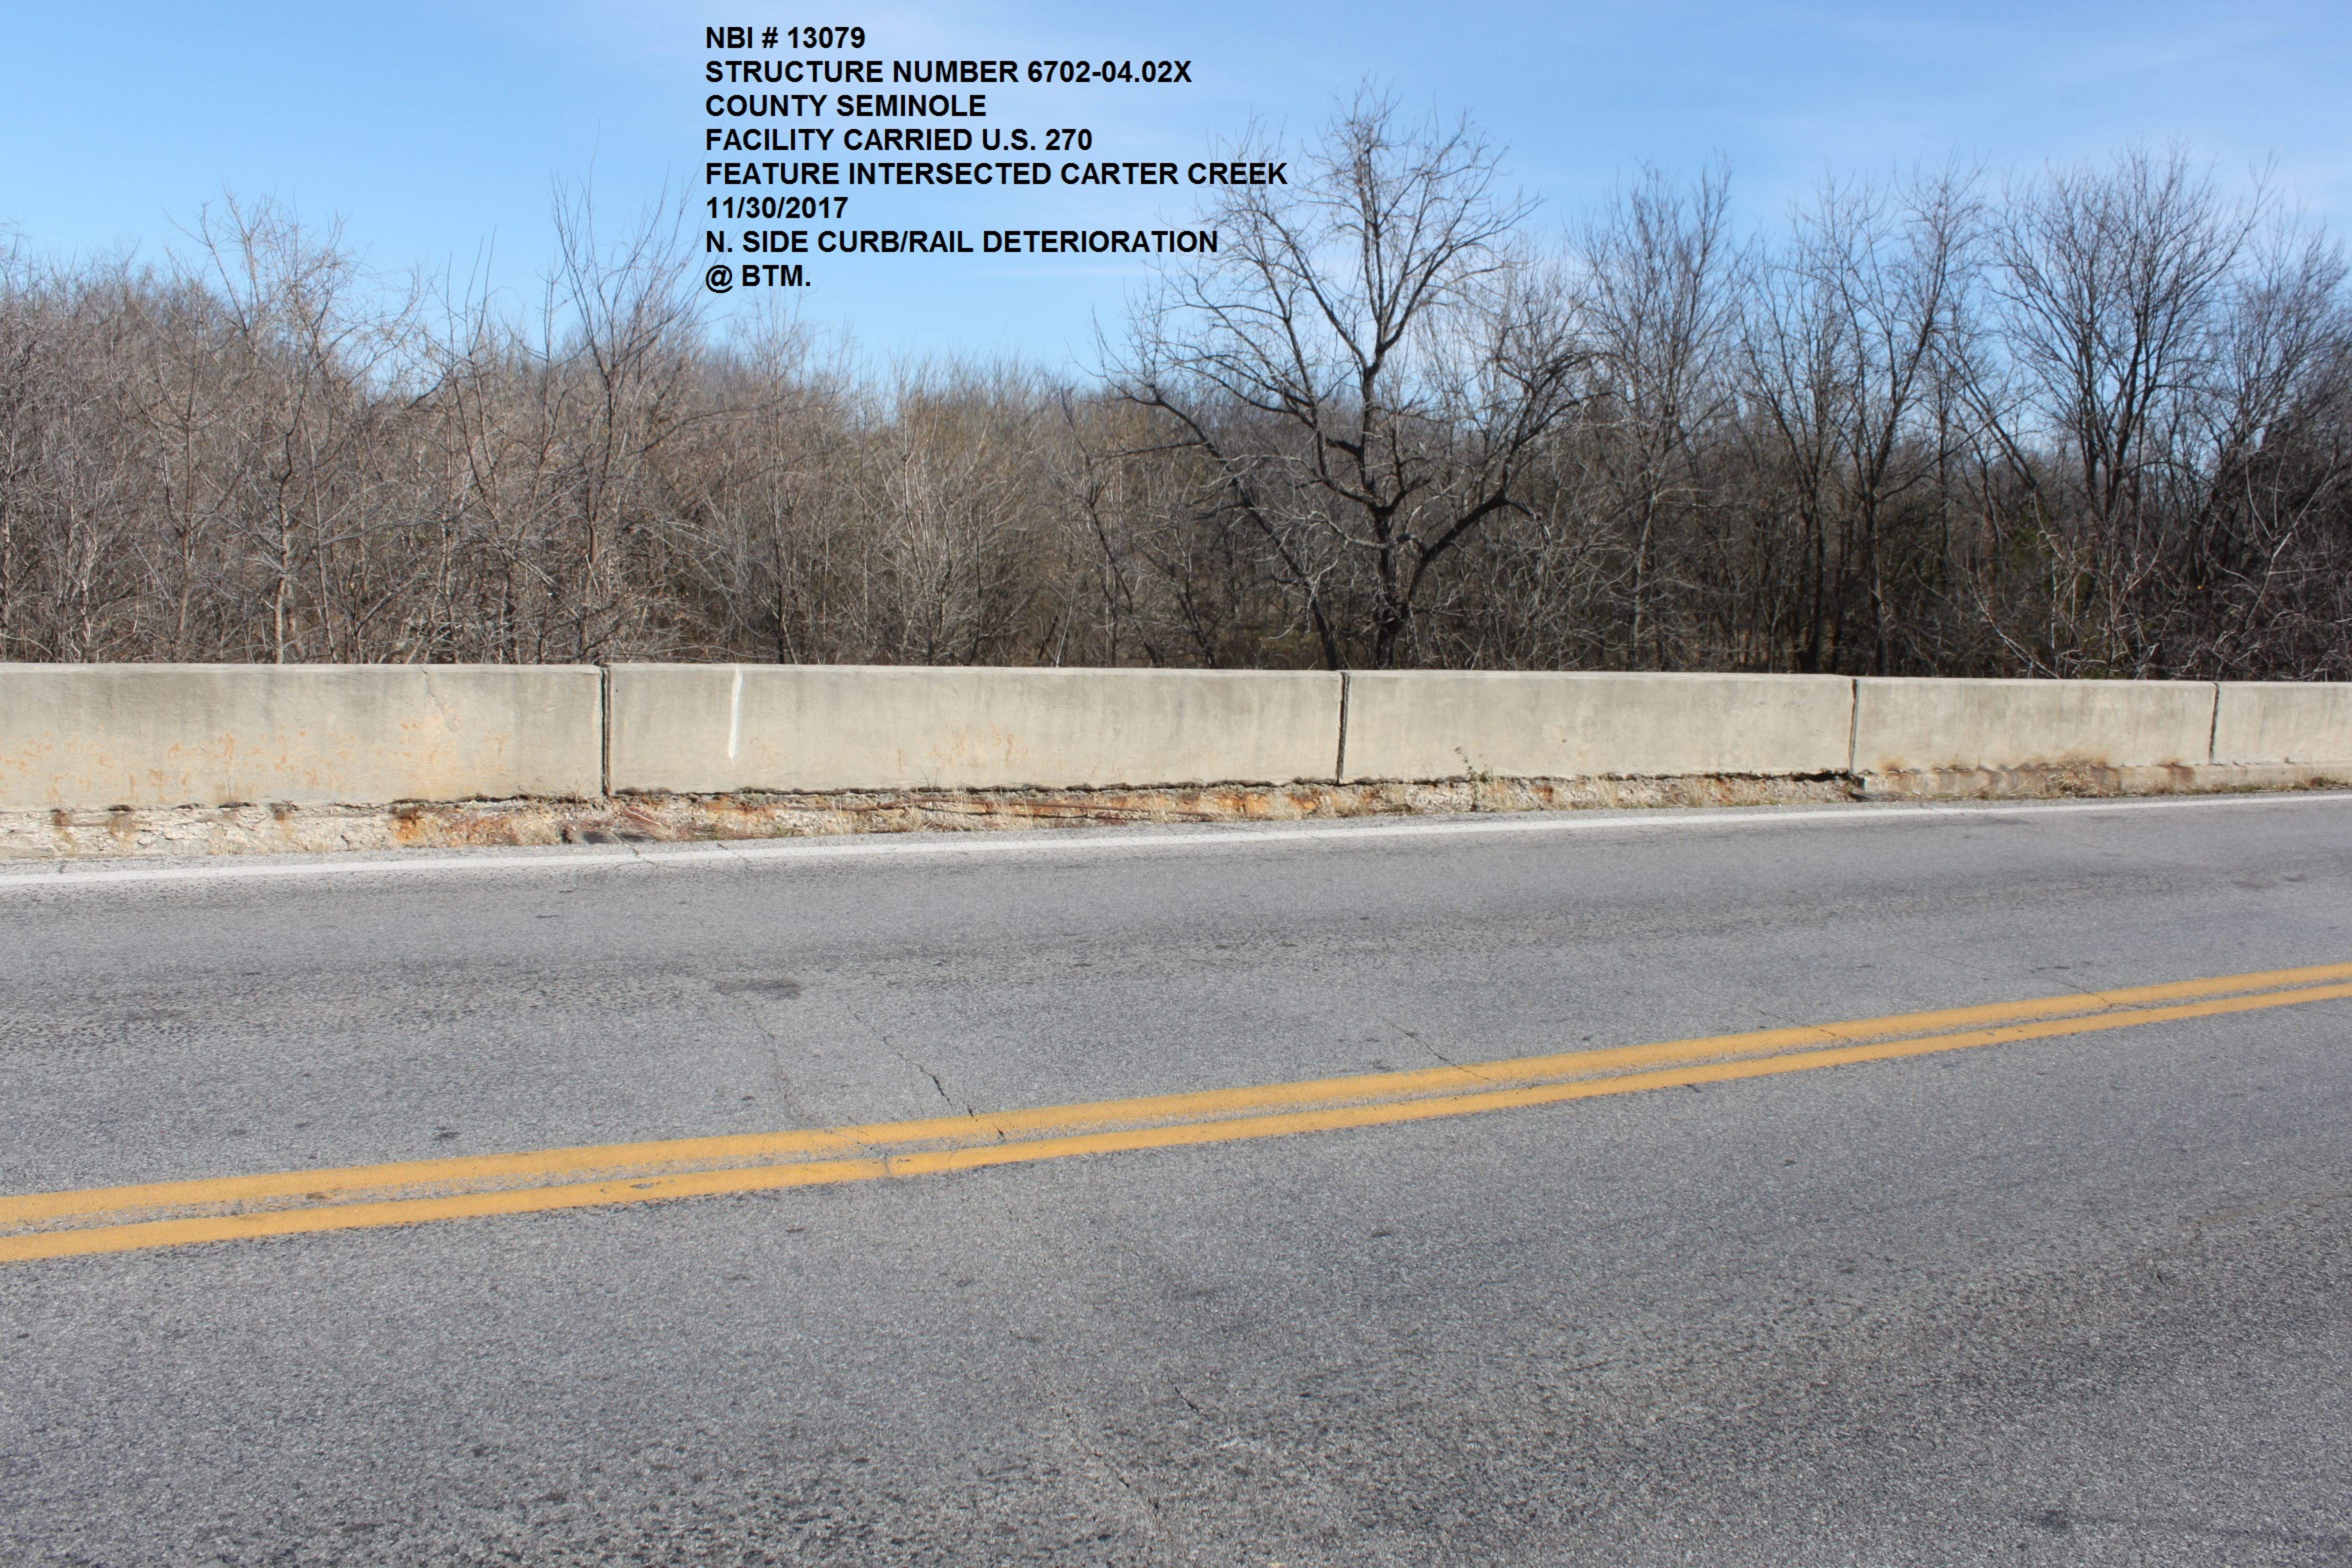
**NBI # 13079
STRUCTURE NUMBER 6702-04.02X
COUNTY SEMINOLE
FACILITY CARRIED U.S. 270
FEATURE INTERSECTED CARTER CREEK
11/30/2017
PIER JT.**

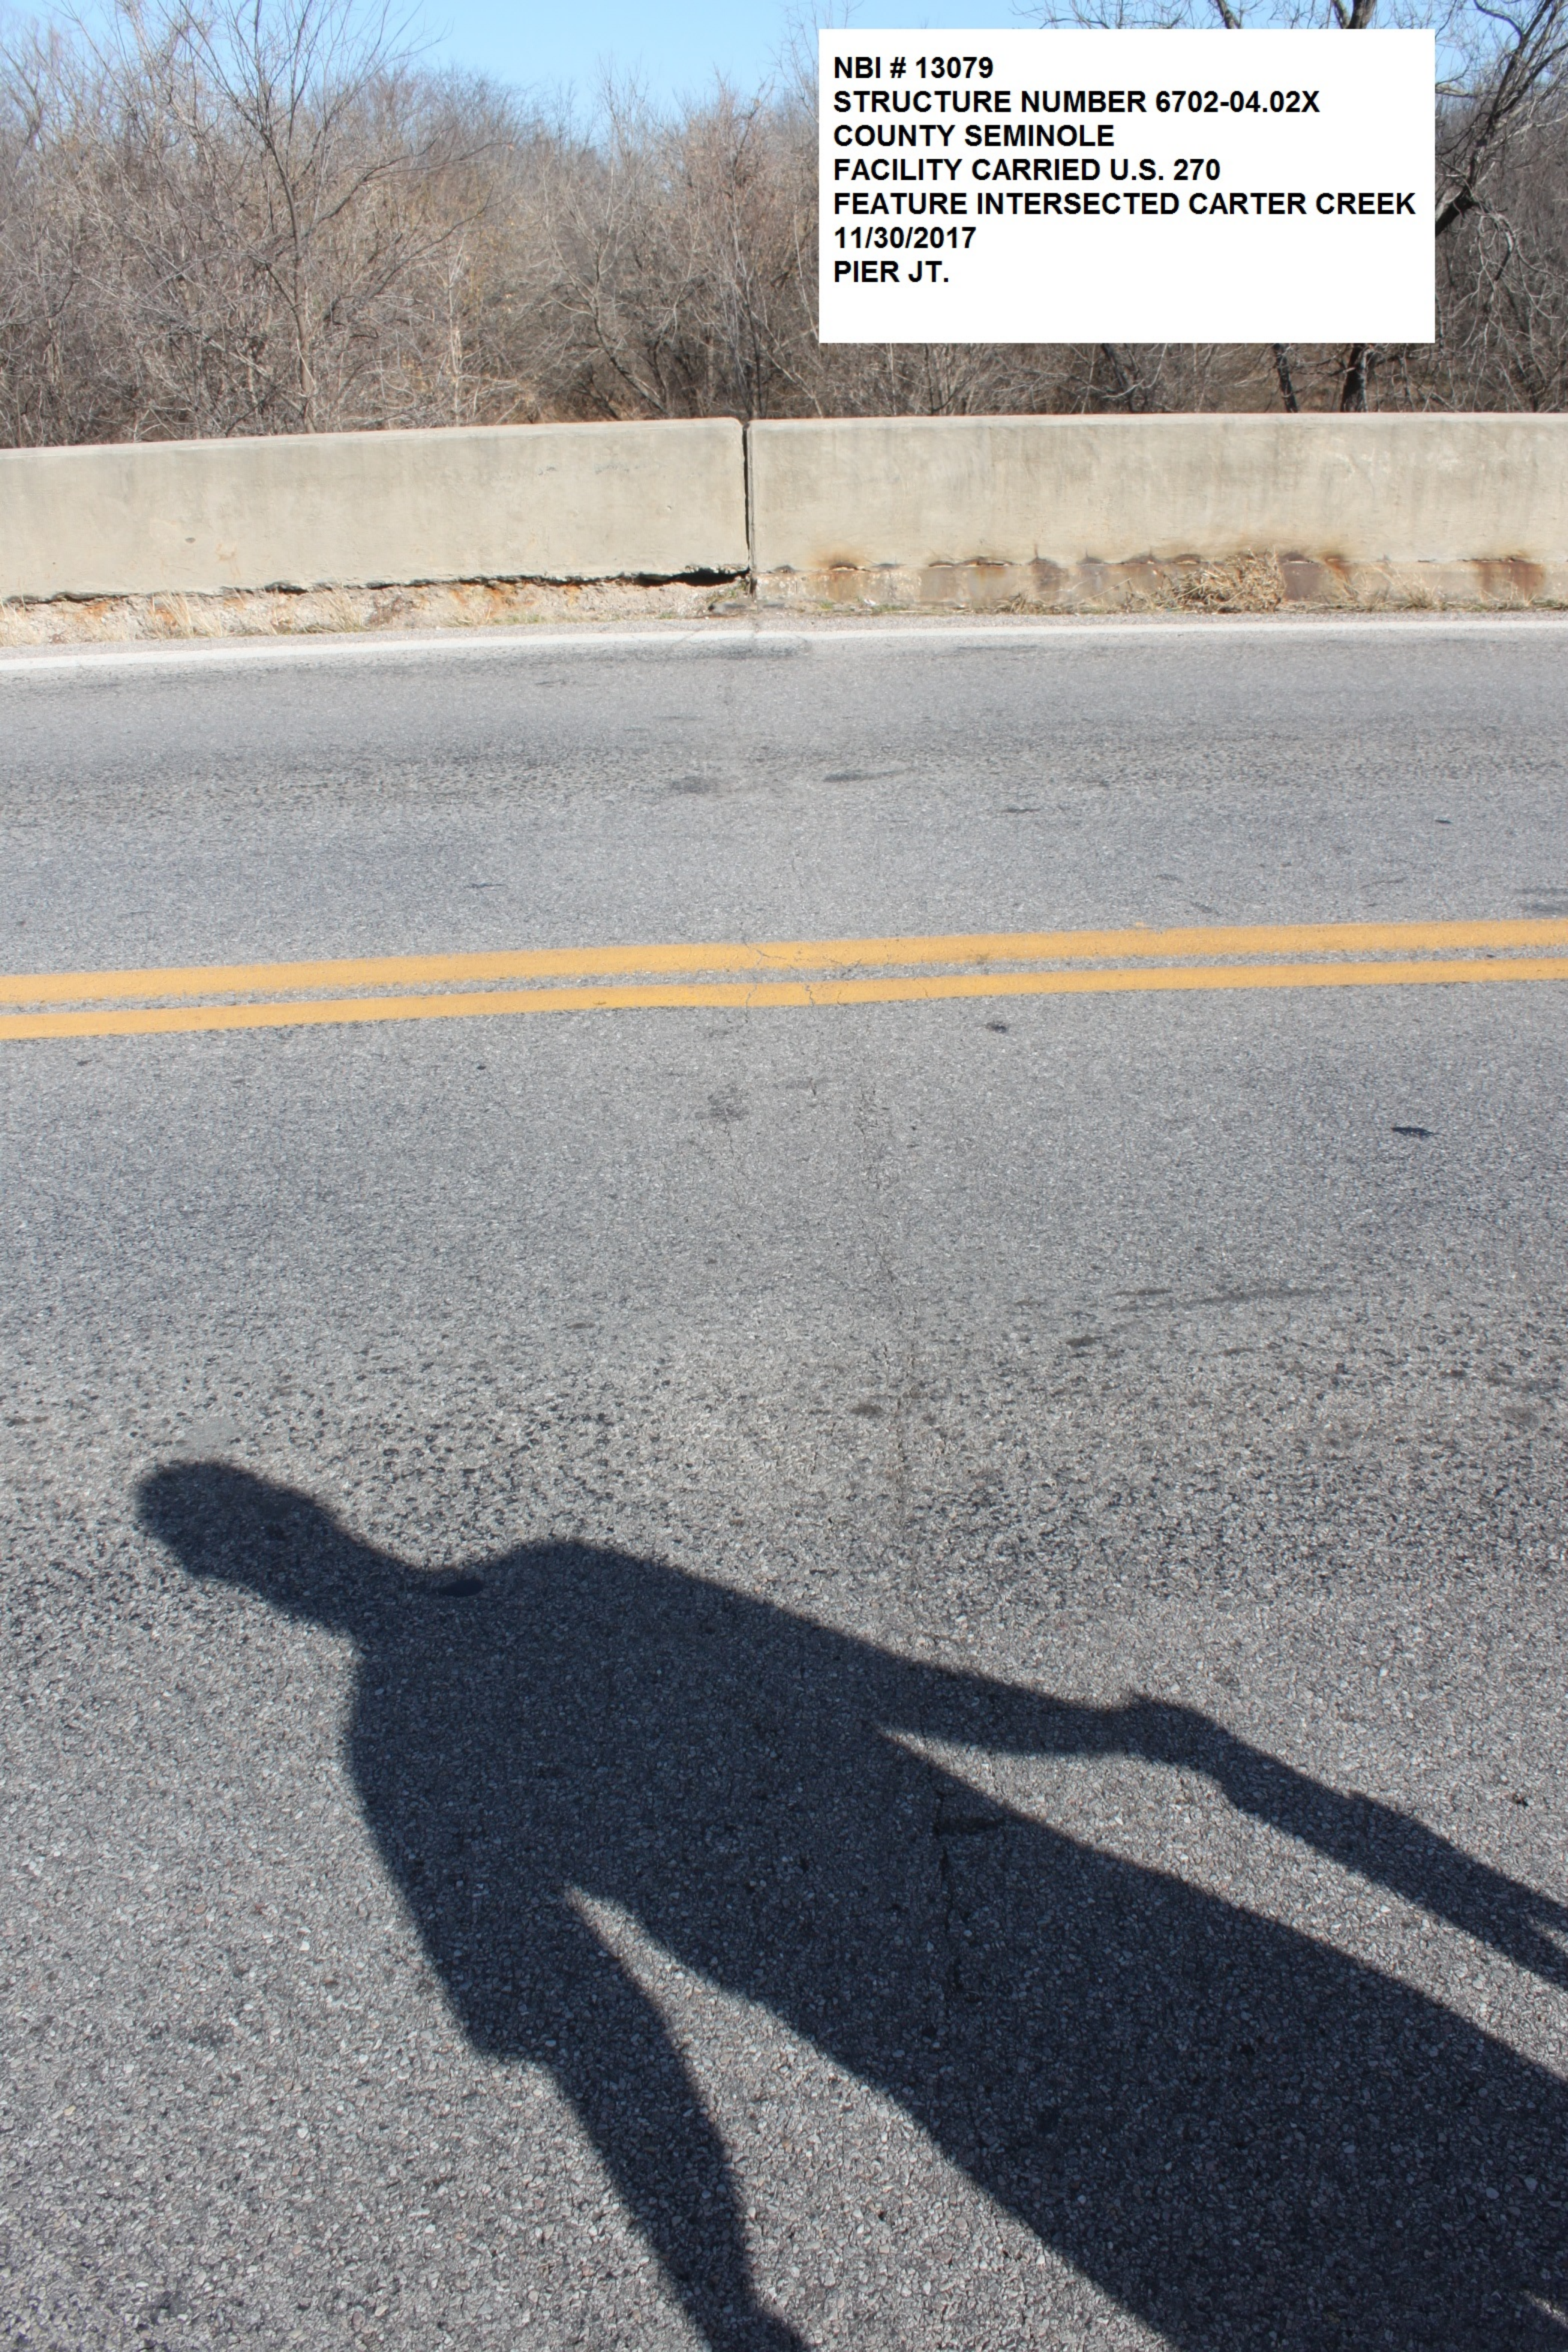
**NBI # 13079
STRUCTURE NUMBER 6702-04.02X
COUNTY SEMINOLE
FACILITY CARRIED U.S. 270
FEATURE INTERSECTED CARTER CREEK
11/30/2017
S. SIDE SECTION OF RAIL MISSING &
CURB/GUTTERS OF DECK IMPACTED W/
DEBRIS & GROWING BRUSH**

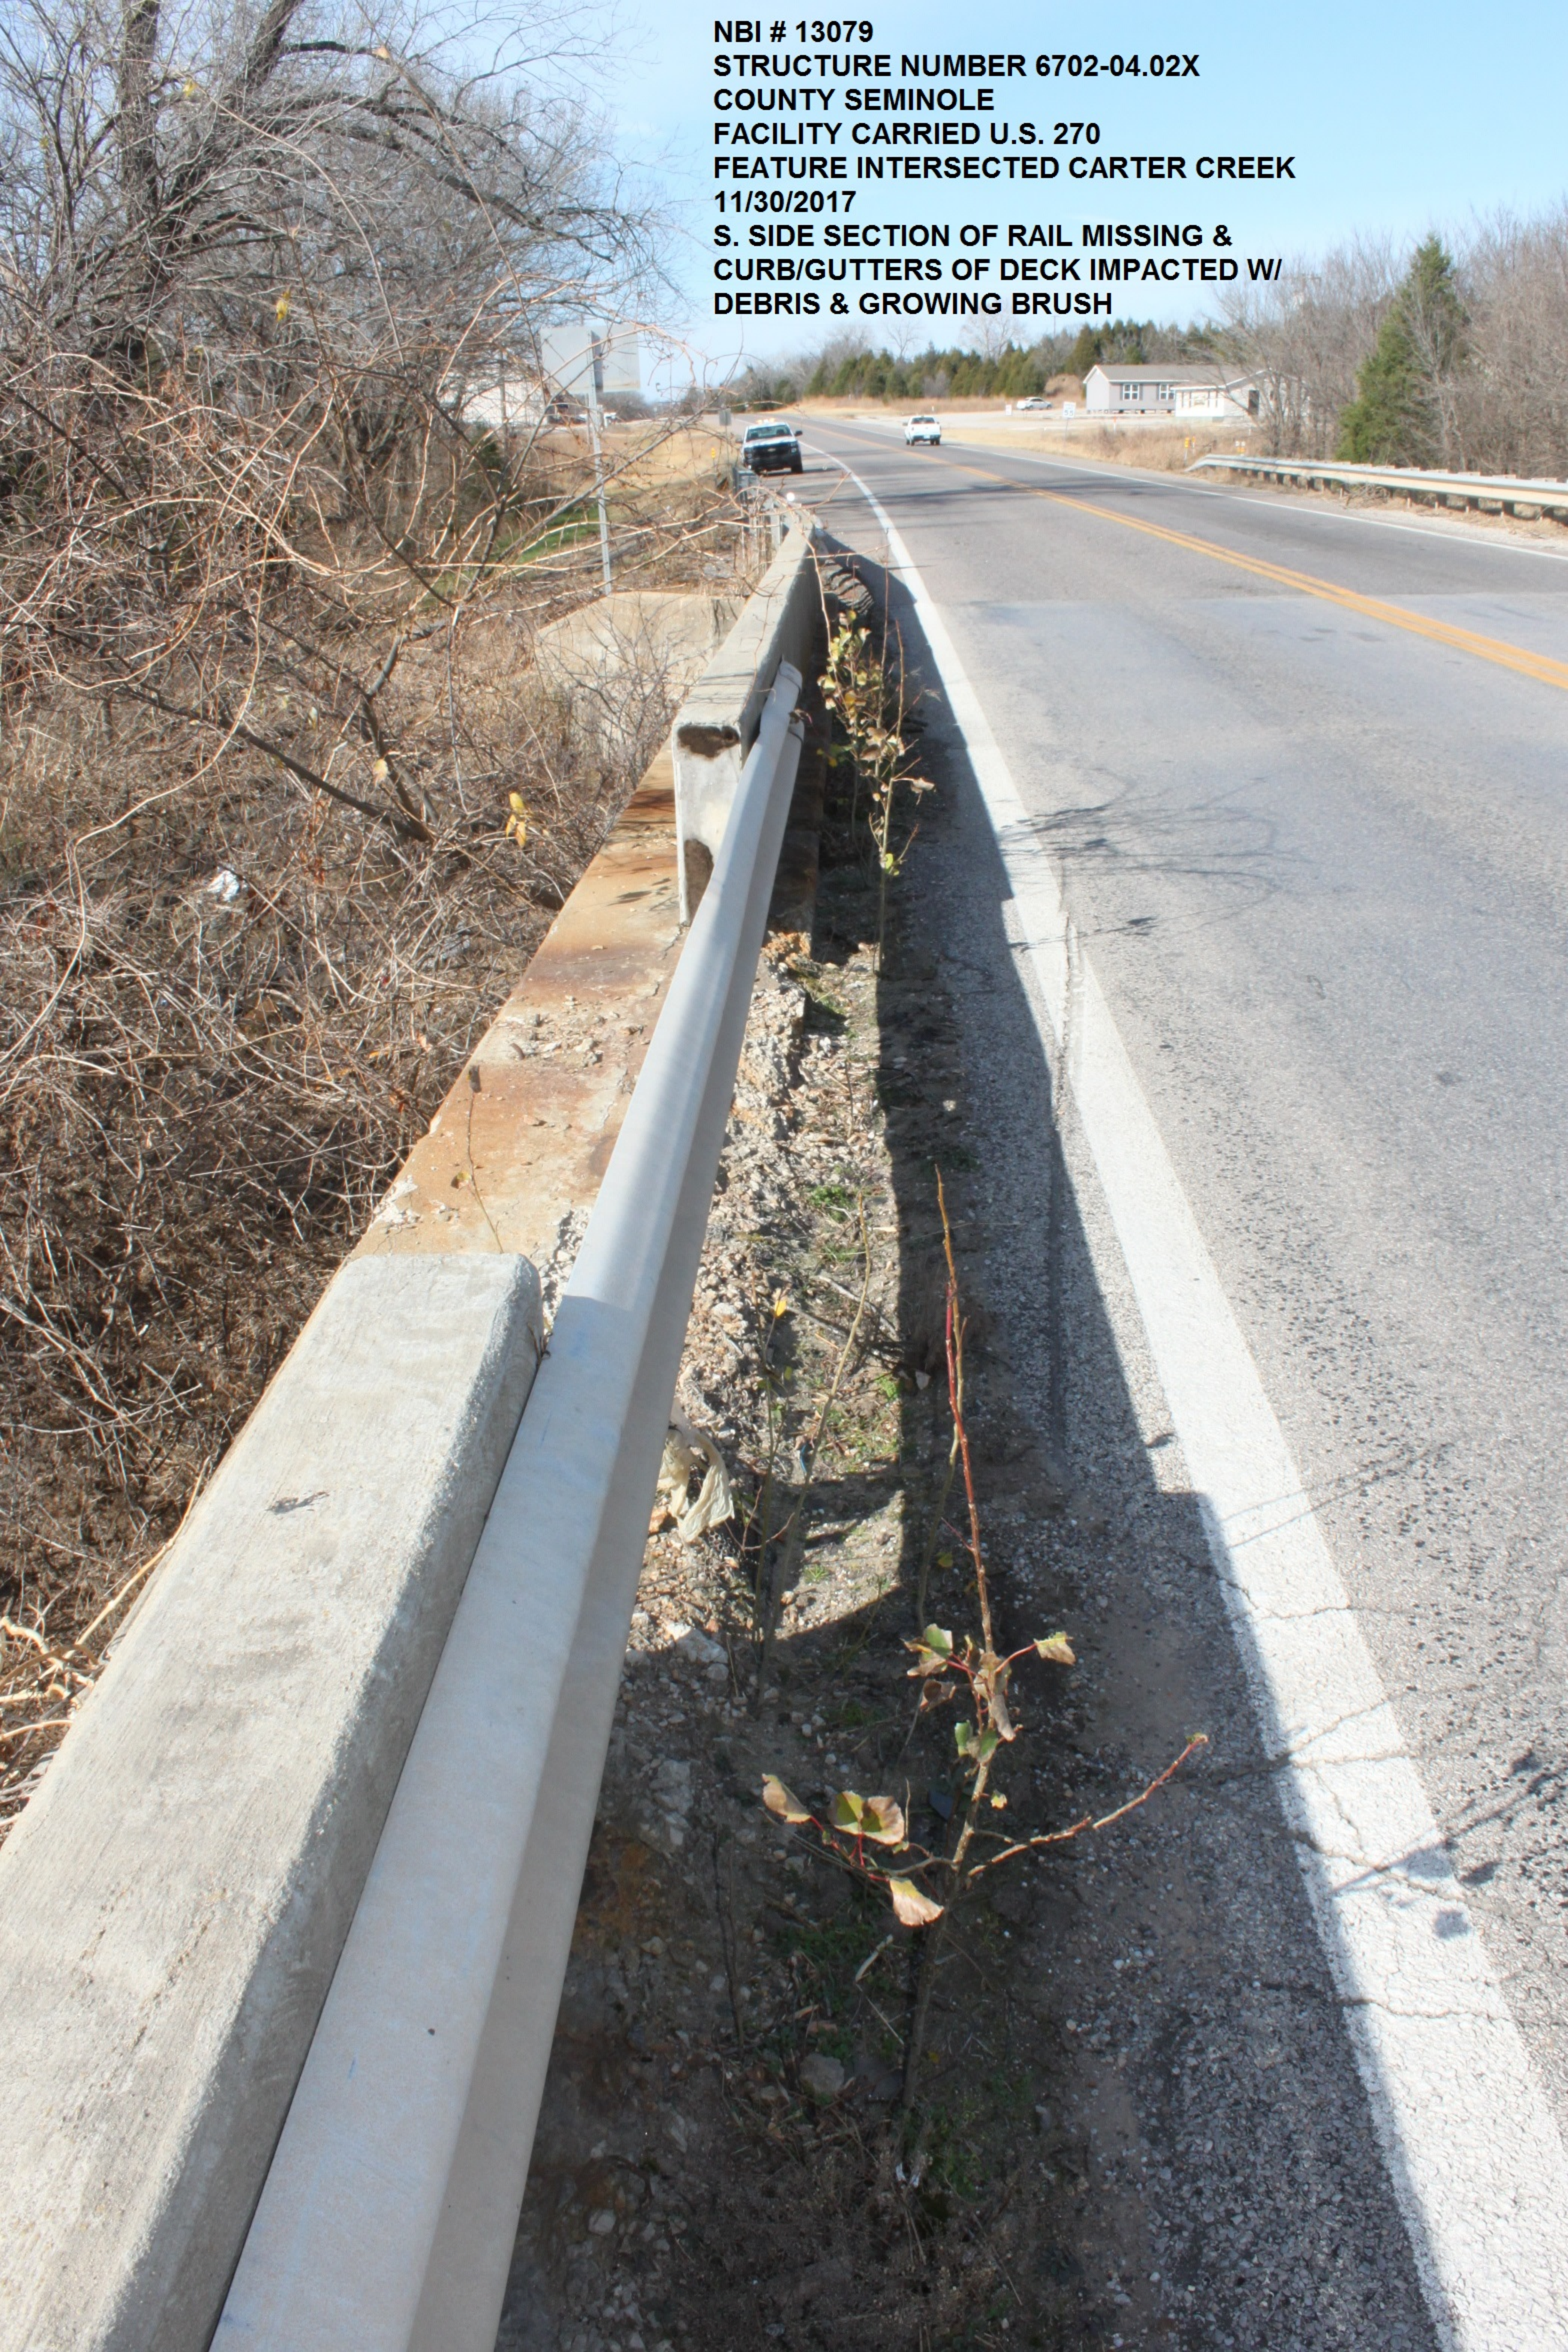
**NBI # 13079
STRUCTURE NUMBER 6702-04.02X
COUNTY SEMINOLE
FACILITY CARRIED U.S. 270
FEATURE INTERSECTED CARTER CREEK
11/30/2017
EAST END JT.**

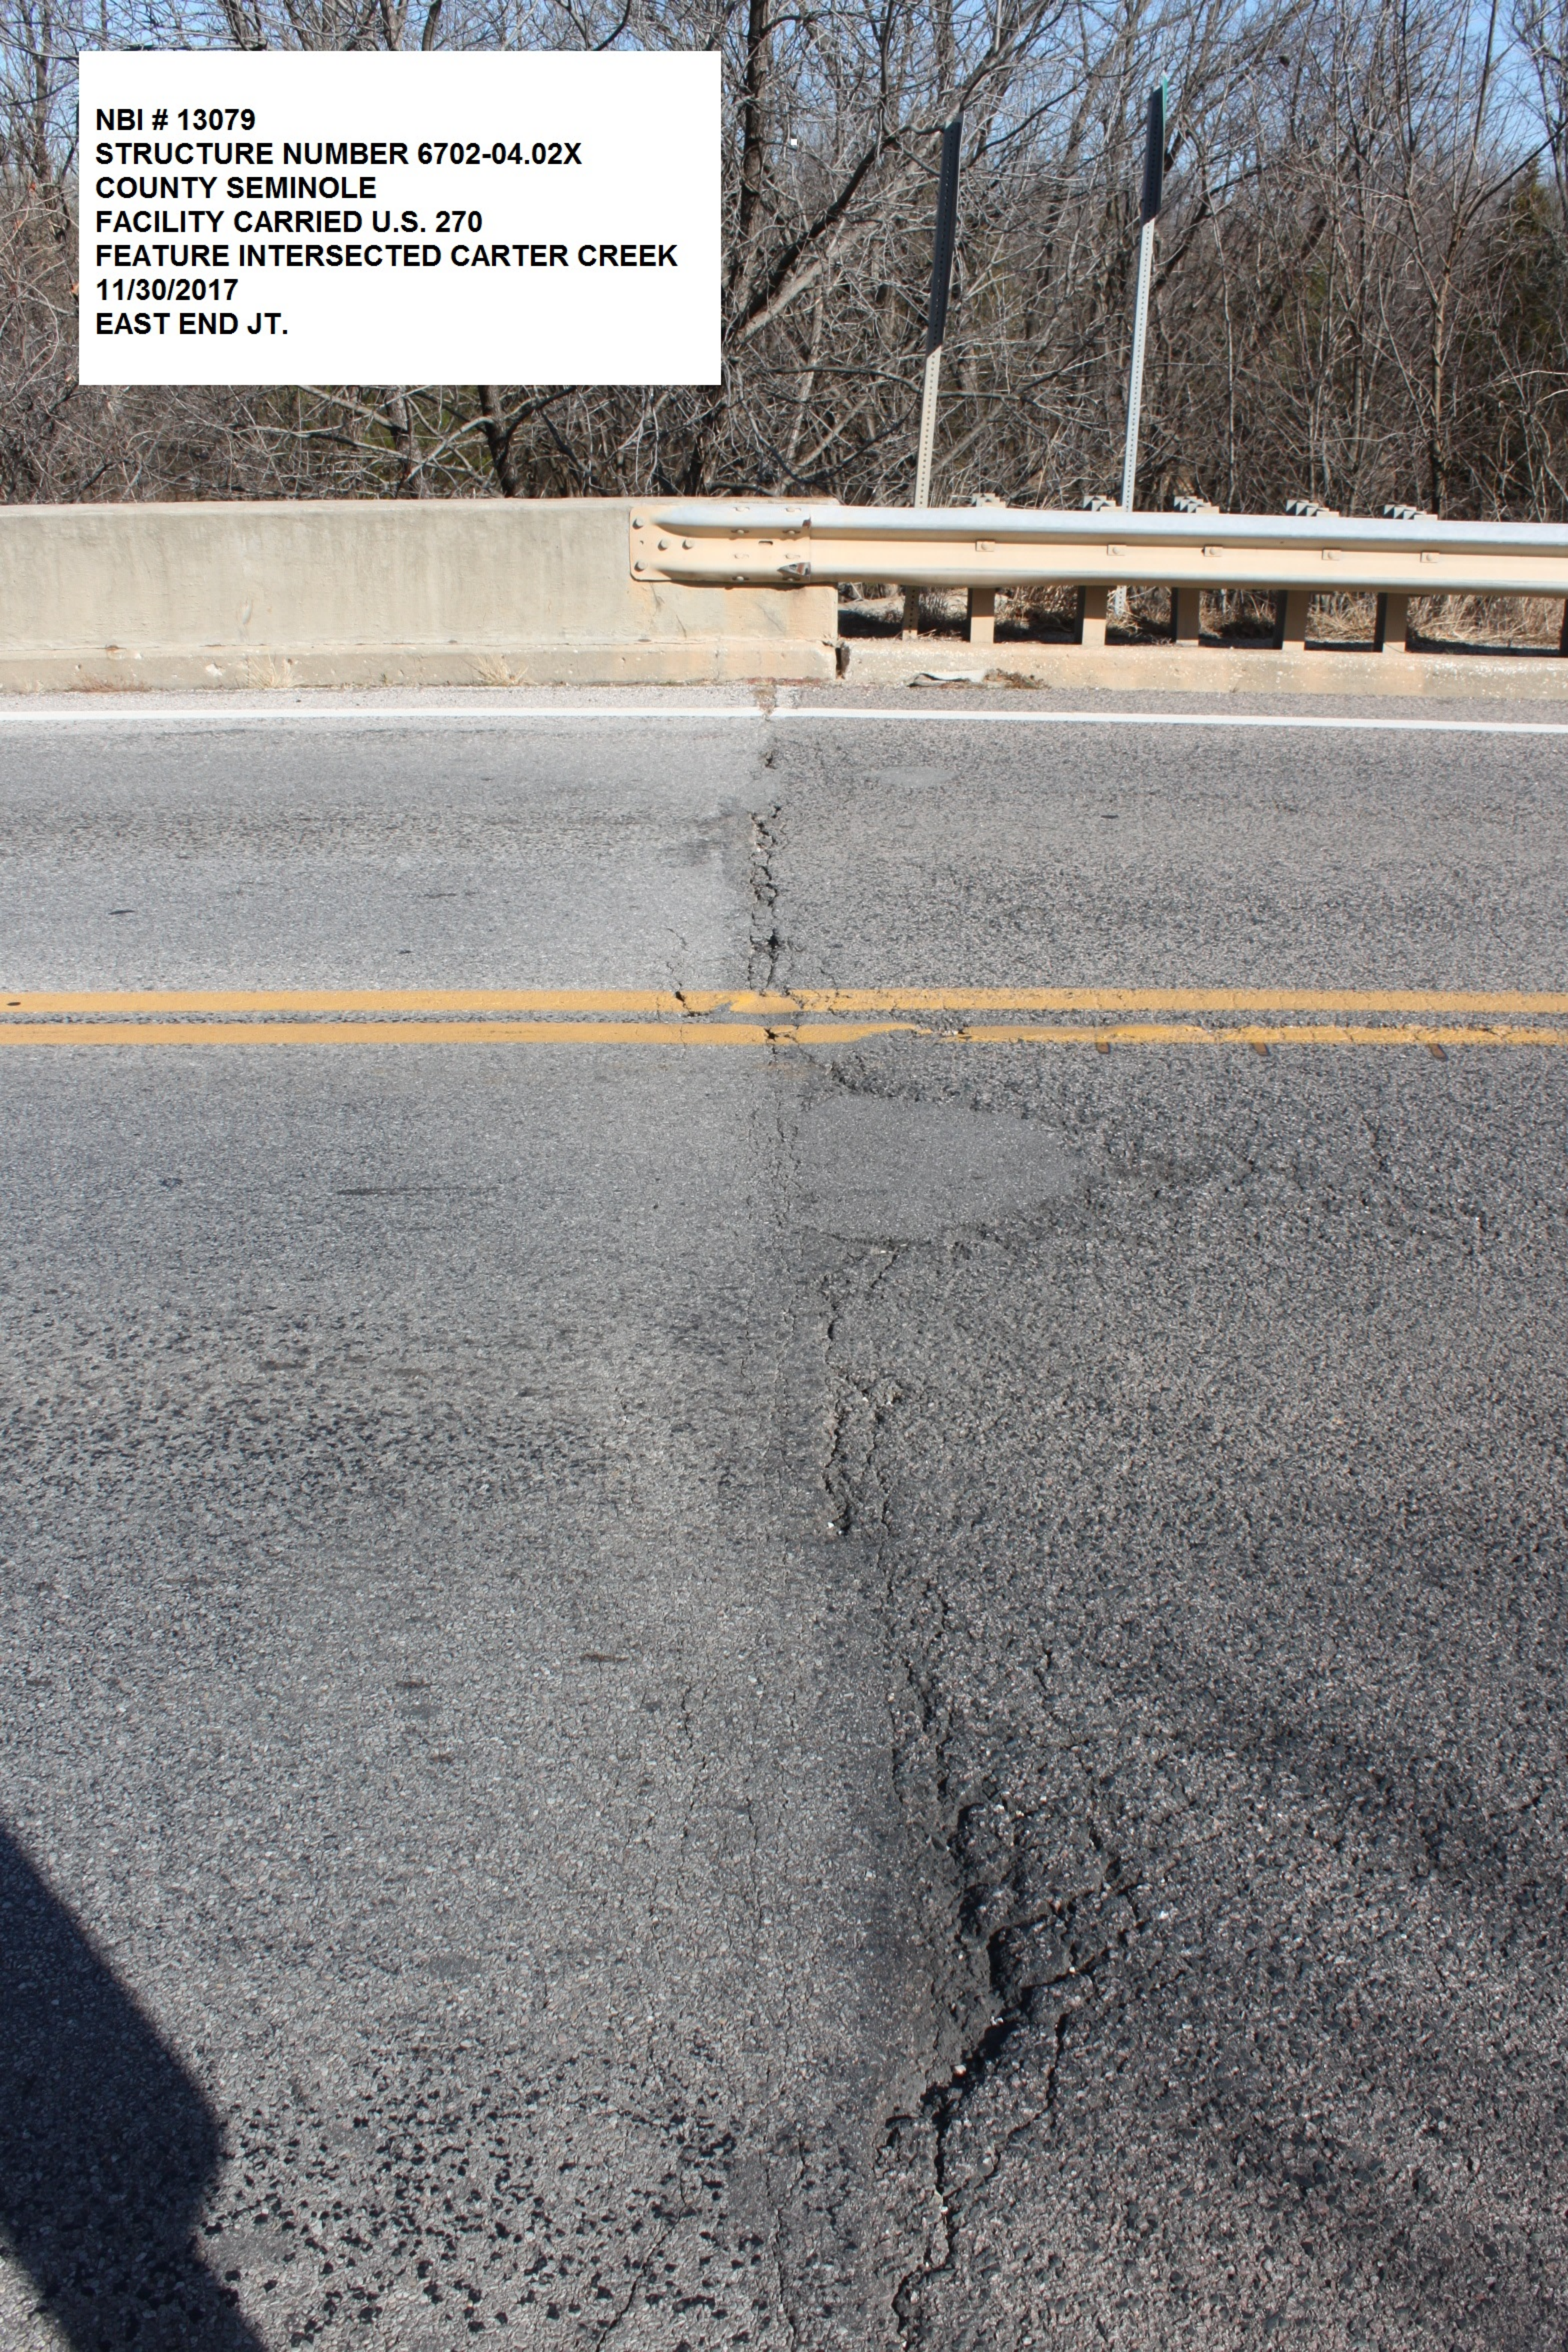
**NBI # 13079
STRUCTURE NUMBER 6702-04.02X
COUNTY SEMINOLE
FACILITY CARRIED U.S. 270
FEATURE INTERSECTED CARTER CREEK
11/30/2017
PIER # 6, FACING WEST- CRACKS W/
LEACHING & EFFLORESCENCE THIS IS
TYPICAL FOR ALL PIERWALLS**

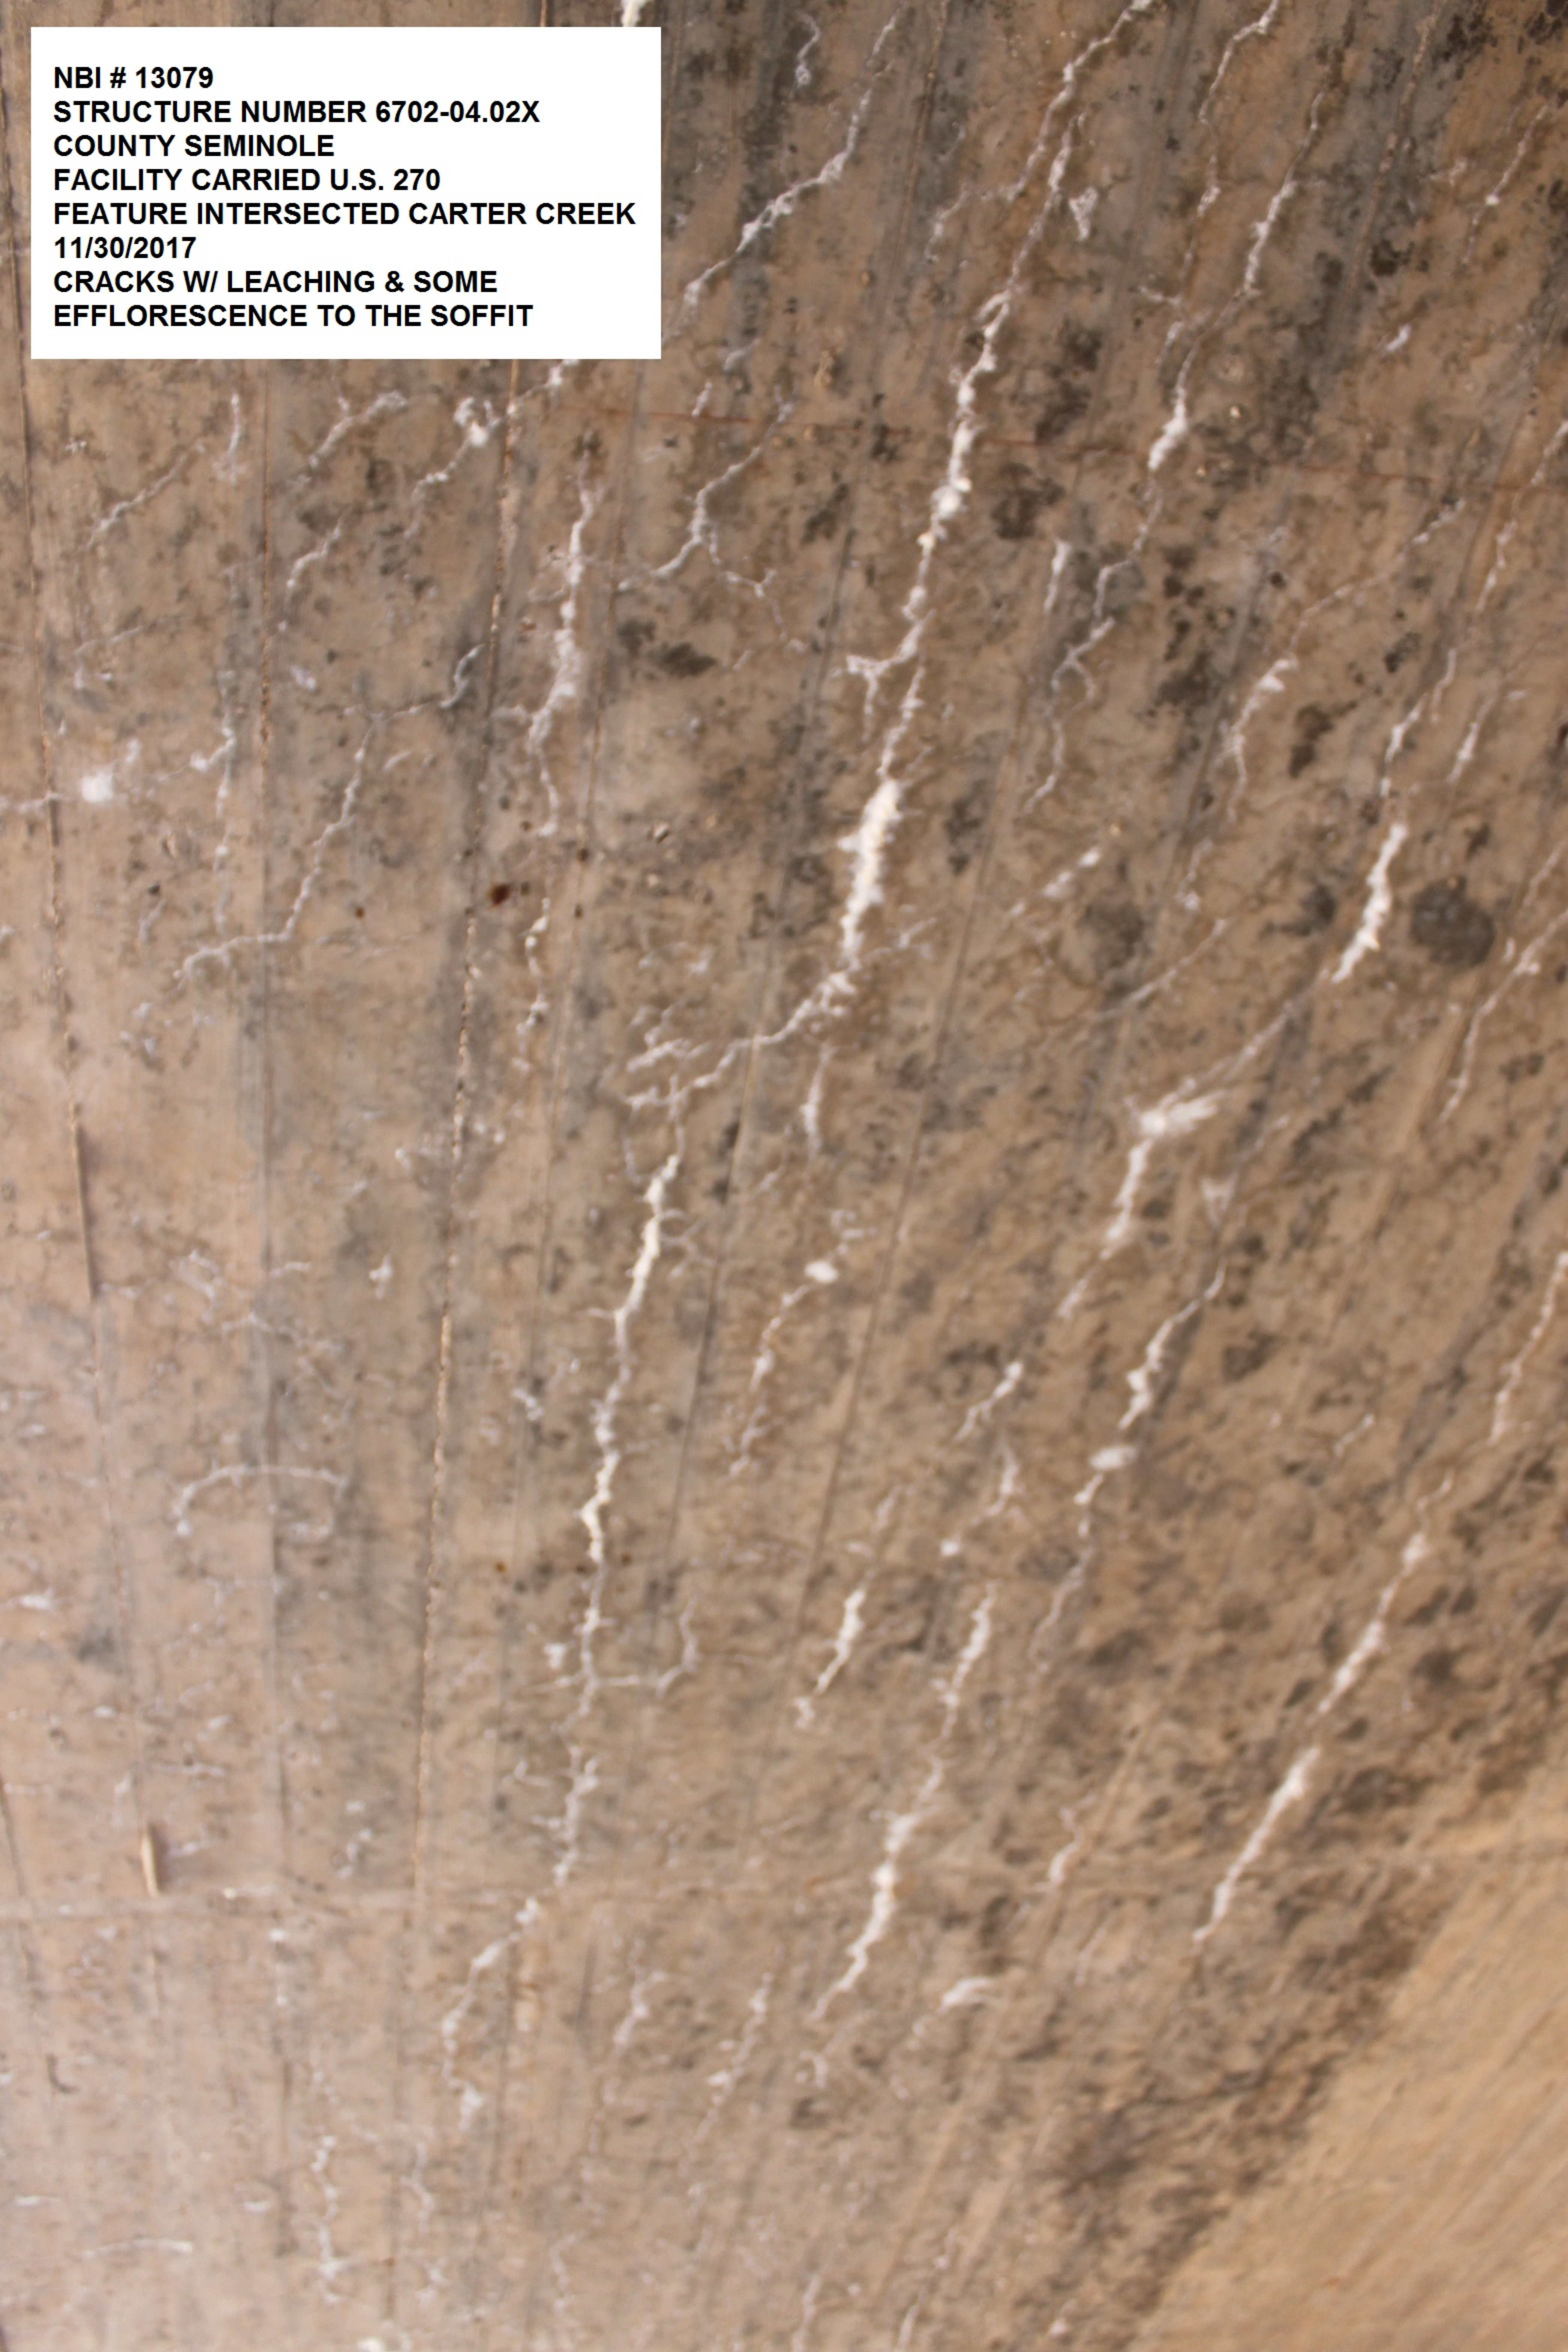
**NBI # 13079
STRUCTURE NUMBER 6702-04.02X
COUNTY SEMINOLE
FACILITY CARRIED U.S. 270
FEATURE INTERSECTED CARTER CREEK
11/30/2017
CRACKS W/ LEACHING & SOME
EFFLORESCENCE TO THE SOFFIT**
