NBI # 13079
STRUCTURE NUMBER 6702-04.02X
COUNTY SEMINOLE
FACILITY CARRIED U.S. 270
FEATURE INTERSECTED CARTER CREEK
11/30/2017

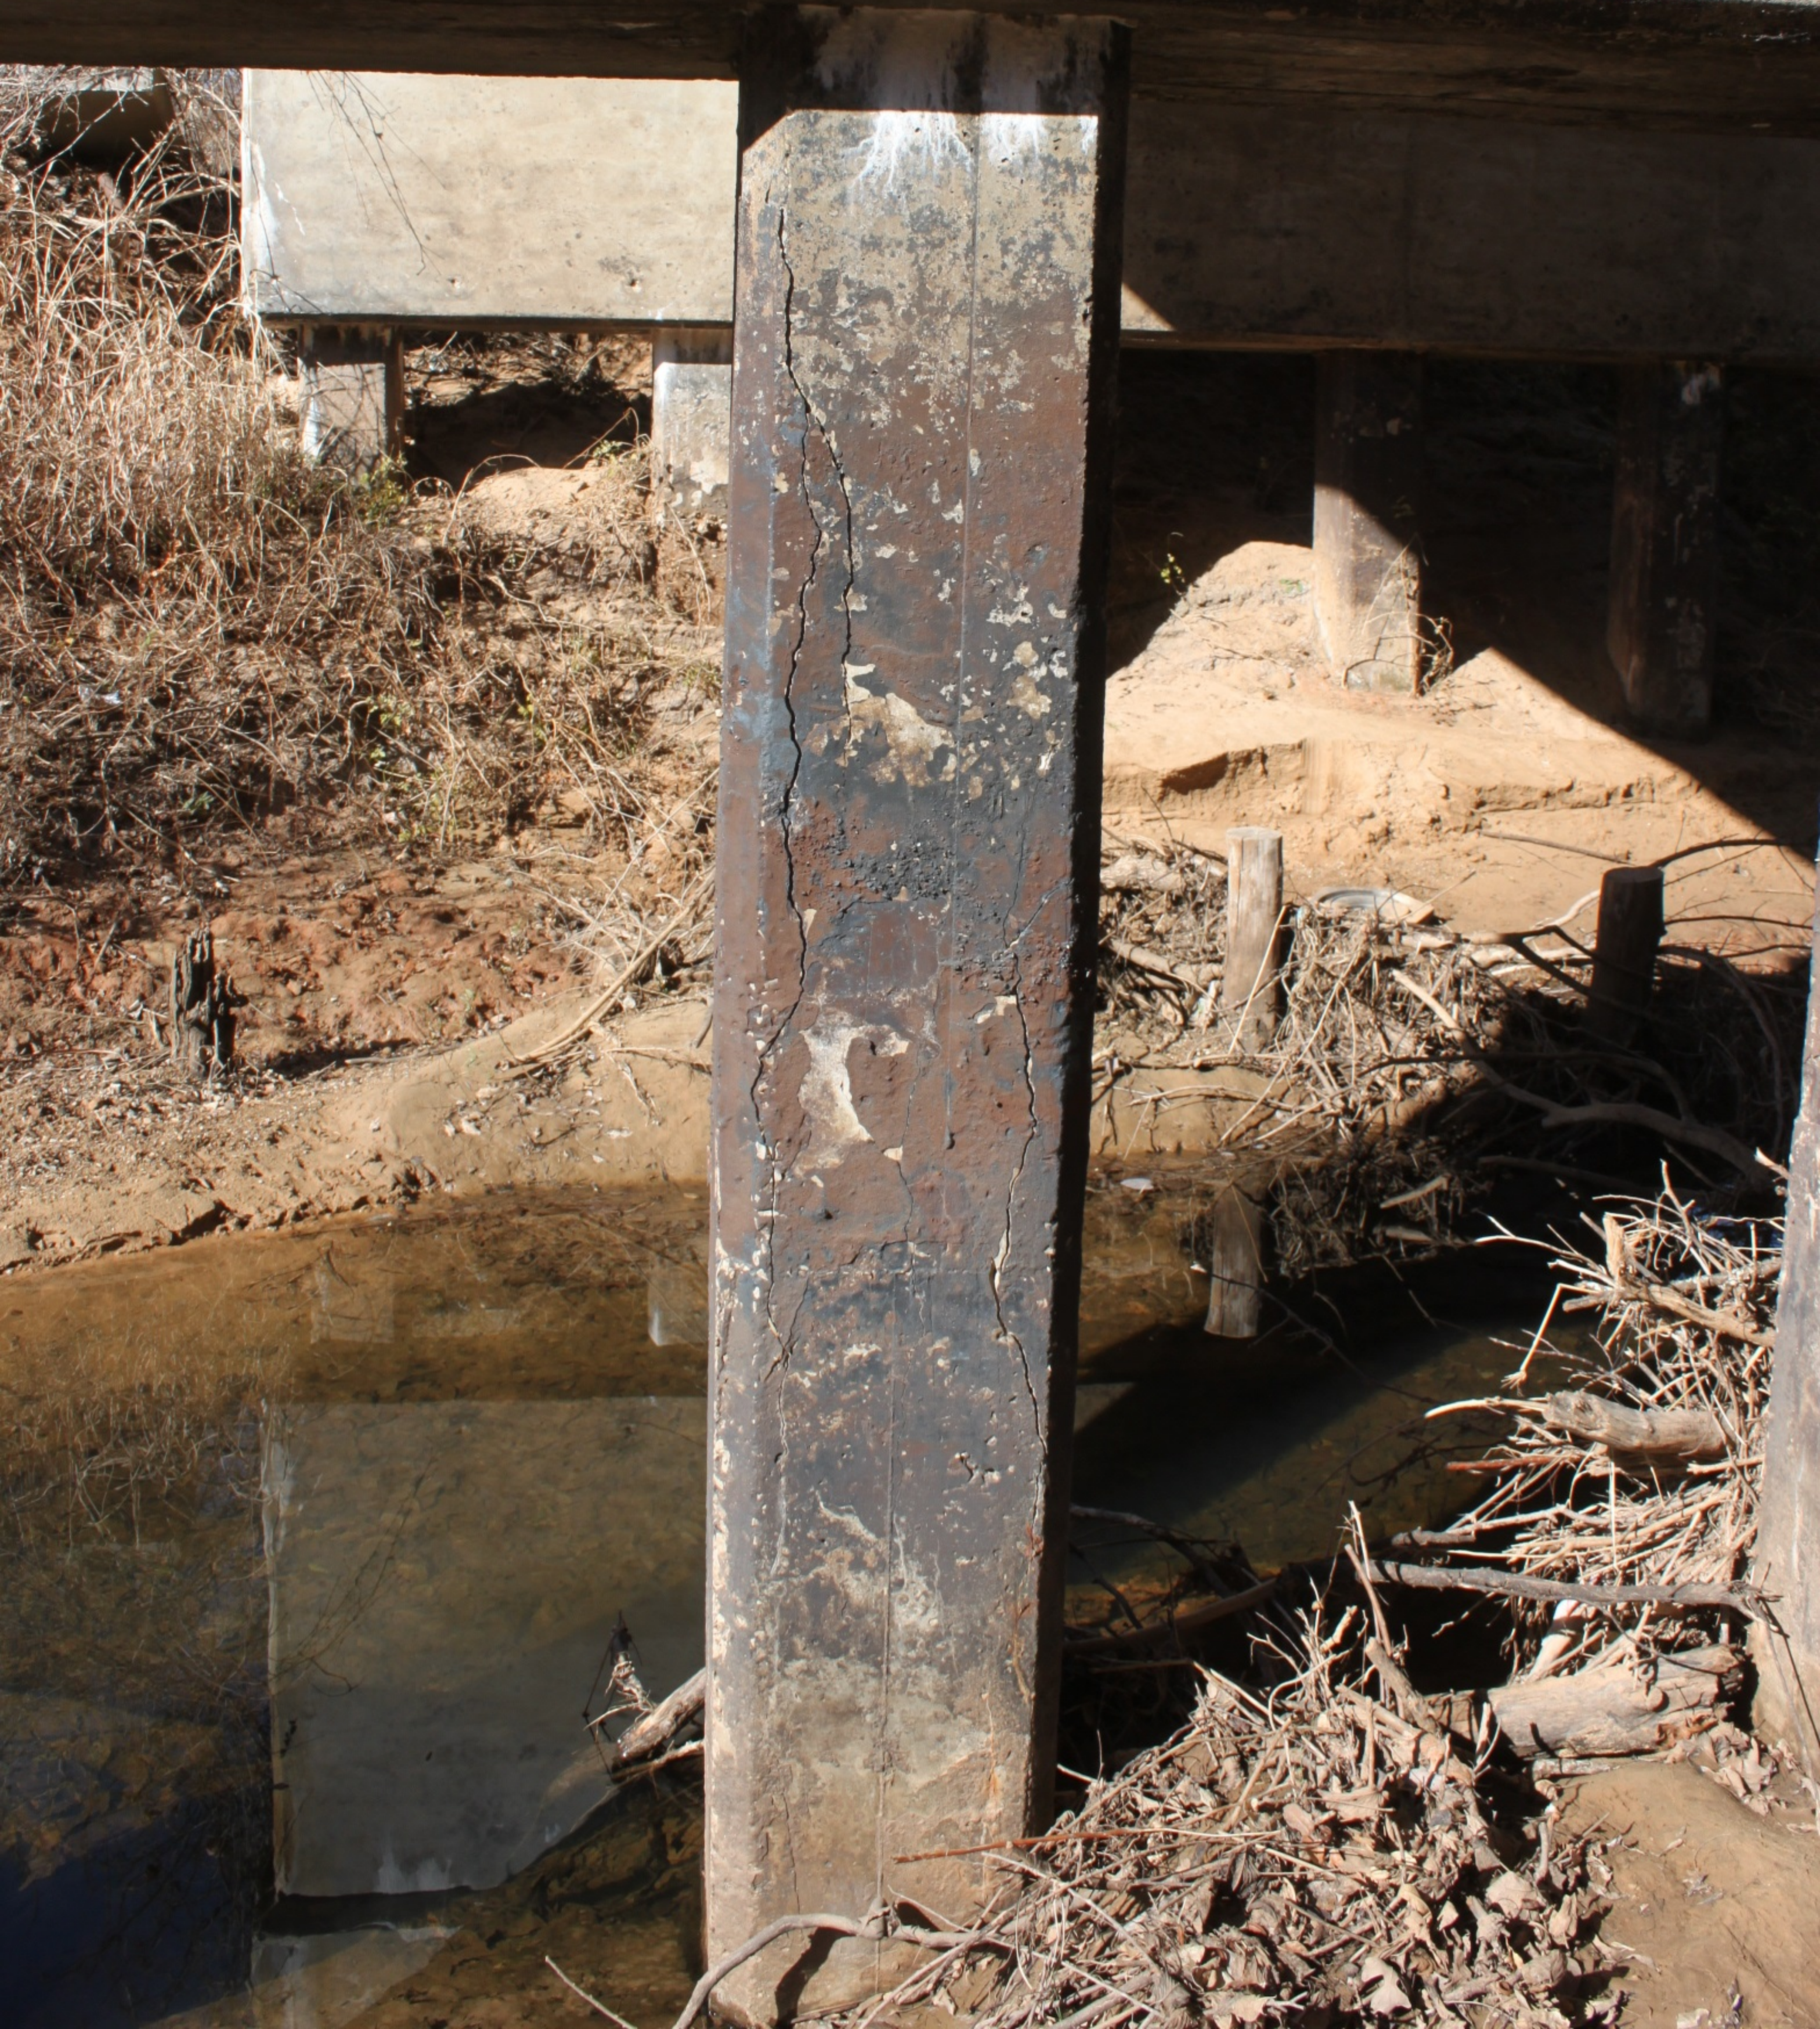
**NBI # 13079
STRUCTURE NUMBER 6702-04.02X
COUNTY SEMINOLE
FACILITY CARRIED U.S. 270
FEATURE INTERSECTED CARTER CREEK
11/30/2017
PIER # 3, COL. # 2 LARGE DELAMINATIONS
TO PILE-THIS IS TYPICAL FOR NUMEROUS
PILING**
