**Documented Categorical Exclusion (DCE) for
I-35: at SH-9W Interchange
McClain County
Project No. J1-9134(004), Job Piece No. 19314(04)**

Existing Conditions and Purpose and Need for the Action

Description of Proposed Action

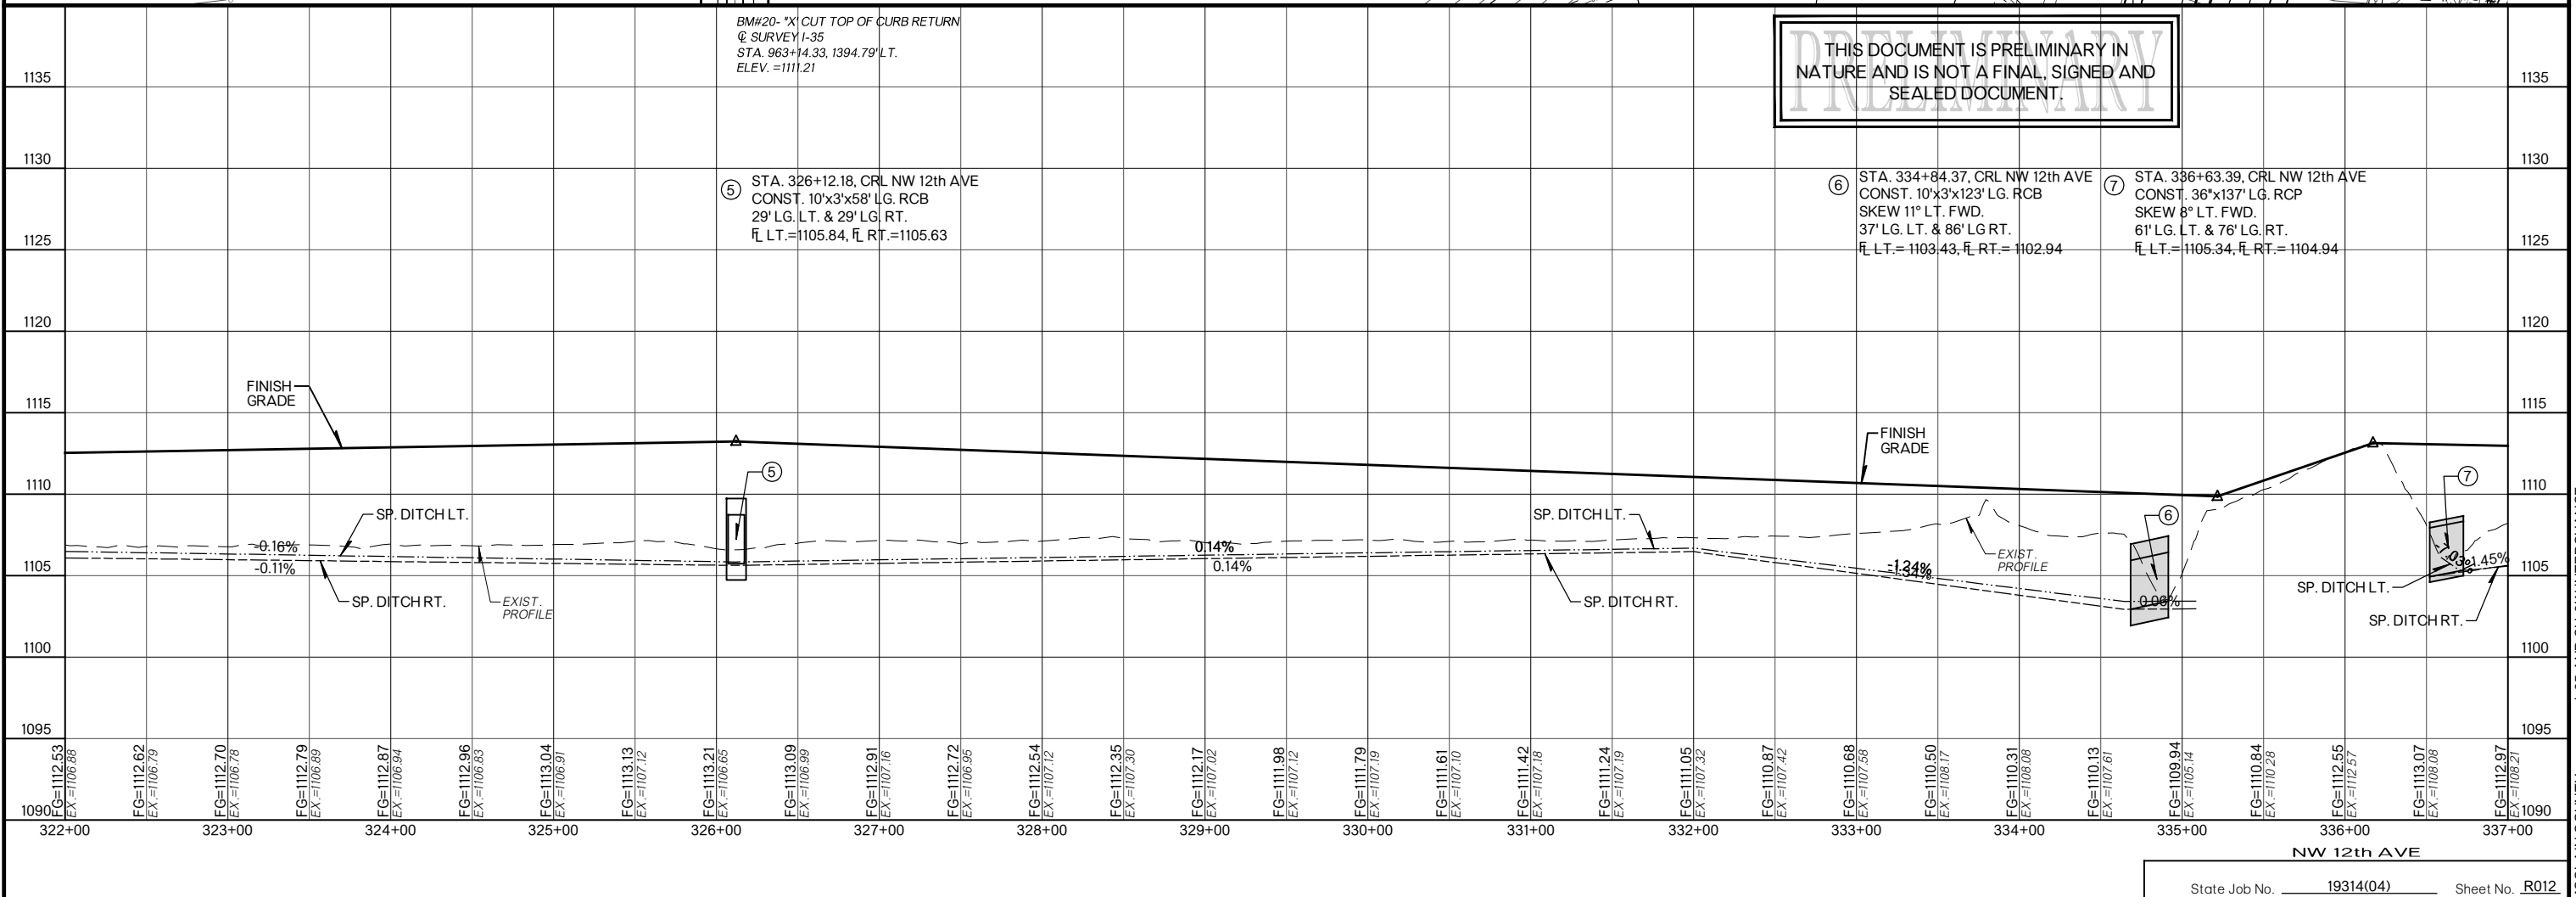
⑤ STA. 326+12.18, CRL NW 12th AVE
CONST. 10'x3'x58' LG. RCB
29' LG. LT. & 29' LG. RT.
FL LT. = 1105.84, FL RT. = 1105.63

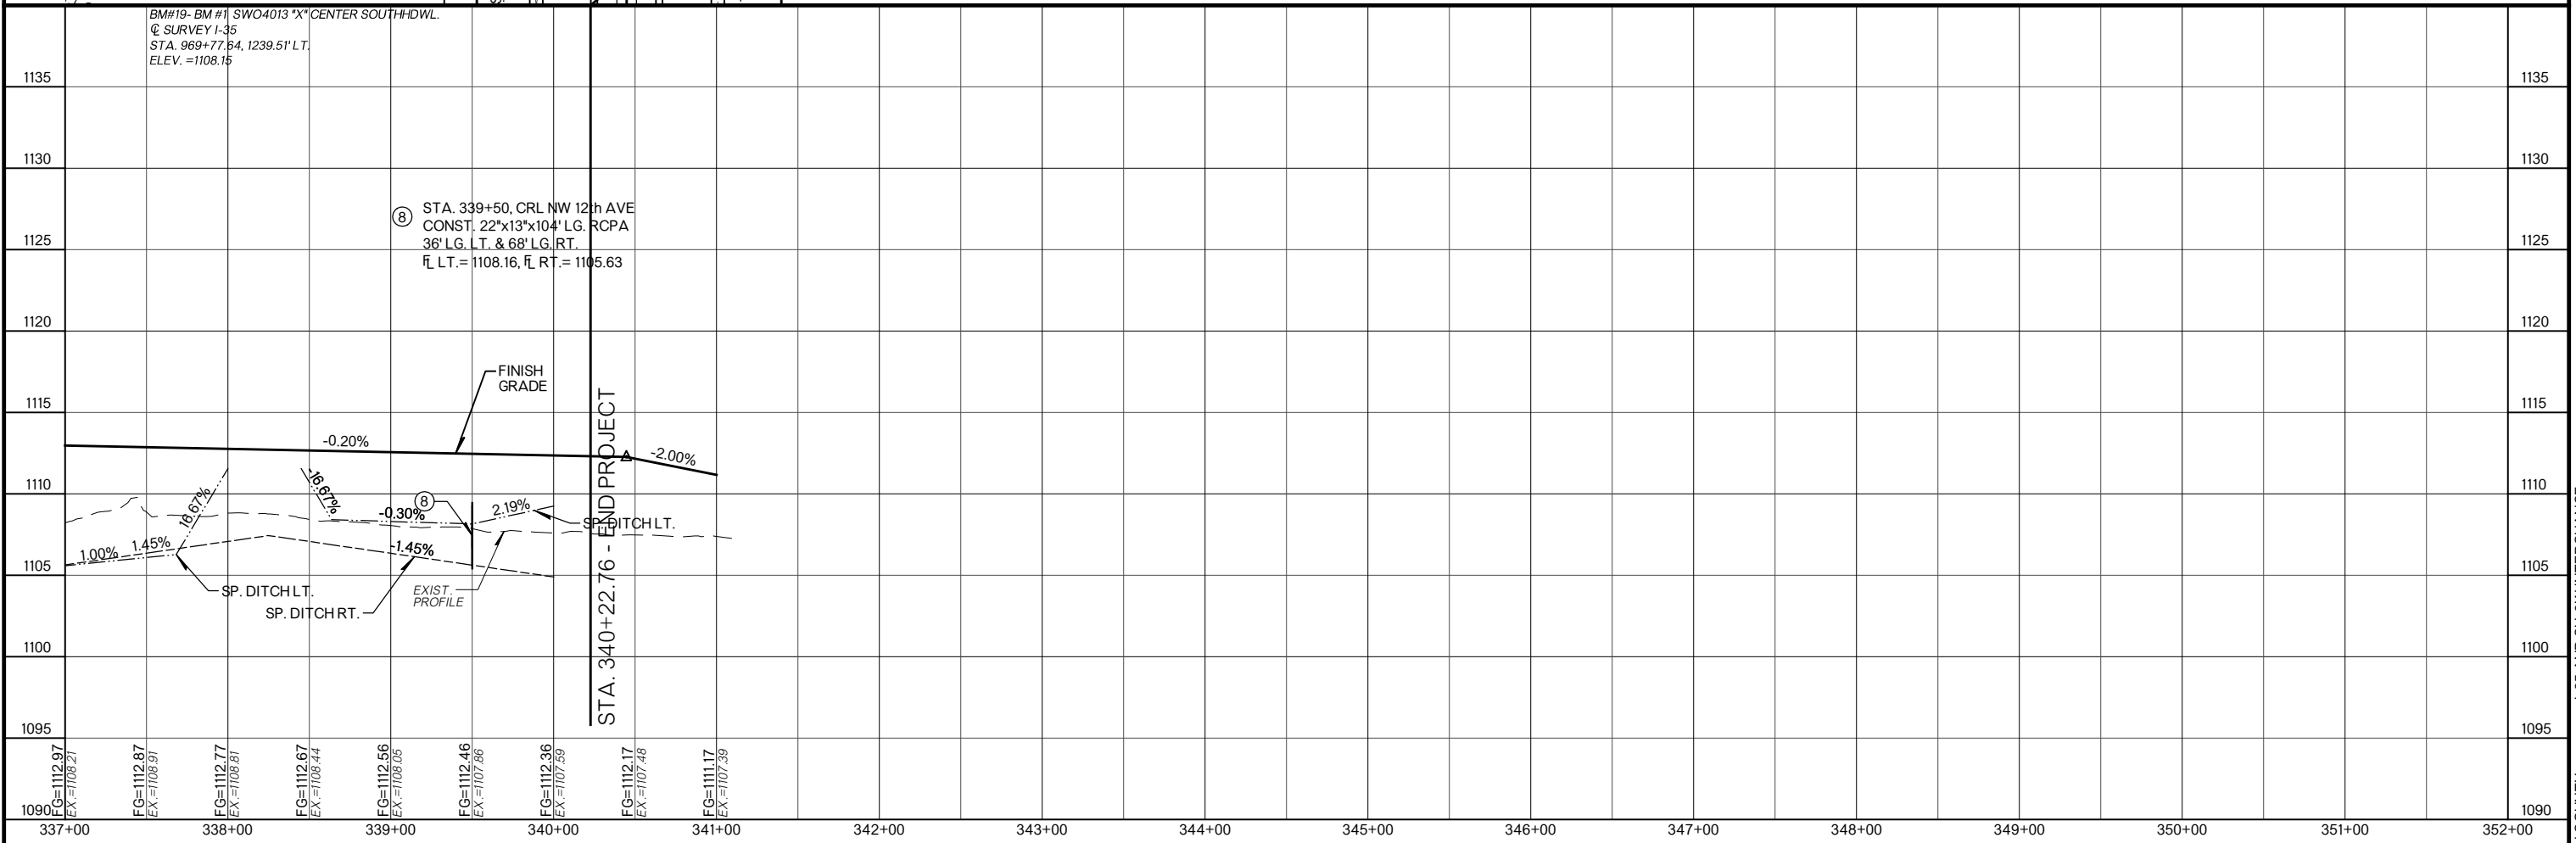
⑧ STA. 339+50, CRL NW 12th AVE
CONST. 22"x13"x104" LG. RCPA
36' LG. LT. & 68' LG. RT.
FL LT. = 1108.16, FL RT. = 1105.63

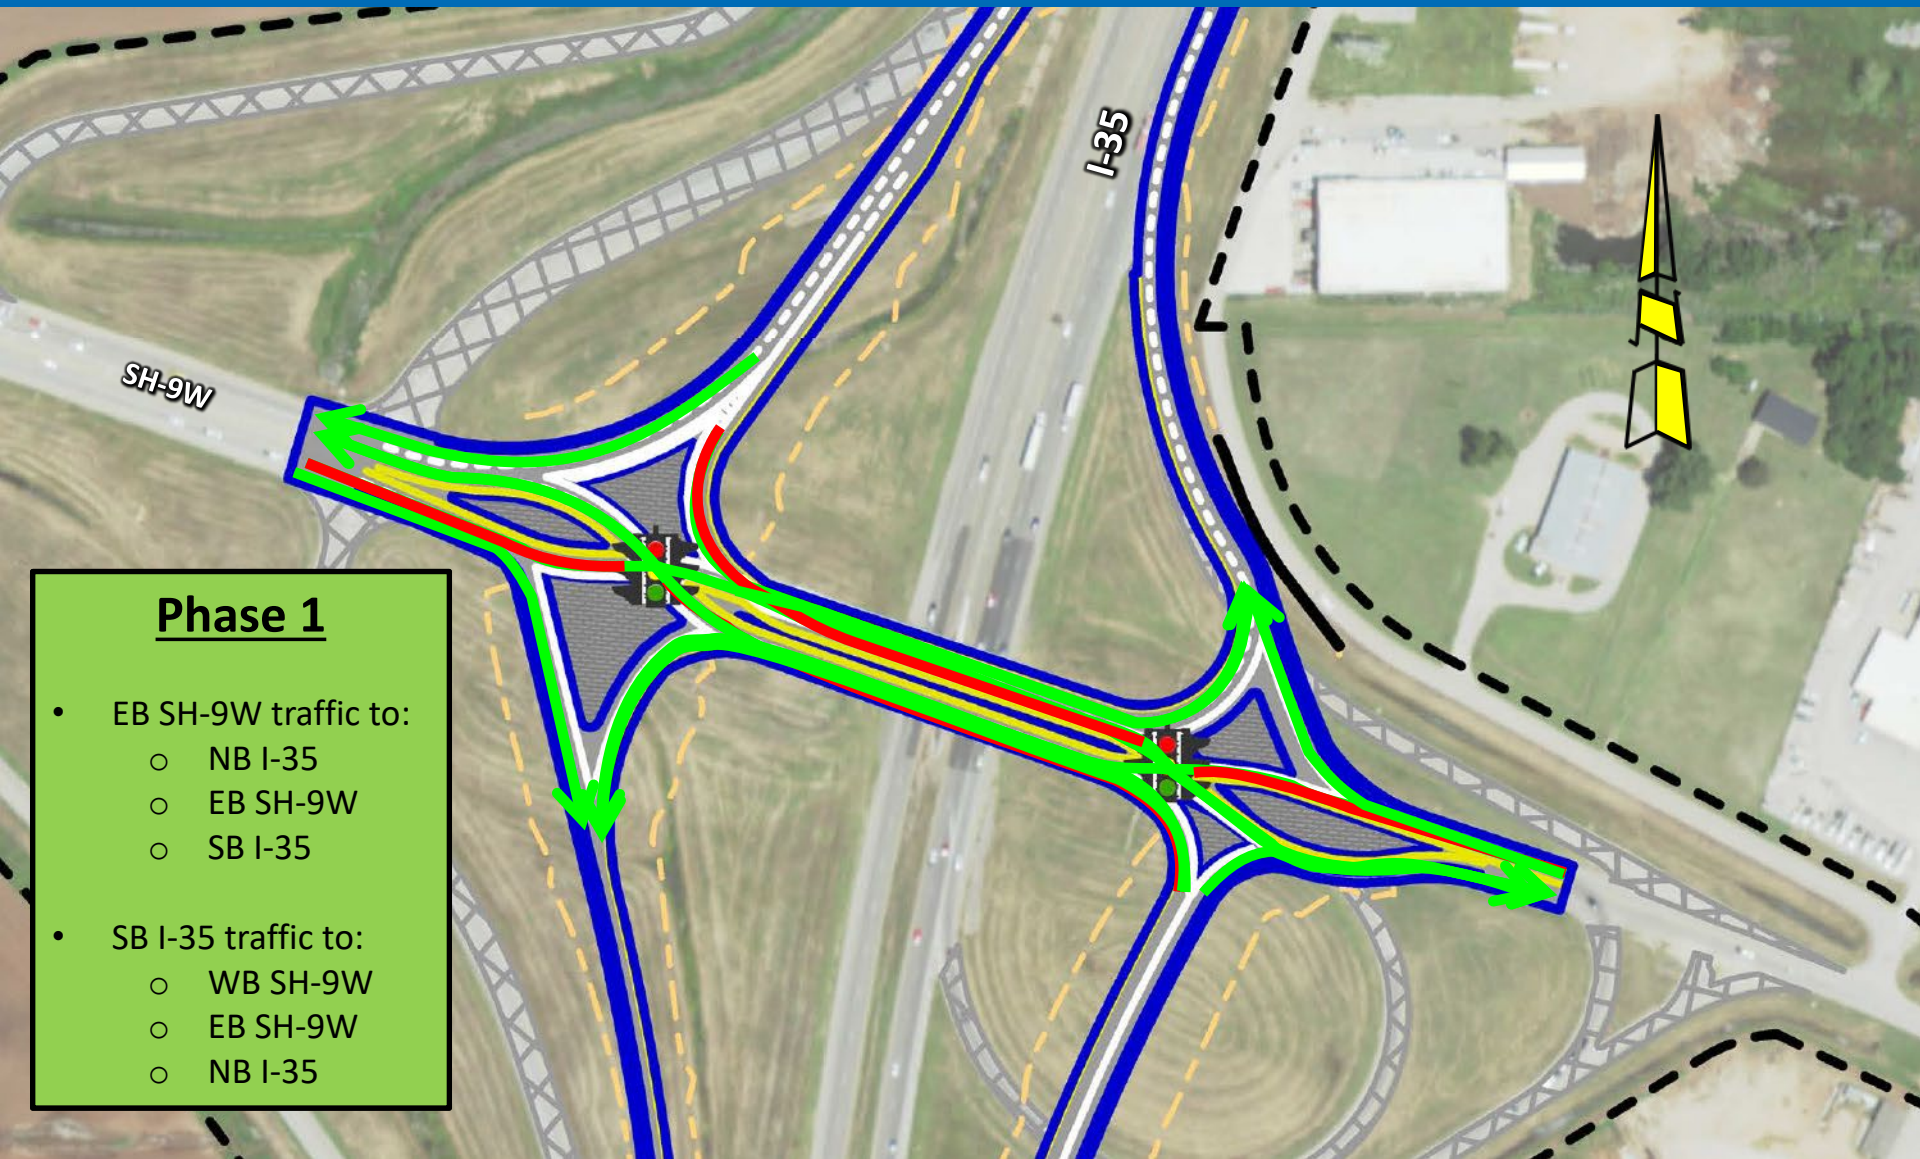
What is a Diverging Diamond Interchange?

- Phase 1**
- EB SH-9W traffic to:
 - NB I-35
 - EB SH-9W
 - SB I-35
 - SB I-35 traffic to:
 - WB SH-9W
 - EB SH-9W
 - NB I-35

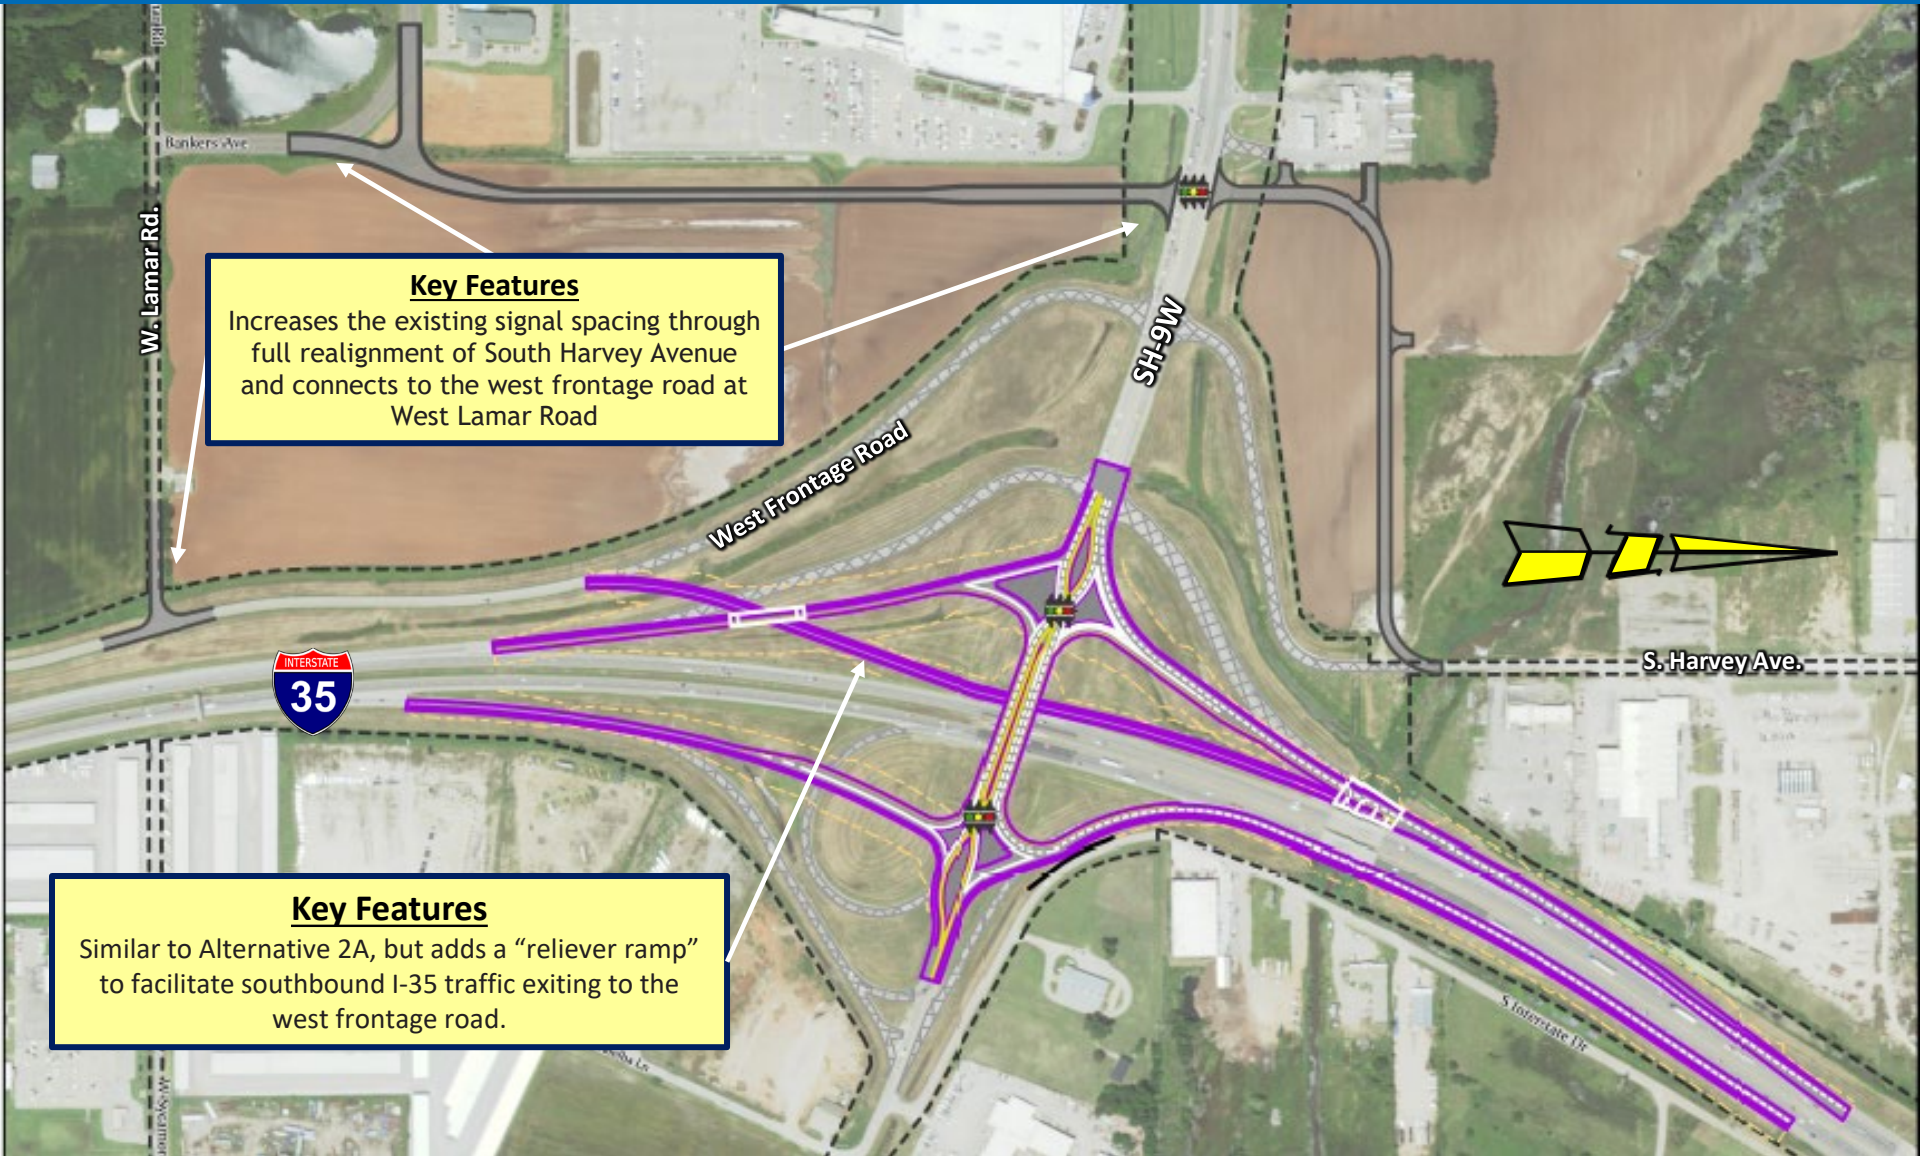
Alternative 2B: Diverging Diamond Interchange (DDI) with Reliever Ramp

Key Features
Increases the existing signal spacing through full realignment of South Harvey Avenue and connects to the west frontage road at West Lamar Road

Key Features
Similar to Alternative 2A, but adds a “reliever ramp” to facilitate southbound I-35 traffic exiting to the west frontage road.

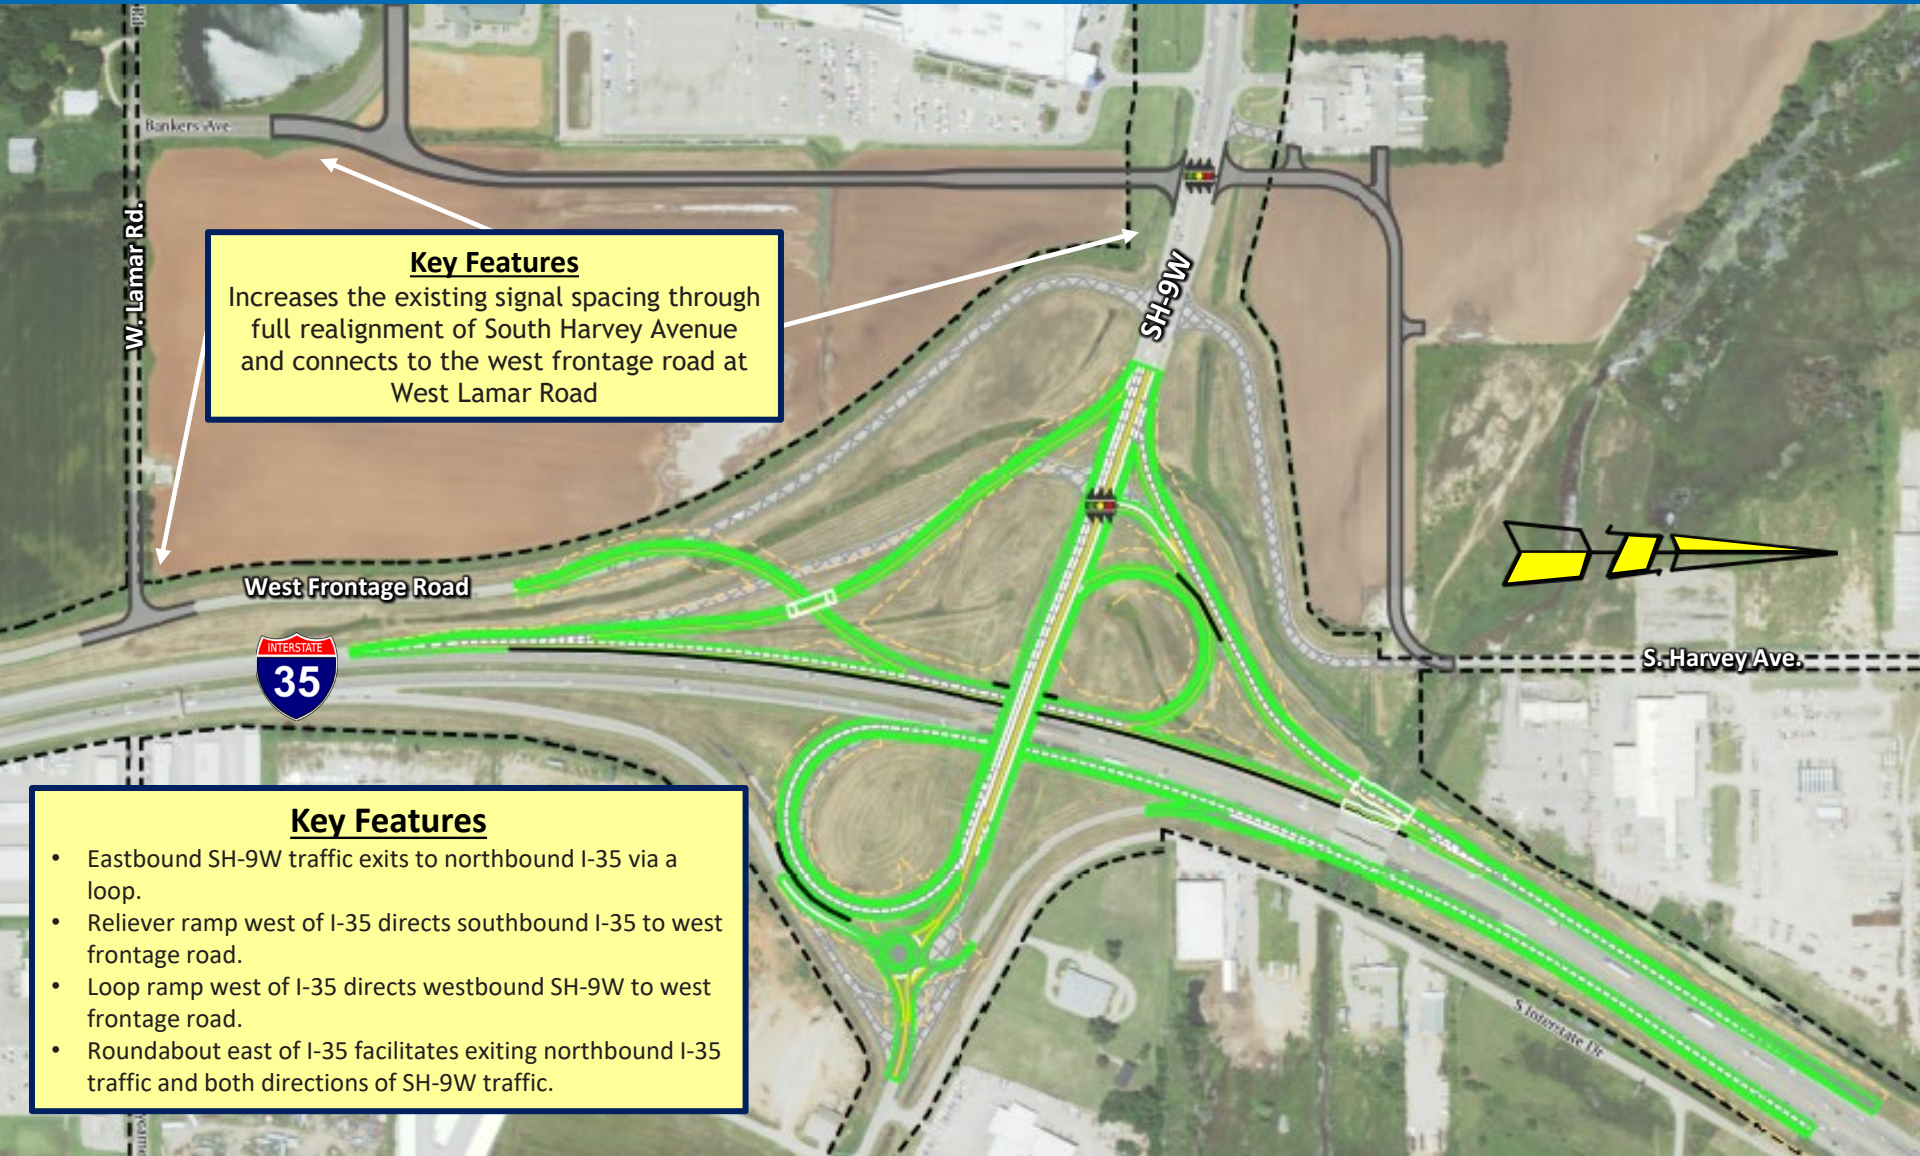
Alternative 3D: Loop Interchange with Reliever Ramp

Key Features
Increases the existing signal spacing through full realignment of South Harvey Avenue and connects to the west frontage road at West Lamar Road

- Key Features**
- Eastbound SH-9W traffic exits to northbound I-35 via a loop.
 - Reliever ramp west of I-35 directs southbound I-35 to west frontage road.
 - Loop ramp west of I-35 directs westbound SH-9W to west frontage road.
 - Roundabout east of I-35 facilitates exiting northbound I-35 traffic and both directions of SH-9W traffic.

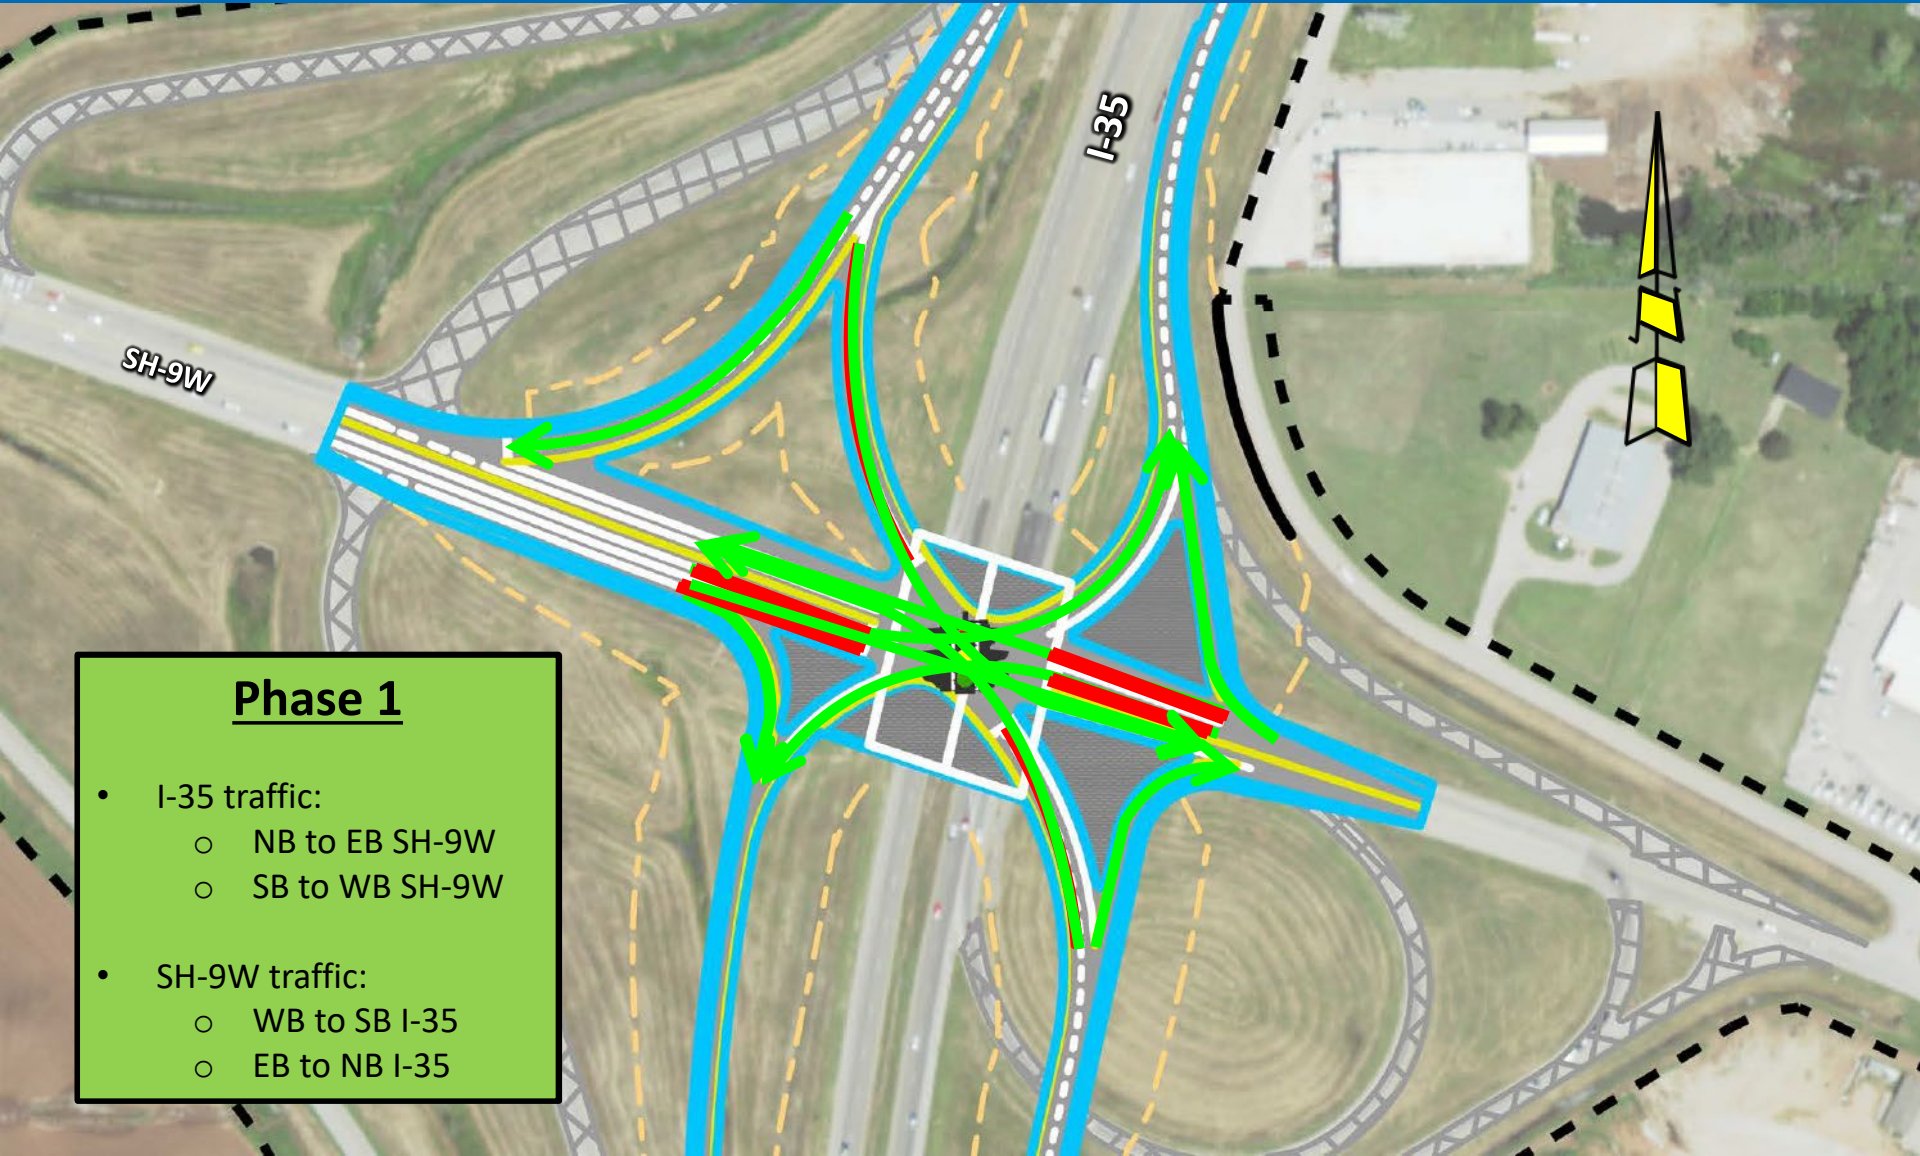
What is a Single Point Urban Interchange?

Phase 1

- I-35 traffic:
 - NB to EB SH-9W
 - SB to WB SH-9W
- SH-9W traffic:
 - WB to SB I-35
 - EB to NB I-35
