7300–Facilities  
January 2012  
1273–2805P–MTDC  
FEMA P–911

# Pocket Safety Guide for Dams and Impoundments

This “Pocket Safety Guide for Dams and Impoundments” was developed for dam owners and other people as a quick reference when assessing low hazard dams and impoundments. For in-depth discussion, please refer to the U.S. Fish and Wildlife Service “Low Hazard Dams—Standing Operating Procedures” or FEMA 145, “Dam Safety: An Owner’s Guidance Manual.”

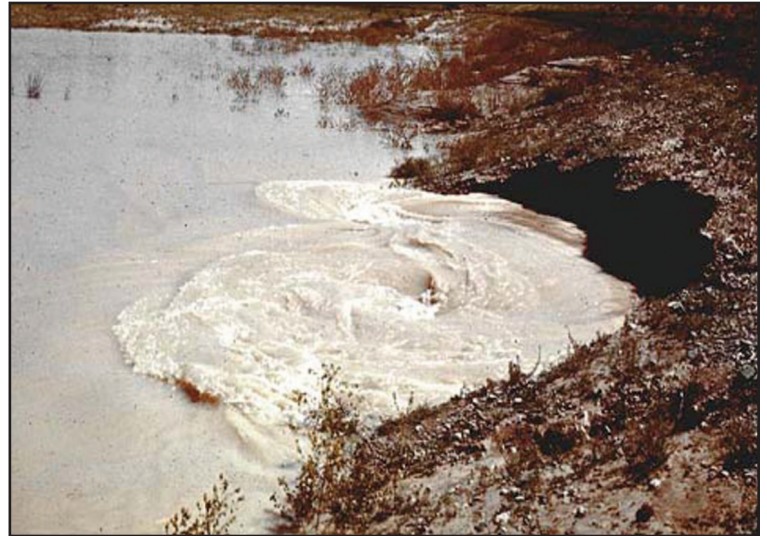
Figure 6—Whirlpool action is an indication of advanced piping.

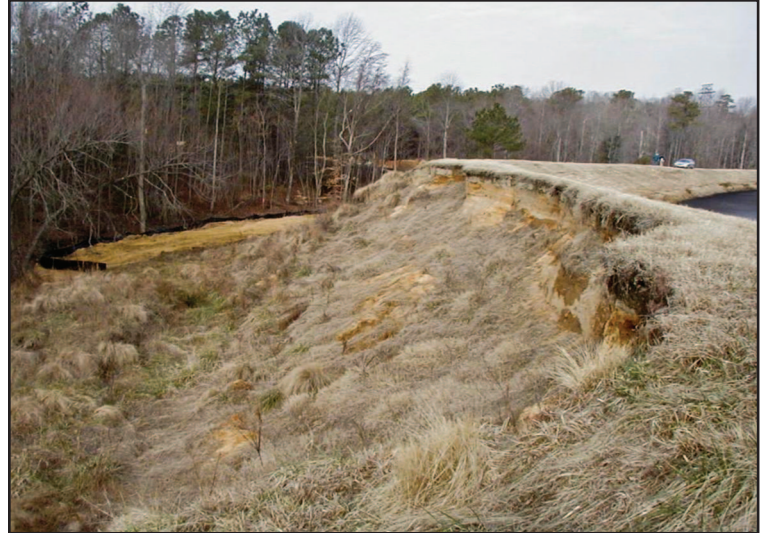
Figure 8—Slumping on the downstream face of a dam.

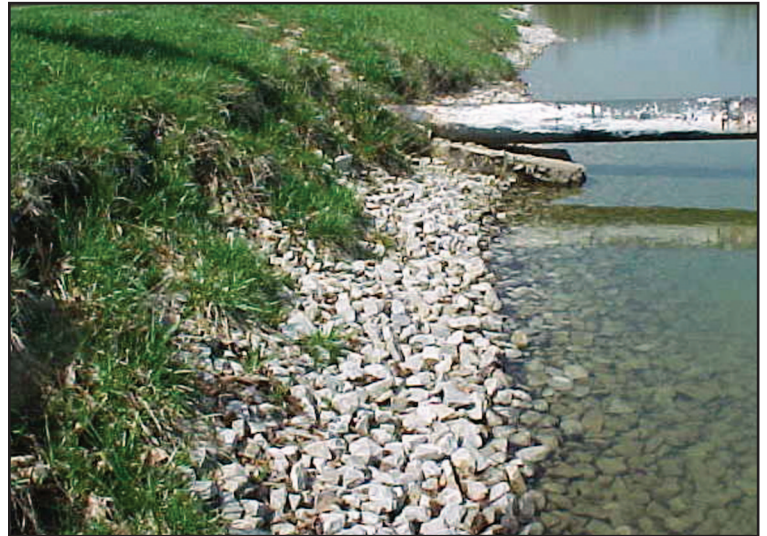
Figure 10—Wave erosion on the unprotected face of a dam.

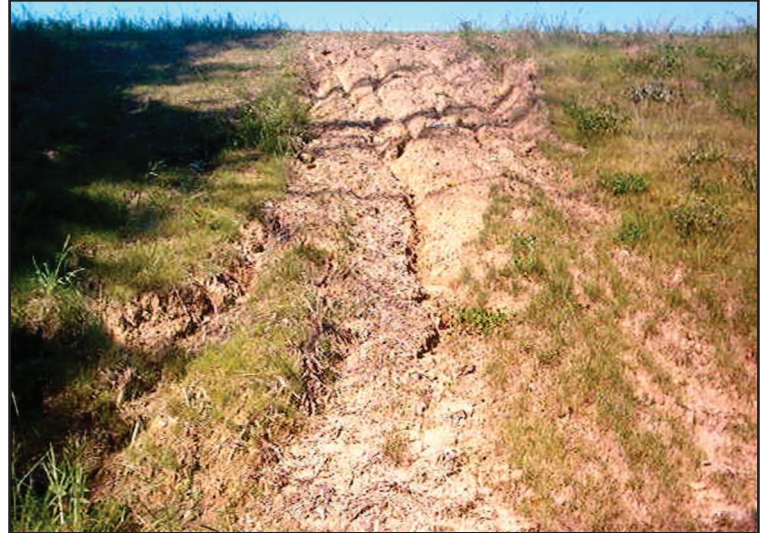
Figure 12—Erosion on the downstream face of a dam.

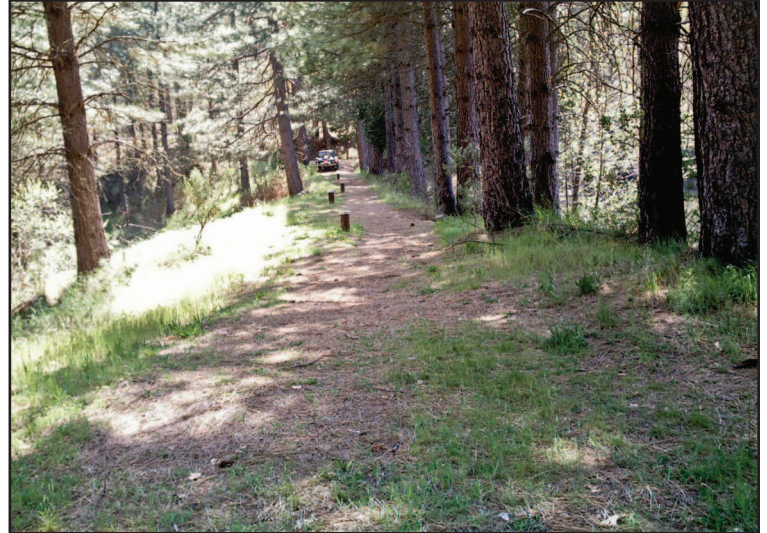
Figure 14—Trees growing on the crest and the faces of a dam.

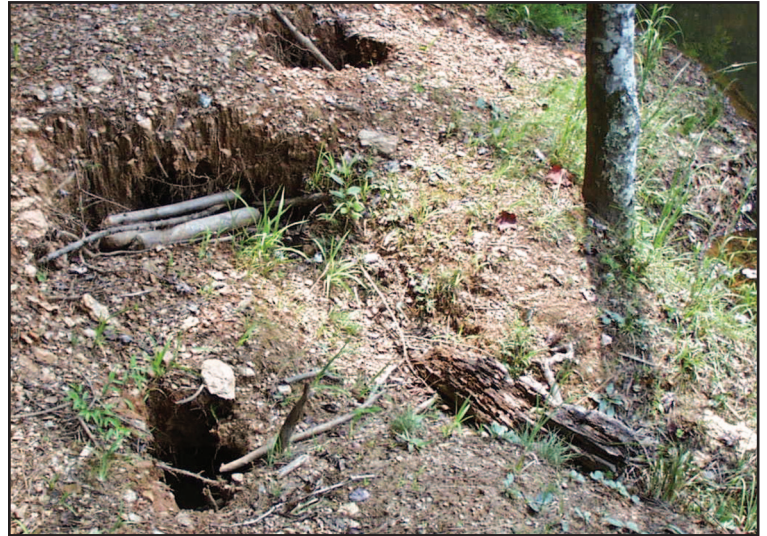
Figure 16—Rodent holes in the dam face can cause dam failure.

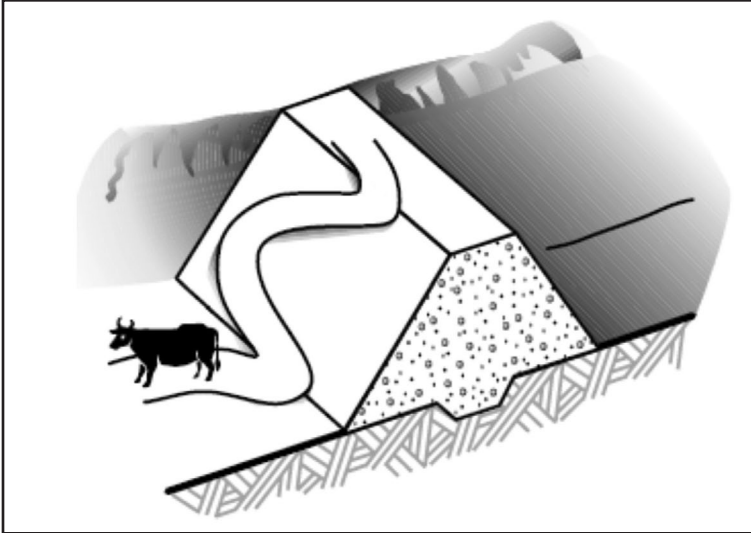
- Livestock paths and activities on the downstream dam face can damage slopes, especially when wet.
- Livestock activities may reduce erosion protection and cause erosion channels.
- Bare areas may allow water to stand and be susceptible to drying cracks.

Figure 17—Livestock and cattle traffic.

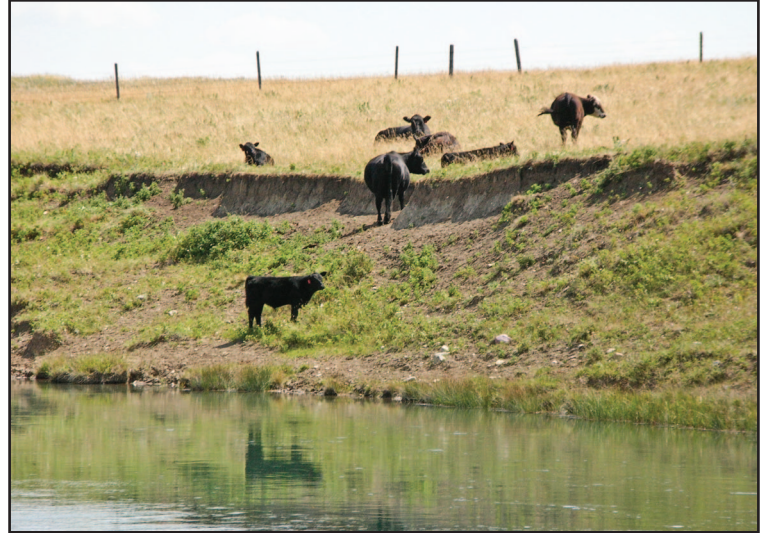
Figure 18—Livestock paths on dam faces can lead to dam erosion.

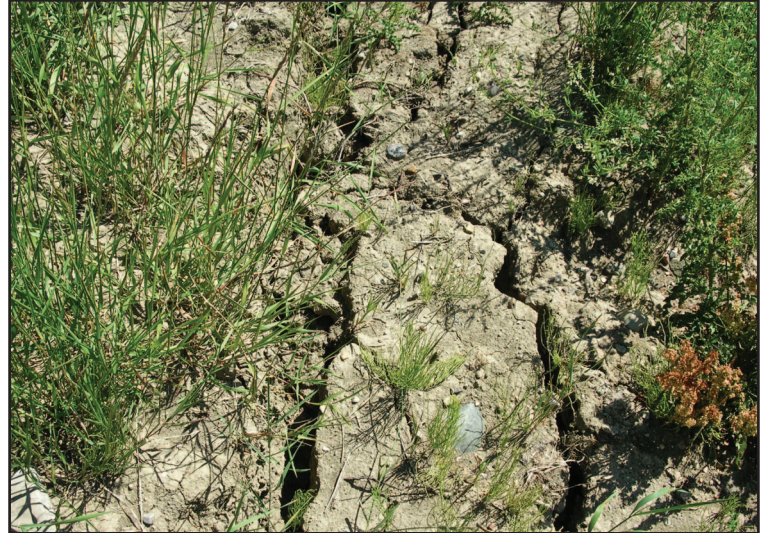
Figure 20—Transverse cracks can be an indication of dam instability.

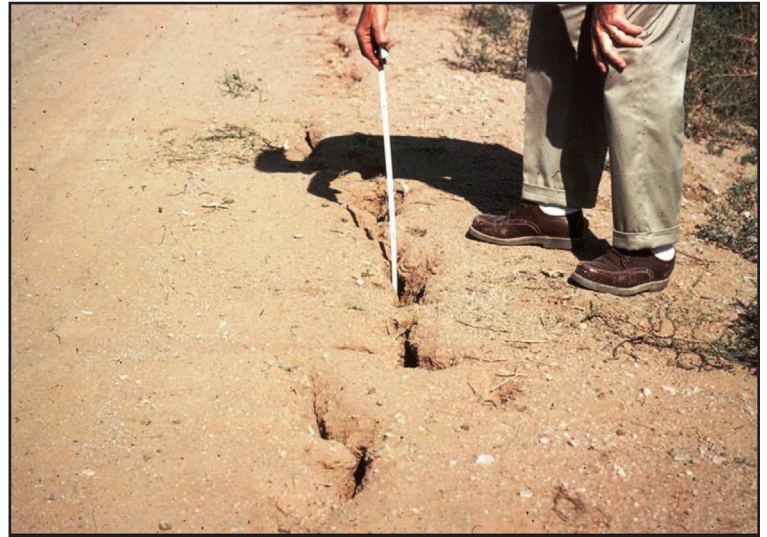
Figure 22—Longitudinal cracks can be an indication of dam instability.

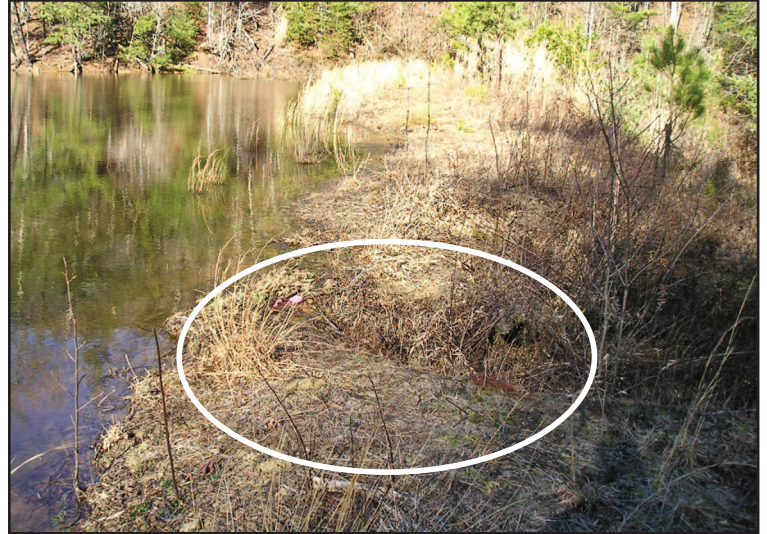
Figure 24—Low areas in the crest of a dam reduce the freeboard.

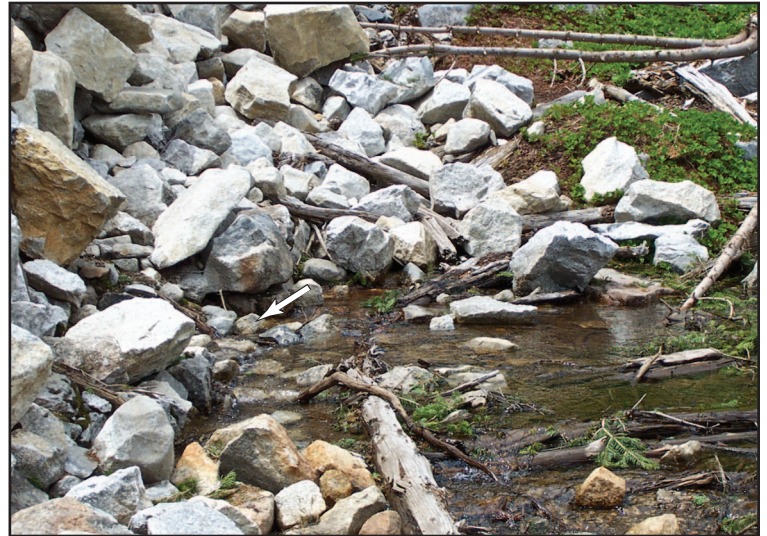
Figure 26—Excessive water piping through the dam at the toe of the embankment.

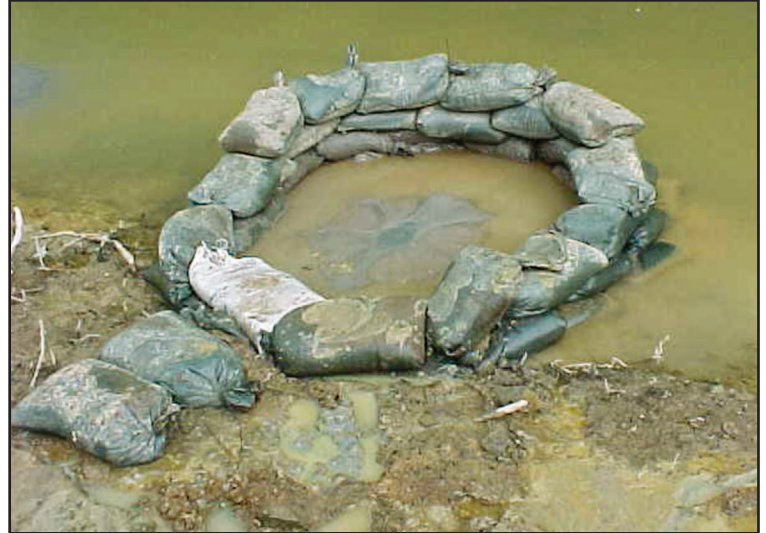
- Examine the boil to see if foundation materials are being transported.
- Have a qualified engineer inspect the condition and recommend further actions.
- If soil particles are moving downstream, use sandbags or earth to create a dike around the boil. The pressures created by the water level may control flow velocities and temporarily prevent further erosion.
- If erosion is increasing, the reservoir level should be lowered.

Figure 28— Sandbags surrounding a boil on the downstream side of the dam.

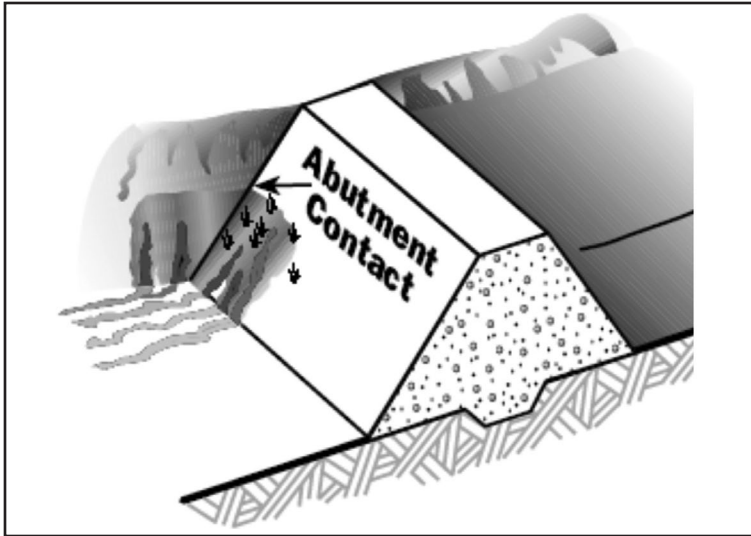
- Water flowing through pathways in the abutment or through the embankment can cause seepage.
- Seepage can lead to erosion of the embankment material and dam failure.

Figure 29—Seepage exiting at the abutment contact (groin).

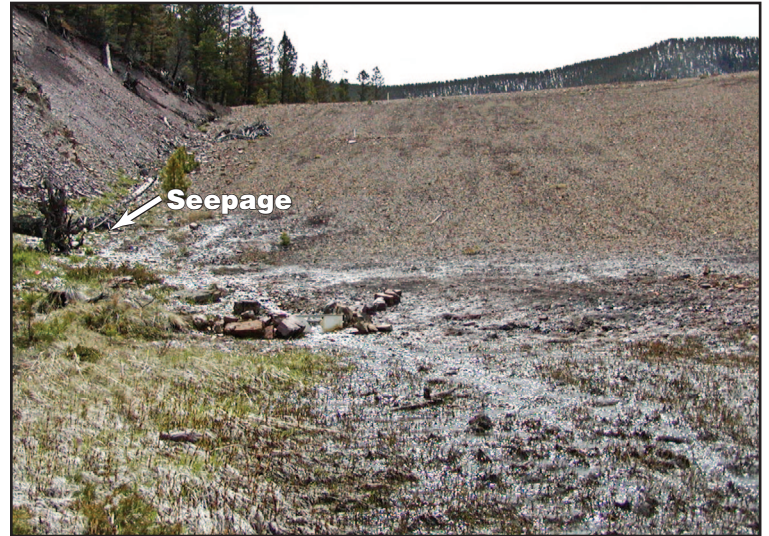
Figure 30—Seepage at the abutment contact (groin) can lead to dam failure.

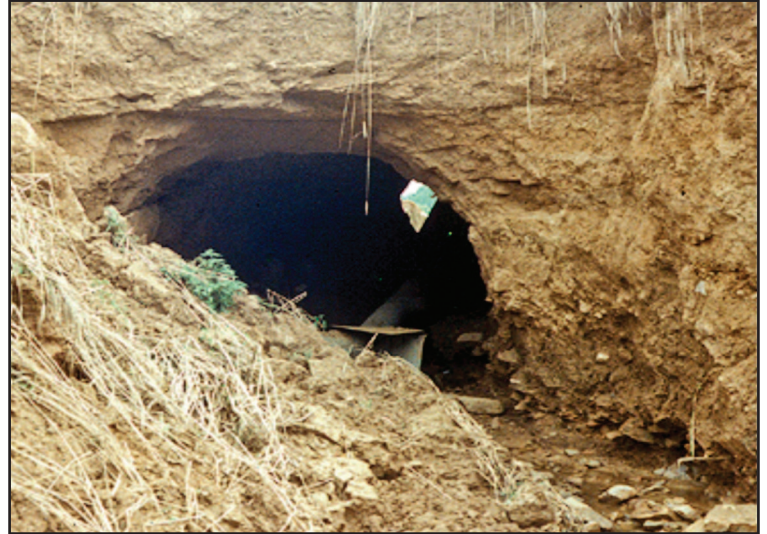
Figure 32—Piping of water alongside an outlet pipe.

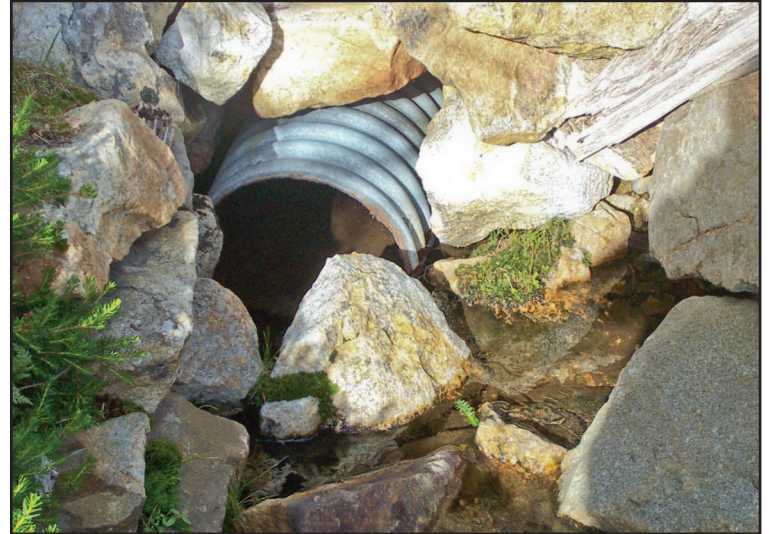
Figure 34—Rock failure around an outlet pipe.

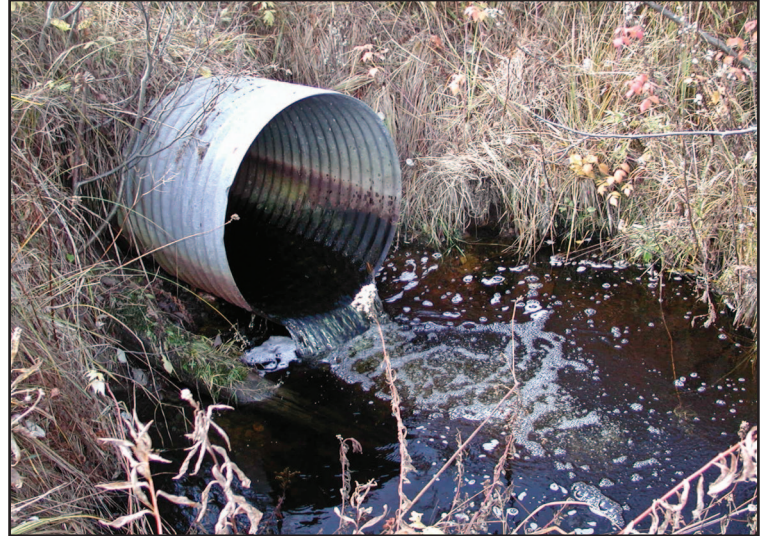
Figure 36—A scour hole at an outlet erodes the toe of the slope.

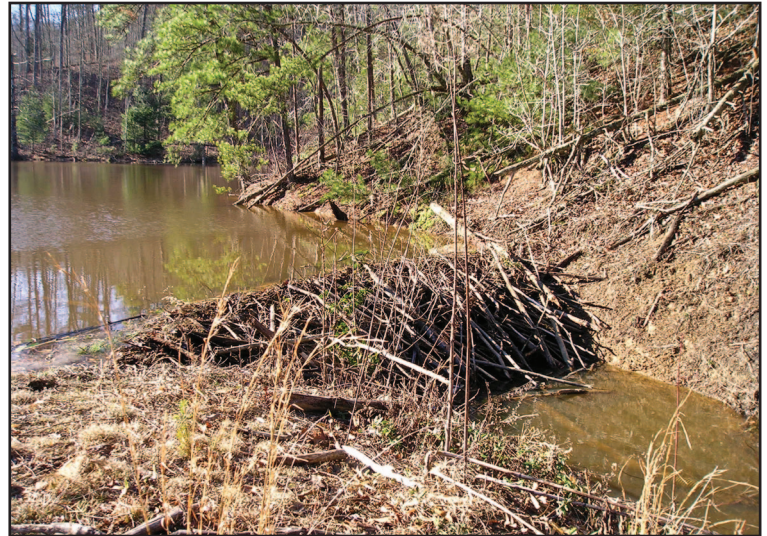
Figure 38—A blocked spillway channel may cause overtopping of the dam.

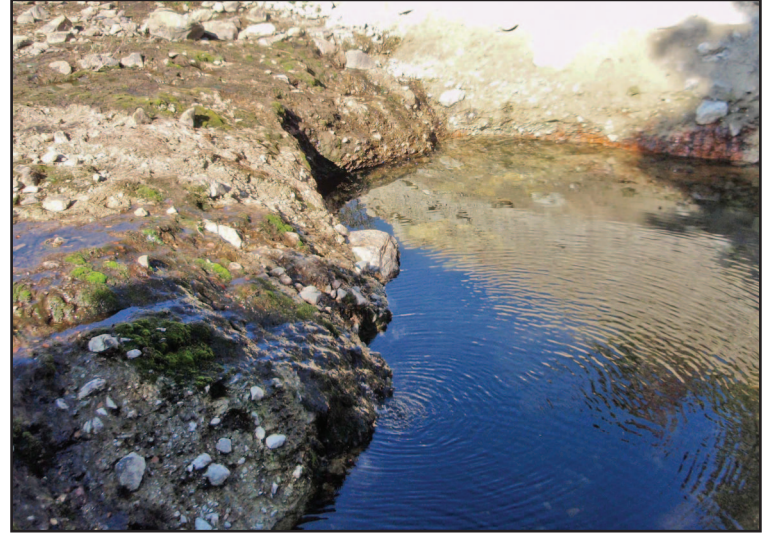
- Surface runoff from intense rainstorms or flow from the spillway carries surface material down the spillway causing continuous troughs.
- Livestock traffic creates gullies where runoff flow can concentrate.
- Unabated erosion can lead to slides, slumps, or slips, which can result in reduced spillway capacity. Inadequate spillway capacity can lead to embankment overtopping and result in dam failure.

Figure 40—Erosion of the spillway channel may lead to slumps or slides of the spillway sides.

- Photograph the condition and bring it to the attention of the engineer.
- Replace eroded material with compacted fill to repair damaged areas.
- Revegetate the areas if appropriate.
- Install suitable rock riprap to protect against future erosion.
